DEKRA's commission No. : PKOL(W)/LODZ/19544/25/03/18
commission/ damage No. : 19/023079
Date of commission: 18-03-2025

Vehicle data

Measurement of thickness of the vehicle lacquer coating

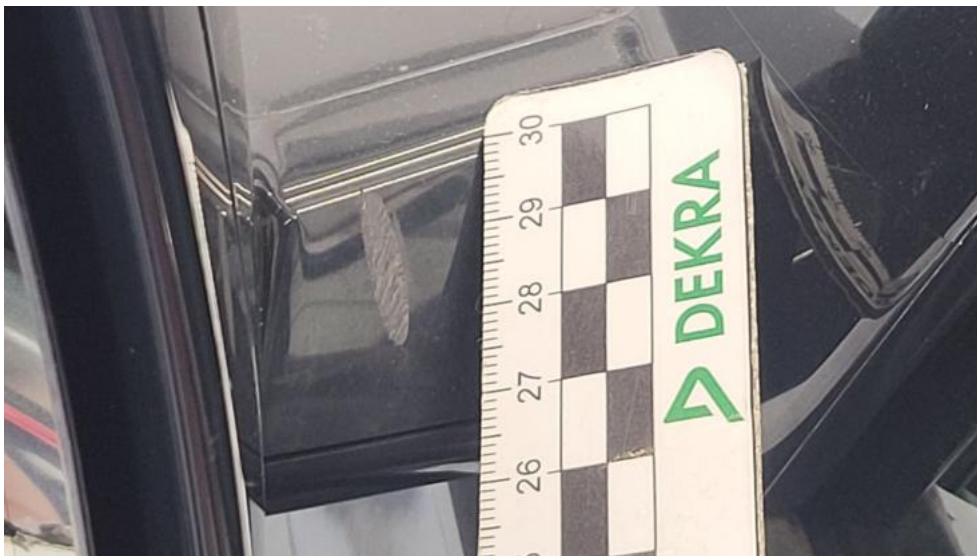
Photo 63.
Lusterko zew L - Rysa/odprysk 1
