DEKRA's commission No. : PKOL(W)/LODZ/84709/26/09/09  
commission/ damage No. : 25/038160  
Date of commission: 09-09-2026

**DEKRA Poland - Headquarters**  
02-673 Warszawa, ul. Konstruktorska 12A

| Model | X5 [F15/F85] 13-18 |
| Type / version | X5 xDrive40d |

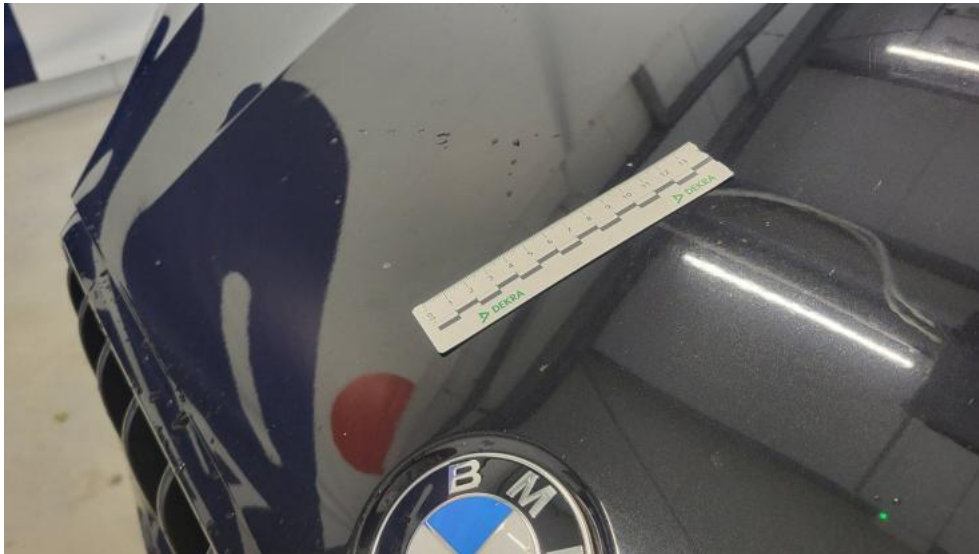
**Photo 39.**

Pokrywa komory silnika - Rysa/odprysk 1

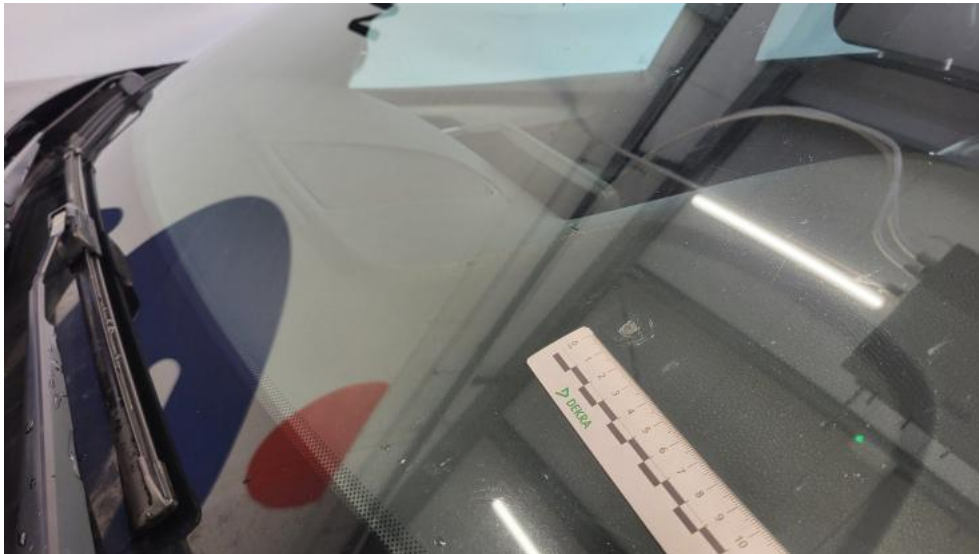
**Photo 41.**

Szyba czołowa - zdjęcie poglądowe 1

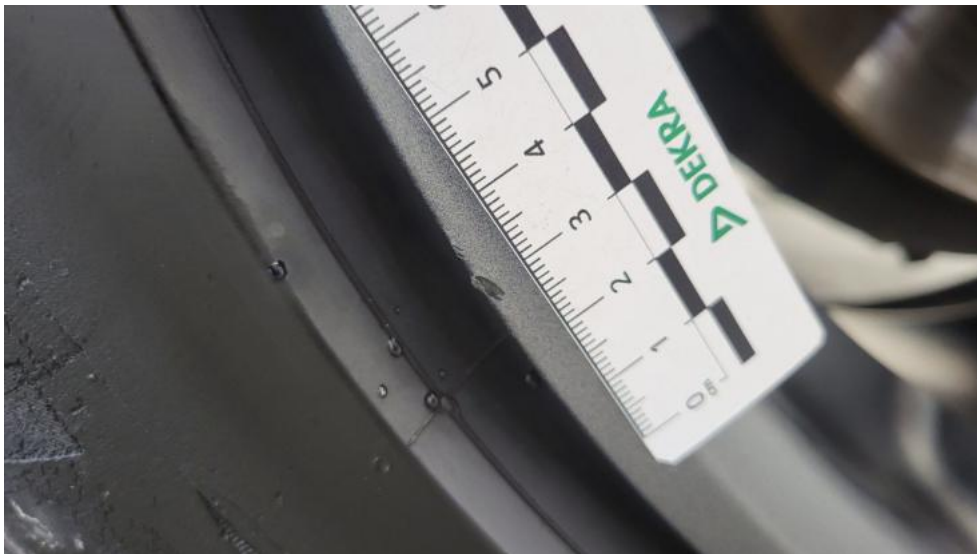
**Photo 45.**

Felga aluminiowa przednia P - Rysa/odprysk 1

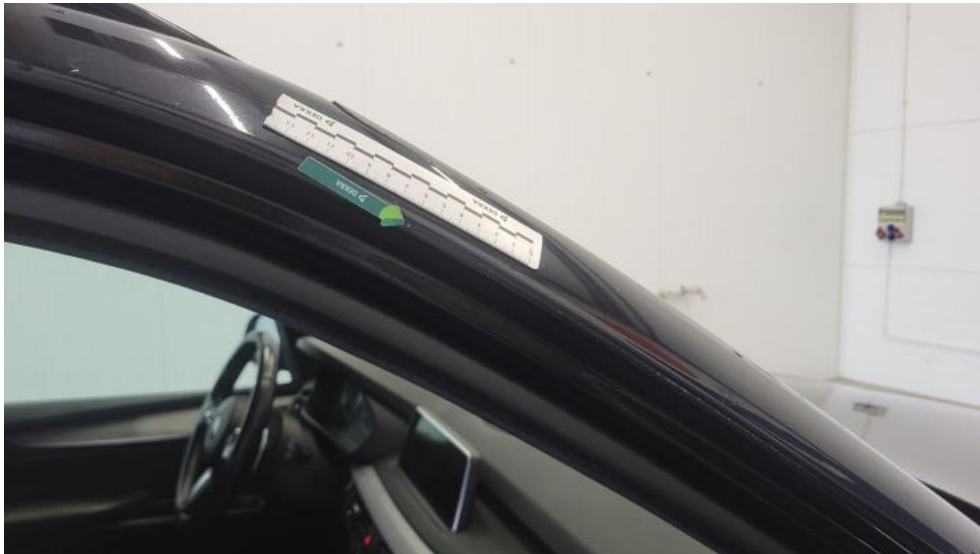
**Photo 51.**

Słupek przedni P - zdjęcie poglądowe 1

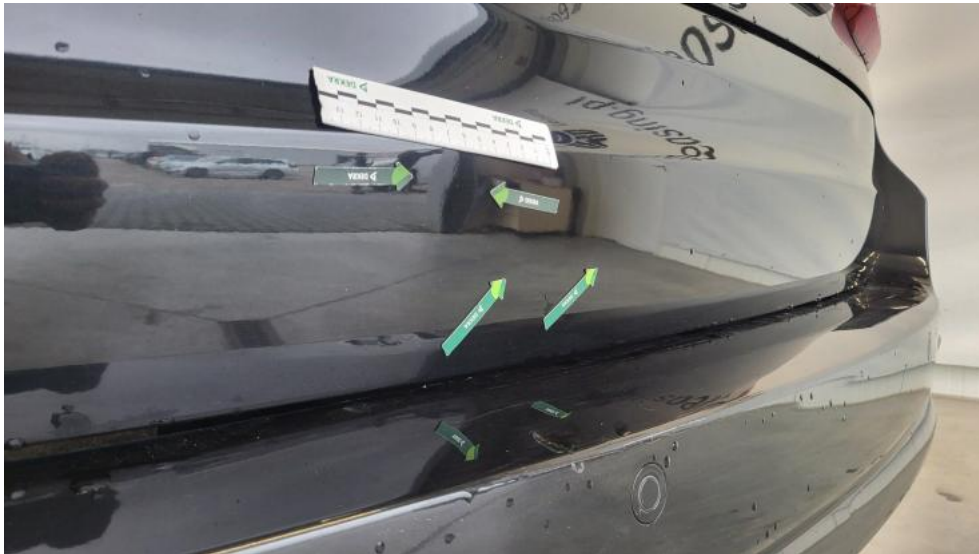
**Photo 61.**

Pokrywy bagażnika - Wgniecenie/odkształcenie 1

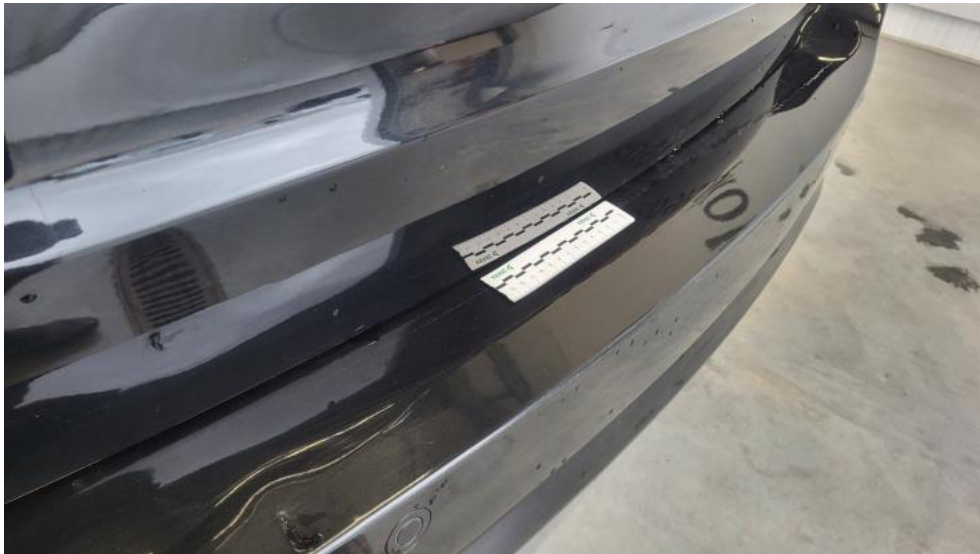
**Photo 65.**

Zderzak tylny - Wgniecenie/odkształcenie 2

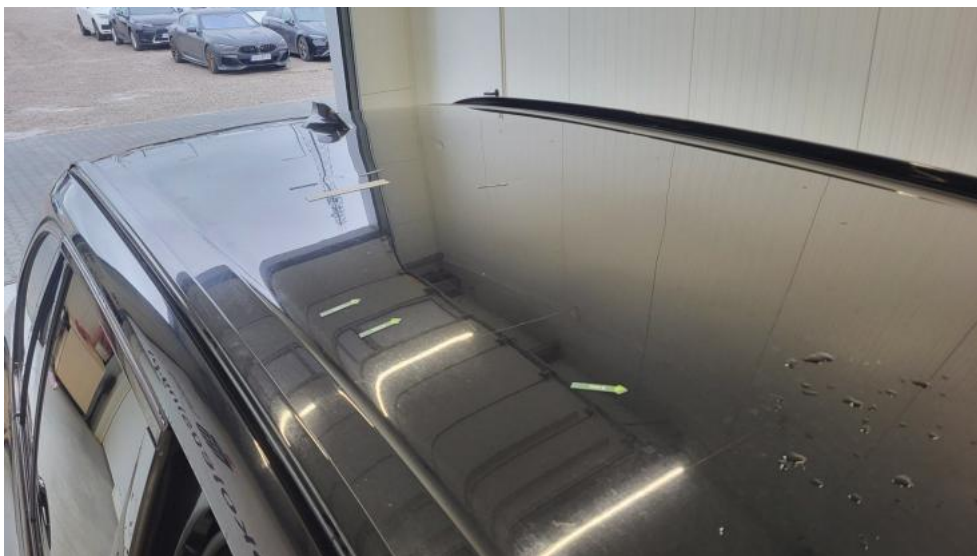
**Photo 69.**

Dach - zdjęcie poglądowe 1

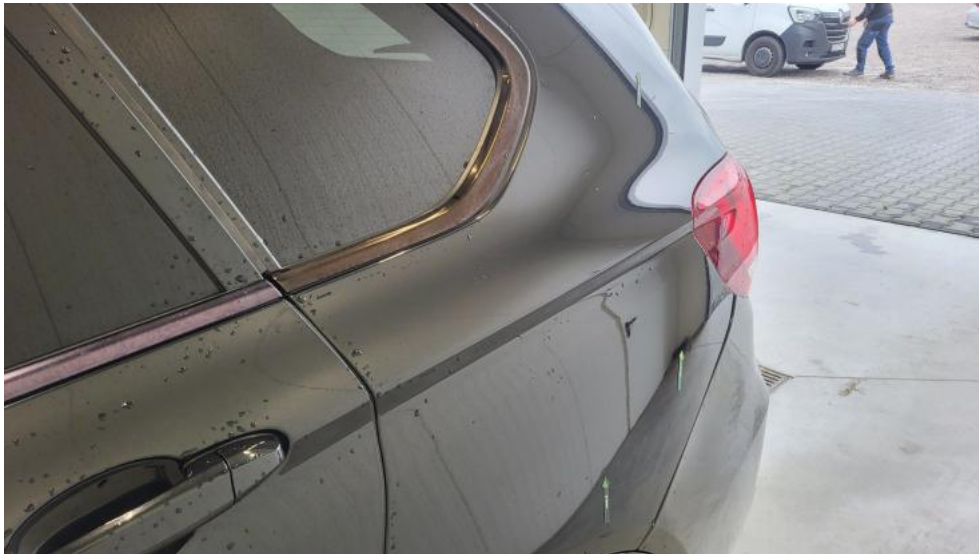
**Photo 71.**

Błotnik tylny L / Ściana boczna L - Wgniecenie/odkształcenie 1

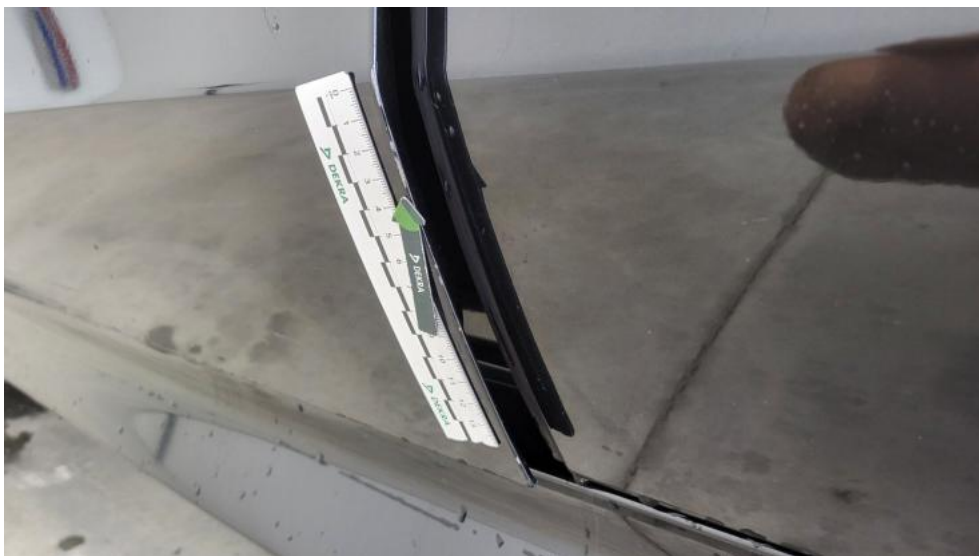
**Photo 72.**

Drzwi przed L - zdjęcie poglądowe 1

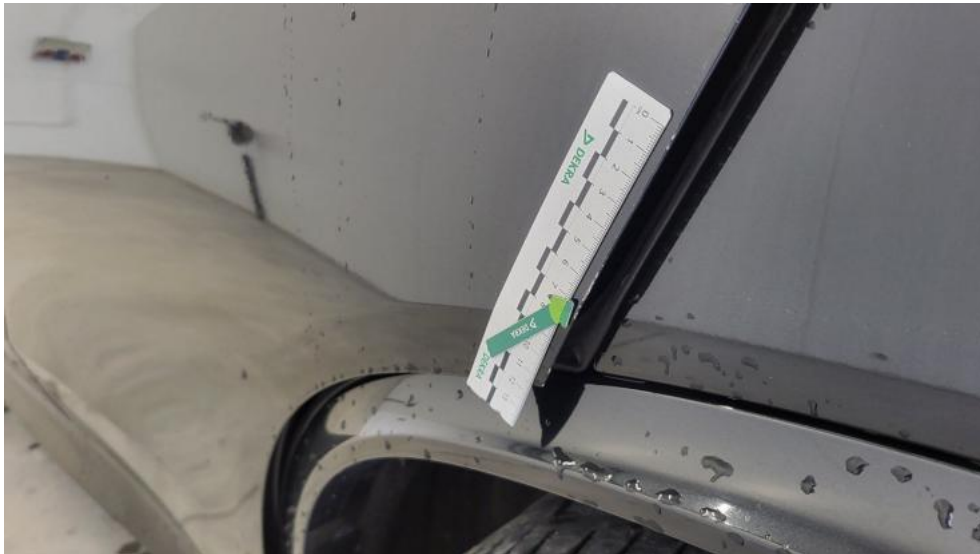
**Photo 75.**

Drzwi tylne L - zdjęcie poglądowe 1

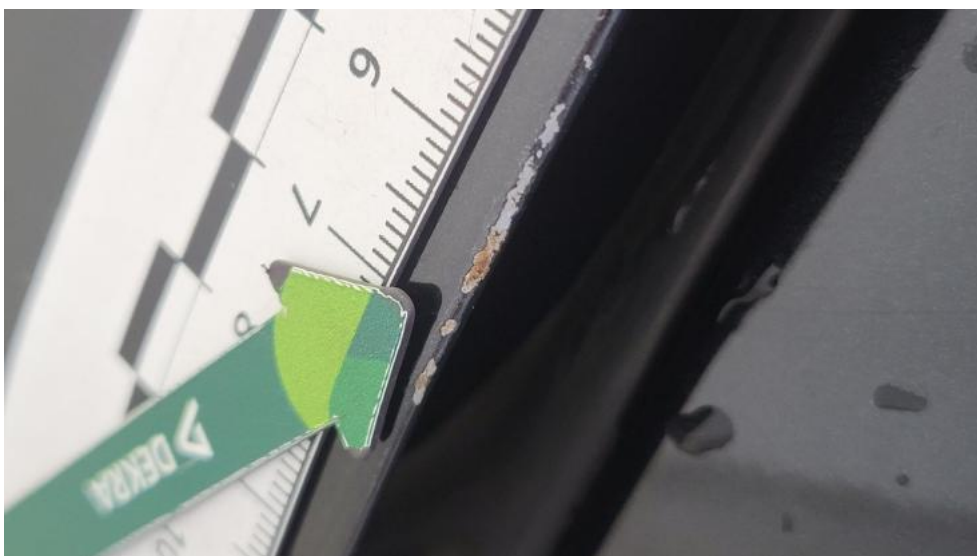
**Photo 78.**

Drzwi tylne L - Inne 1

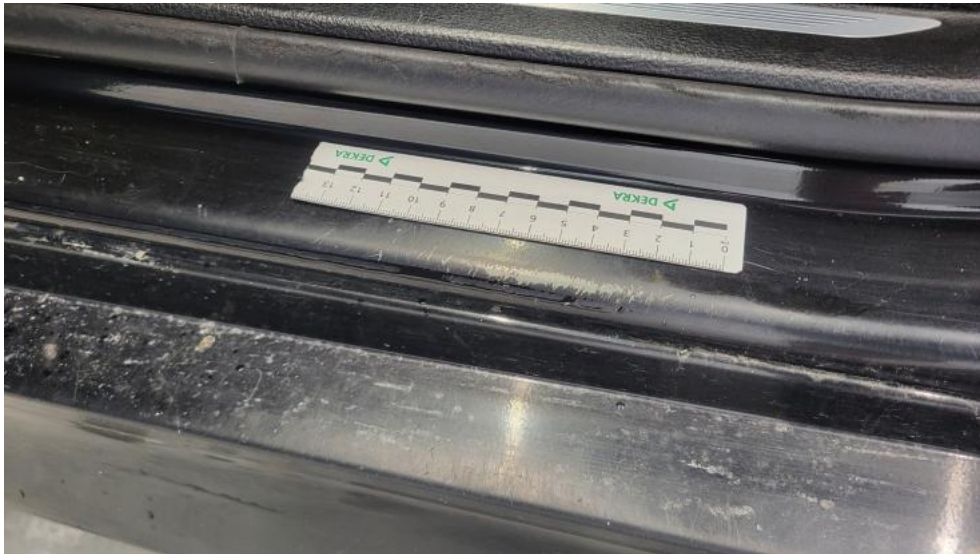
**Photo 79.**

Próg L - Rysa/odprysk 1

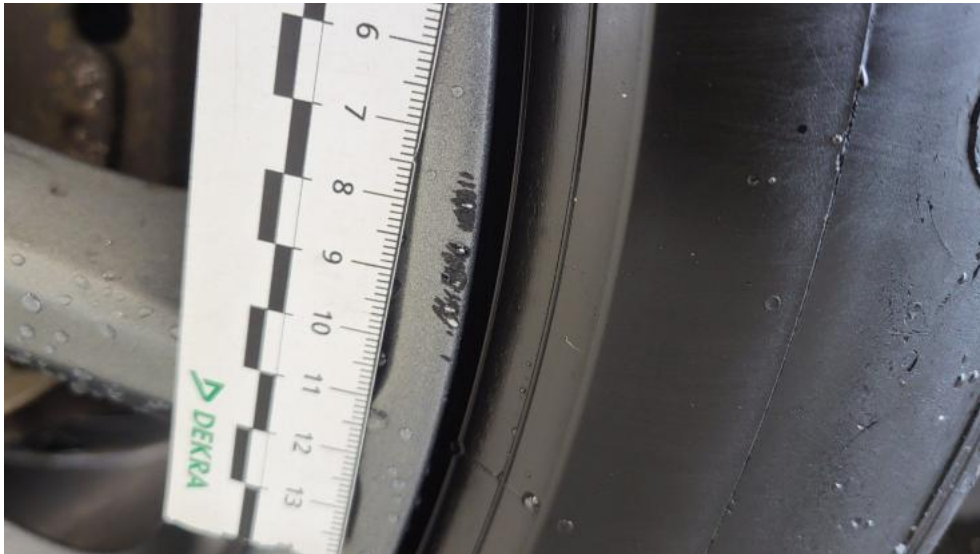
**Photo 81.**

Felga Aluminiowa przednia L - Rysa/odprysk 1

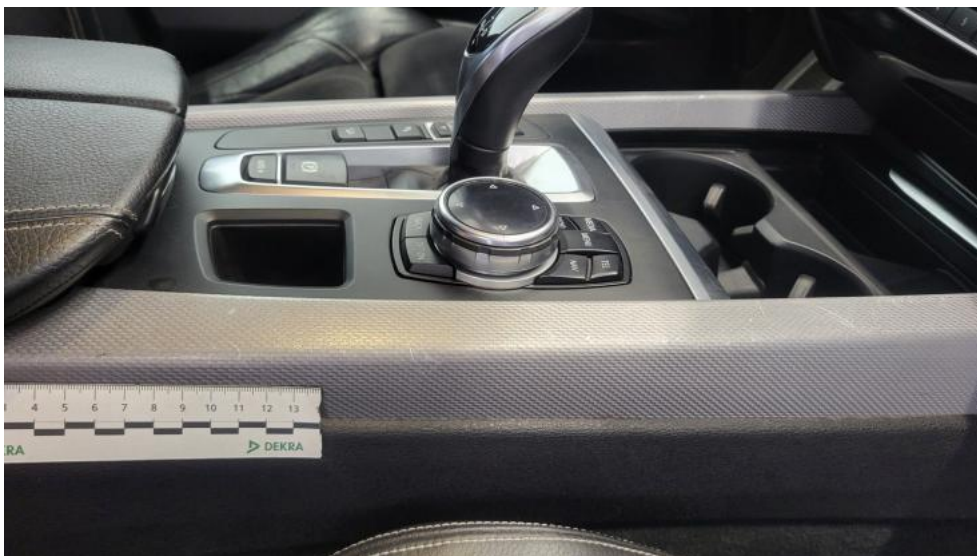
**Photo 83.**

Konsola środkowa - Rysa/odprysk 1

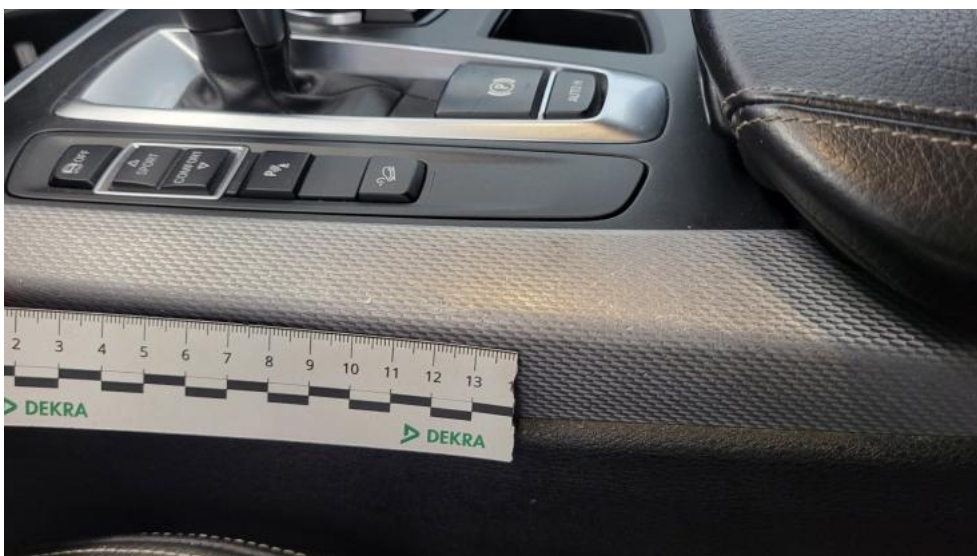
**Photo 84.**

Konsola środkowa - Rysa/odprysk 2

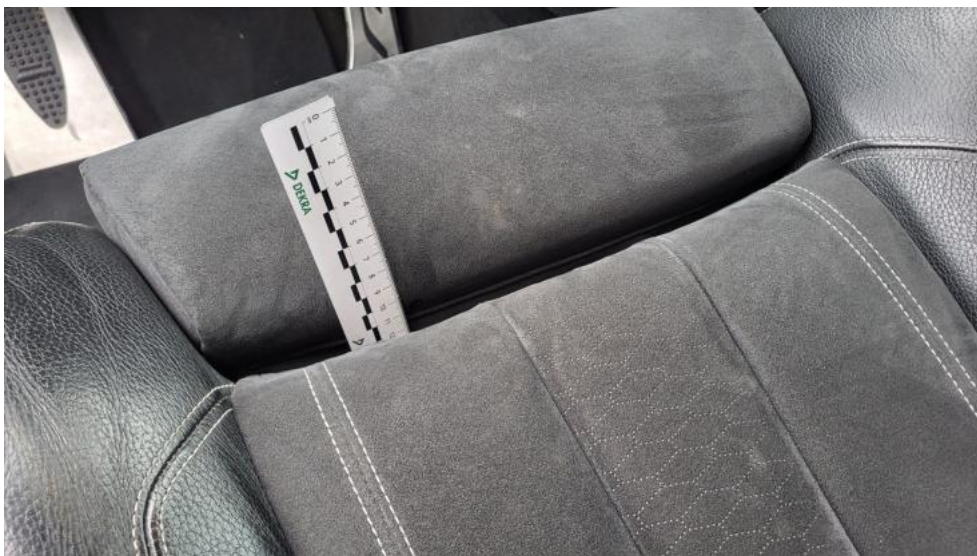
**Photo 85.**

Fotel prz. lew. - zdjęcie pogładowe 1

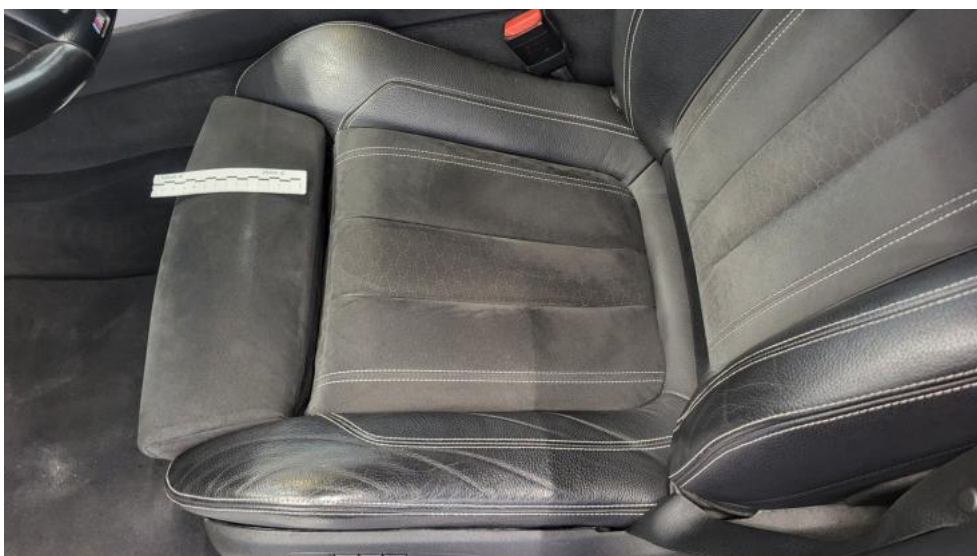
**Photo 86.**

Fotel prz. lew. - Inne 1

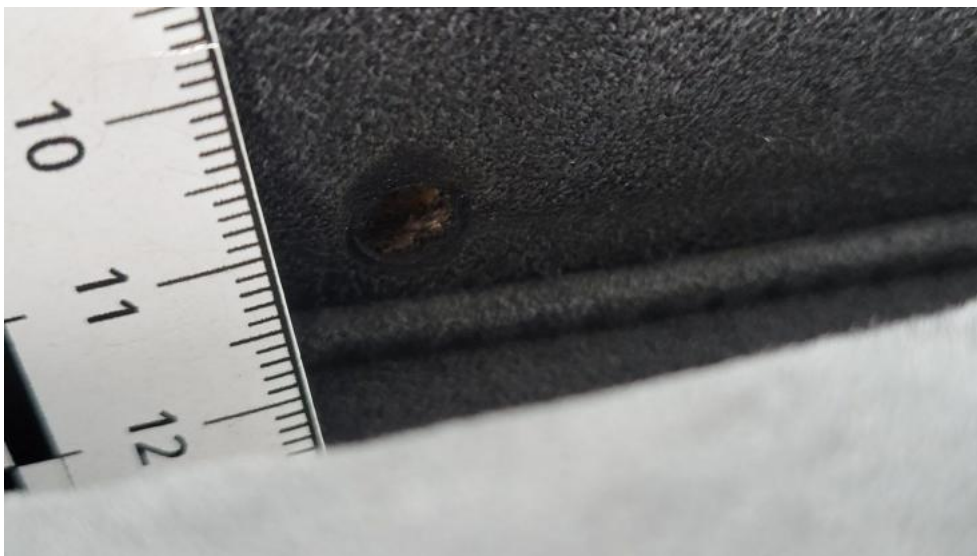
**Photo 87.**

Fotel prz. lew. - Inne 2

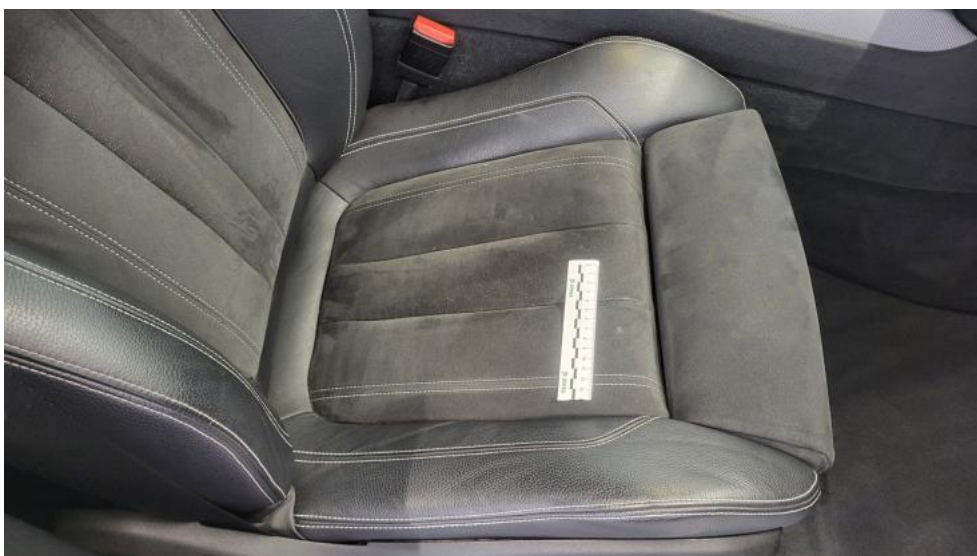
**Photo 88.**

Fotel prz. praw. - Inne 1

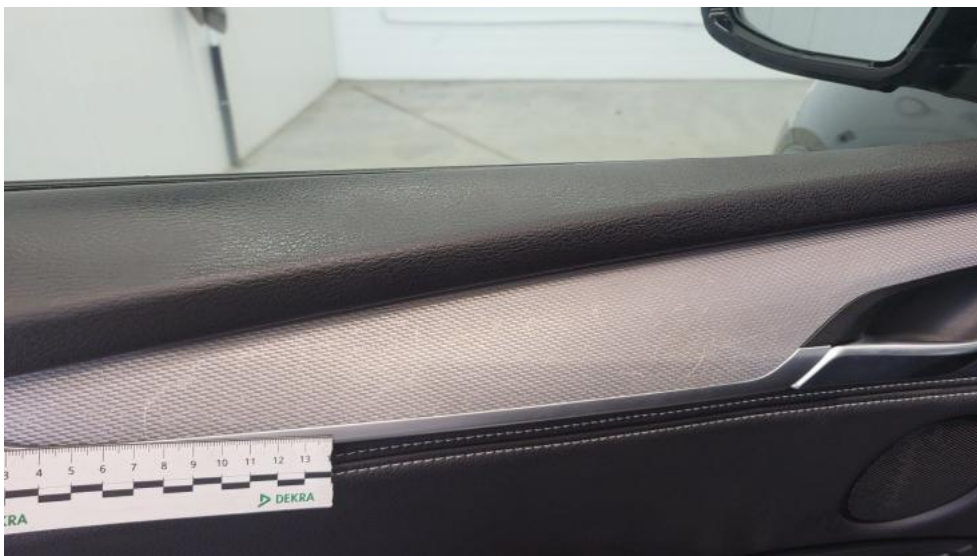
**Photo 89.**

Tapicerka drzwi przednich L - Rysa/odprysk 1

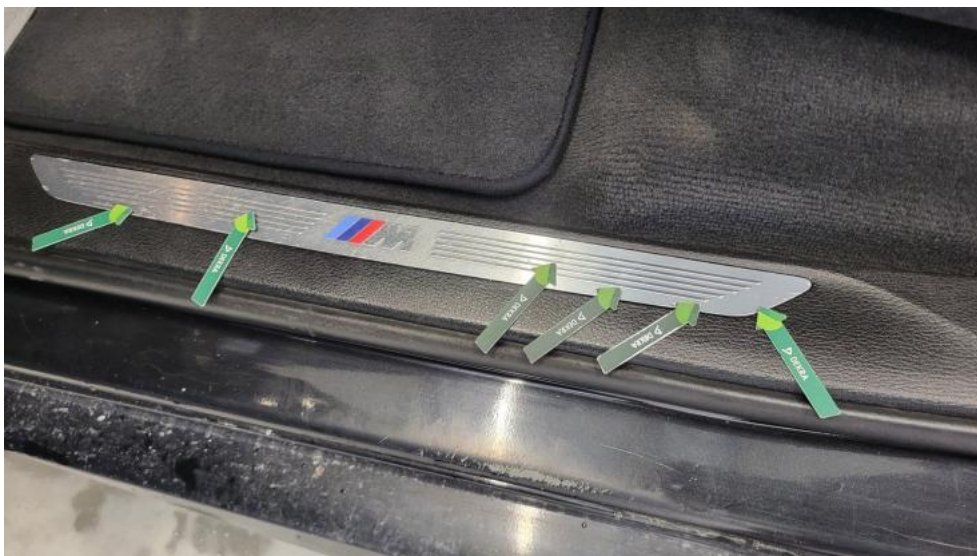
**Photo 95.**

Listwy progowe lew. - Wgniecenie/odkształcenie 1

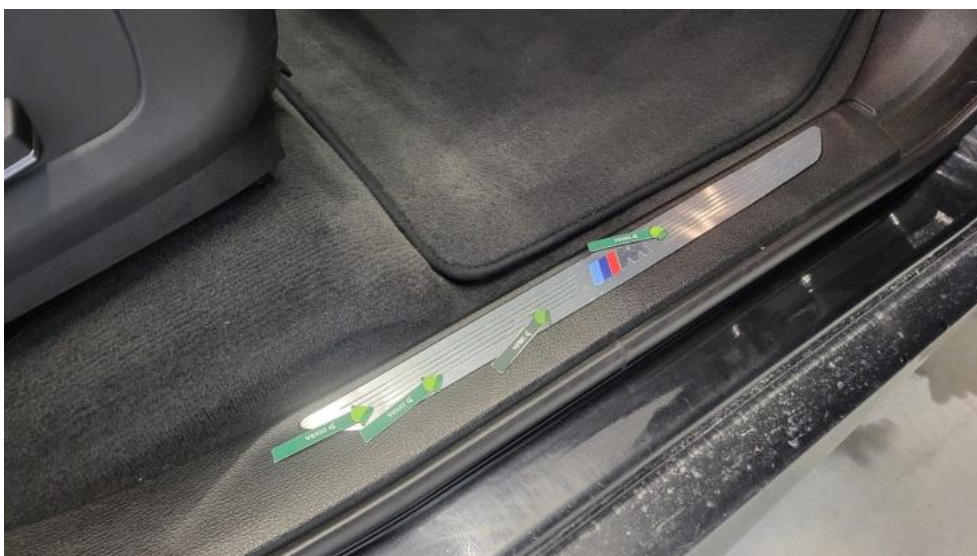
**Photo 96.**

Listwy progowe praw. - Wgniecenie/odkształcenie 1

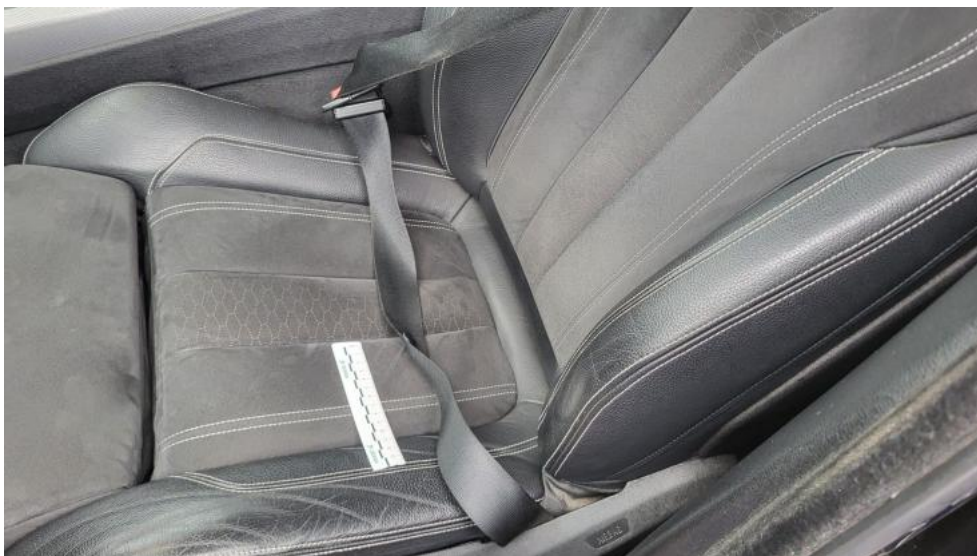
**Photo 97.**

Pas bezpieczeństwa przedni lewy - Inne 1

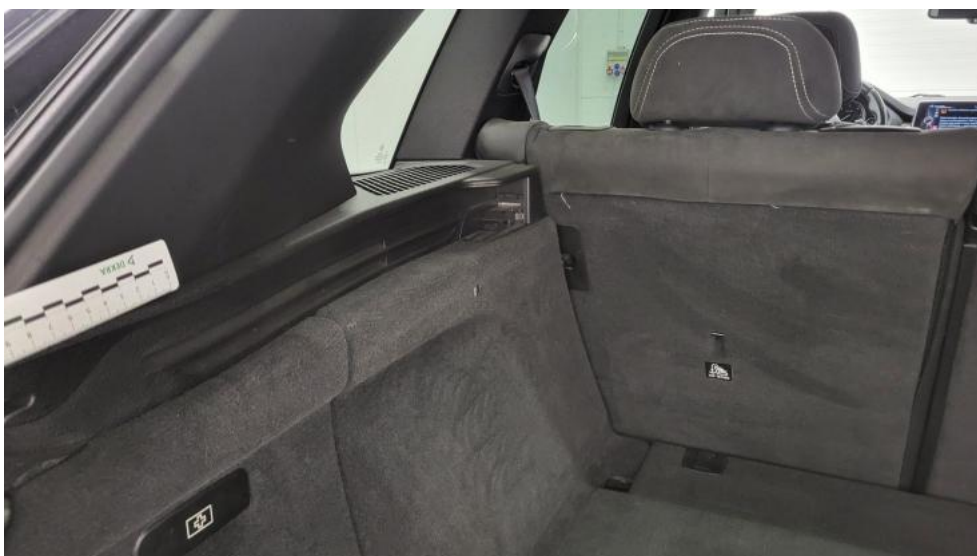
**Photo 98.**

Półka/roleta tylna - Inne 1

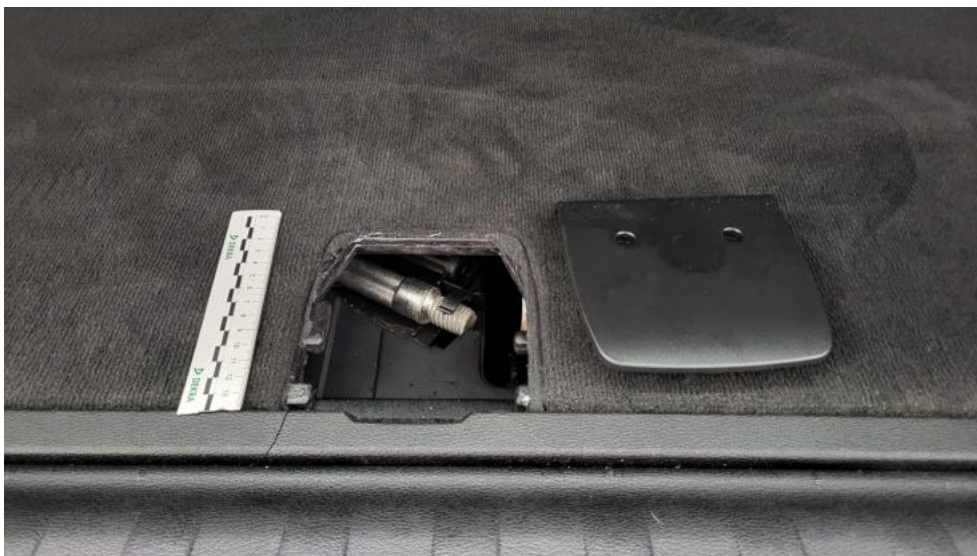
**Photo 99.**

Wykładzina podłogi bagażnika - Inne 1
