DEKRA's commission No. : PKOL(W)/LODZ/32881/25/05/07  
commission/ damage No. : 21/023151  
Date of commission: 07-05-2025

| Manufacturer | TOYOTA |
| Model | Corolla Sedan 18-22 |
| Registration /record No. | WOT82510 |

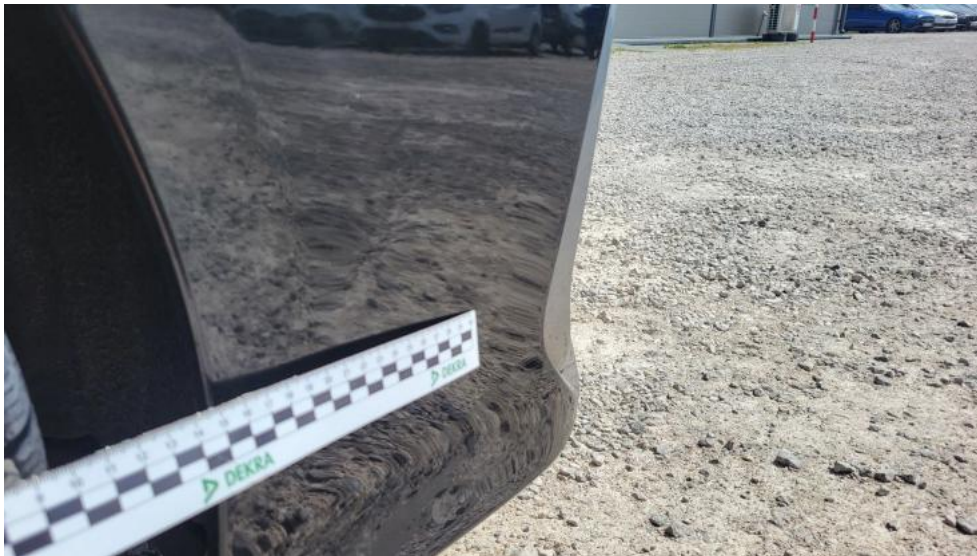
**Photo 43.**

Zderzak() - Wgniecenie/odkształcenie 3

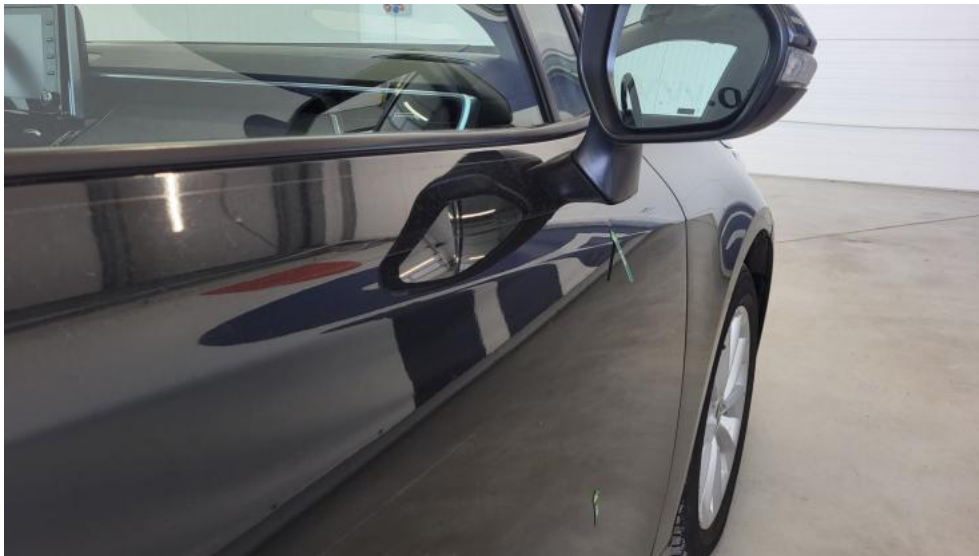
**Photo 51.**

Drzwi przednie P - Wgniecenie/odkształcenie 1

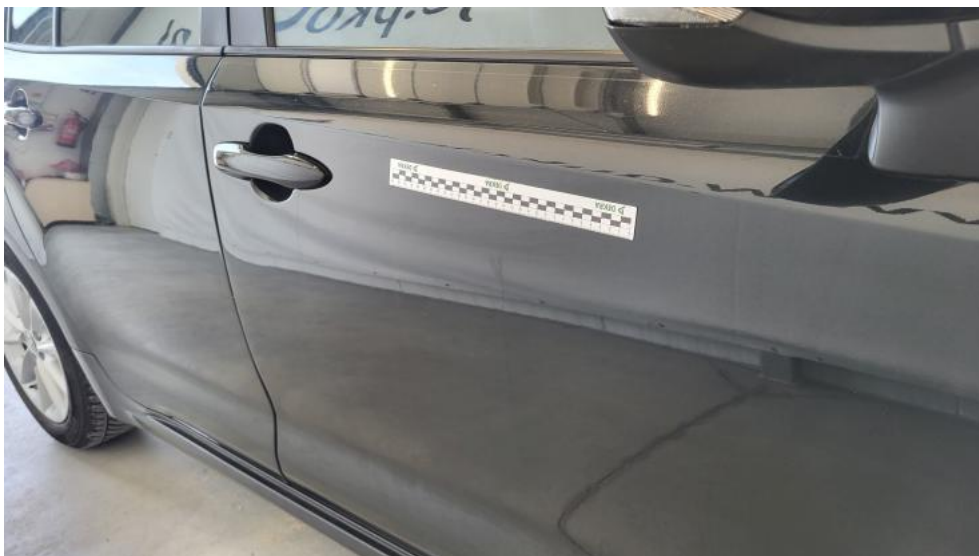
**Photo 52.**

Drzwi przednie P - Inne 1

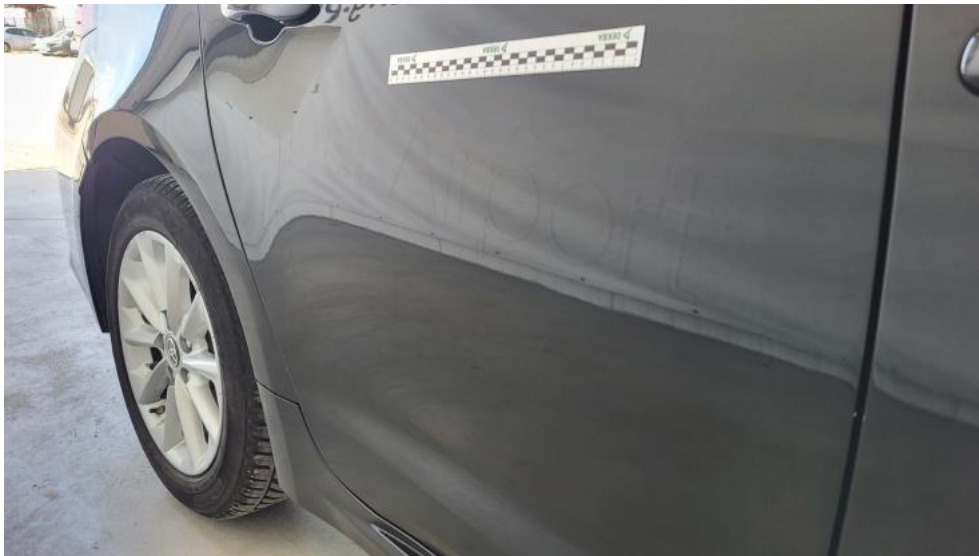
**Photo 55.**

Drzwi tylne P - Inne 1

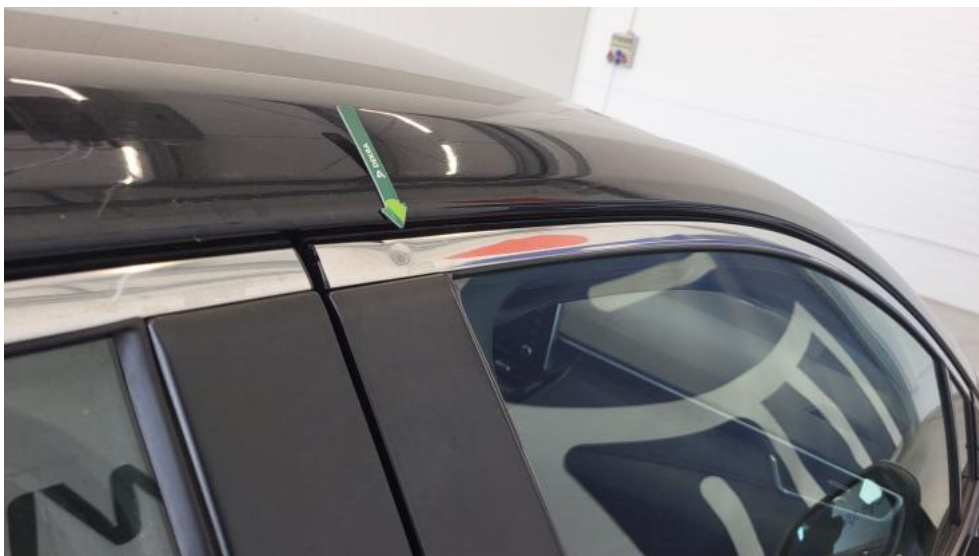
**Photo 56.**

Listwa drzwi przednich P - Wgniecenie/odkształcenie 1

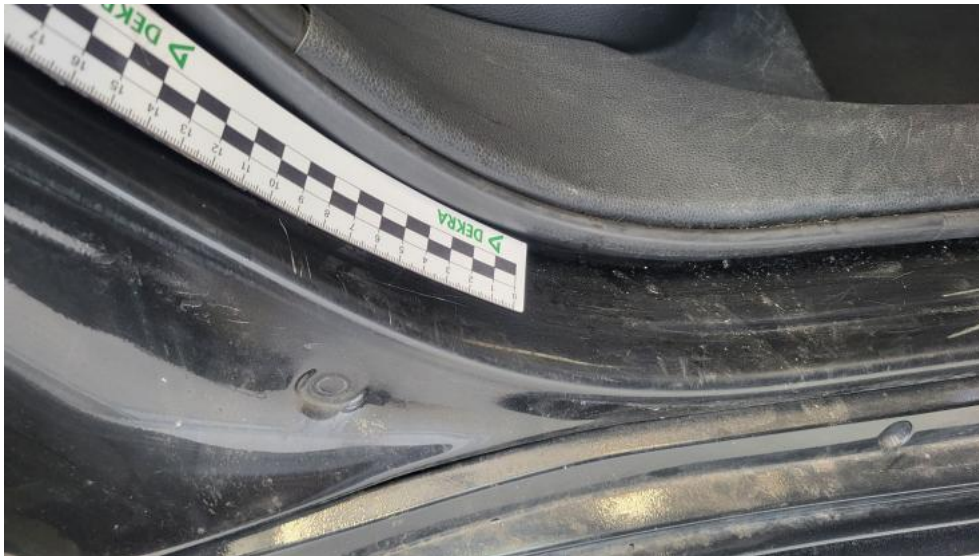
**Photo 59.**

Próg P - Rysa/odprysk 1

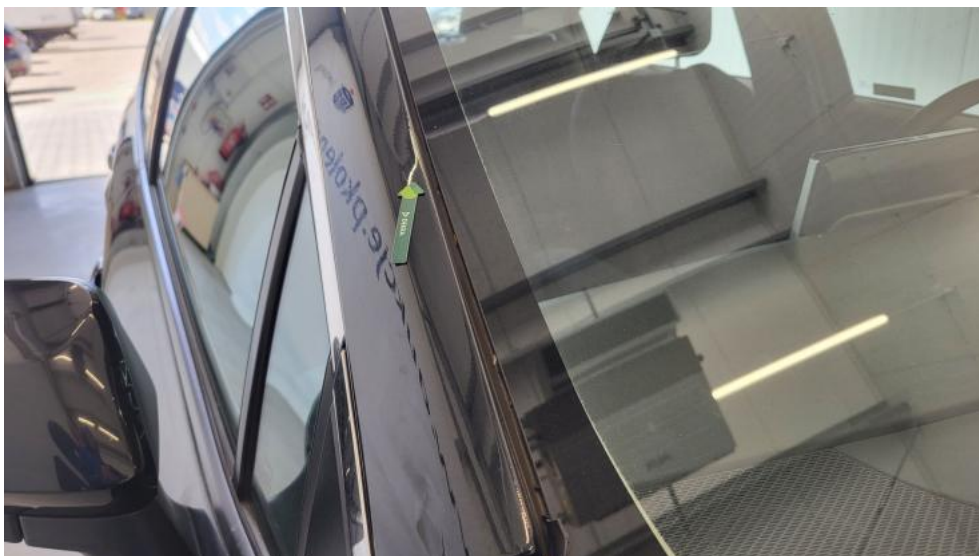
**Photo 60.**

Słupek przedni P - Wgniecenie/odkształcenie 1

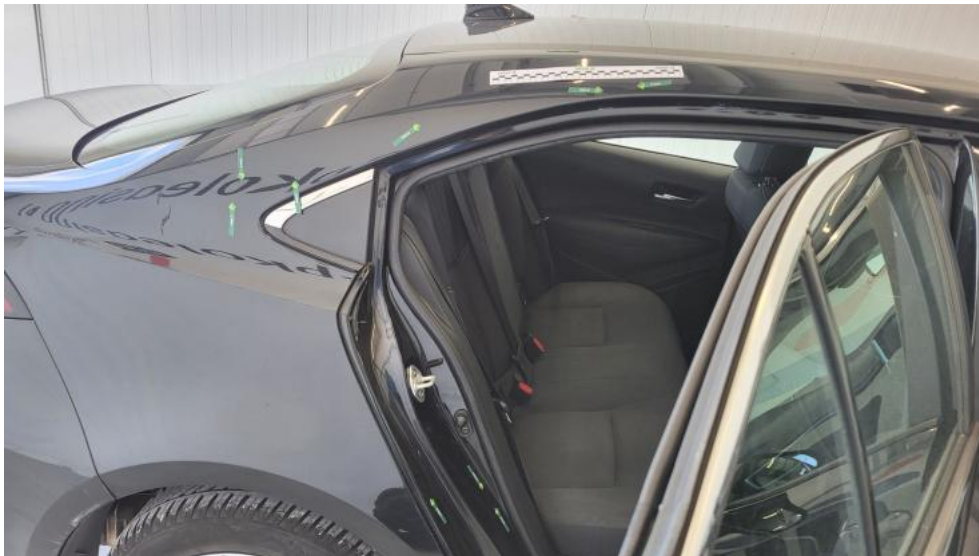
**Photo 61.**

Błotnik tylny P / Ściana boczna P - Wgniecenie/odkształcenie 1

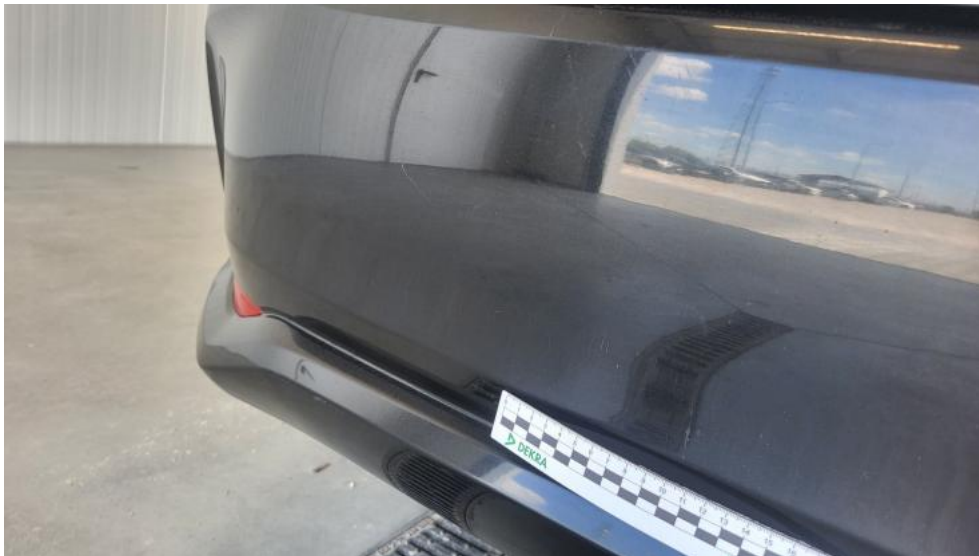
**Photo 69.**

Zderzak tylny - Wgniecenie/odkształcenie 1

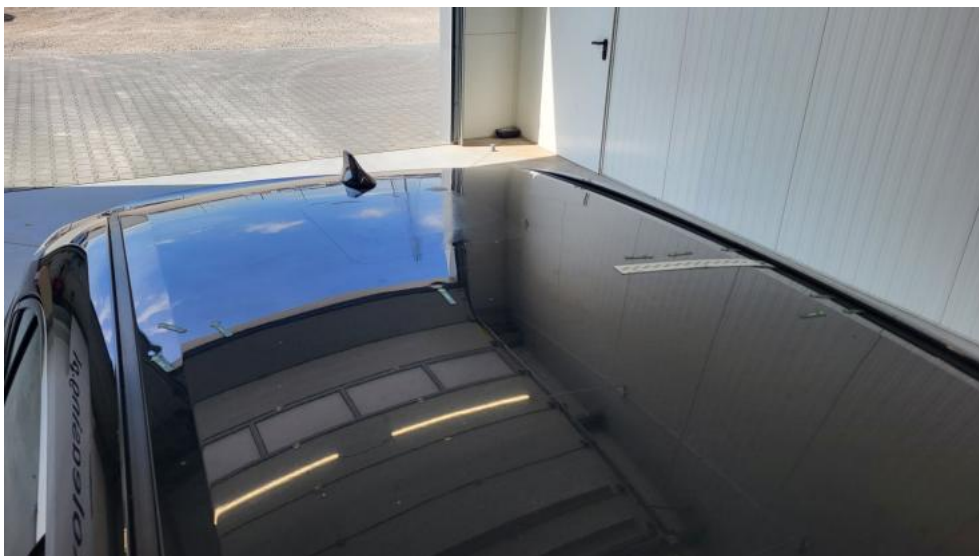
**Photo 70.**

Dach - Wgniecenie/odkształcenie 1

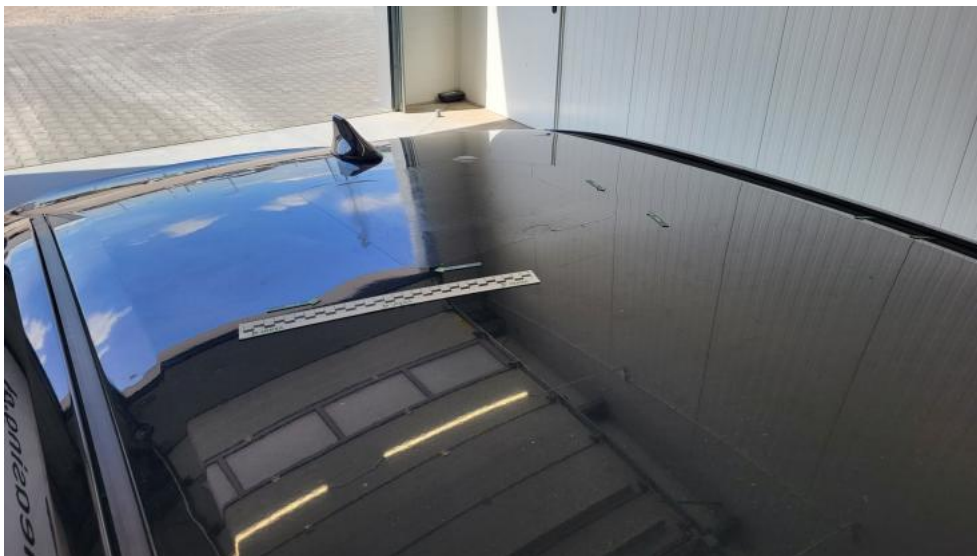
**Photo 71.**

Dach - Wgniecenie/odkształcenie 2

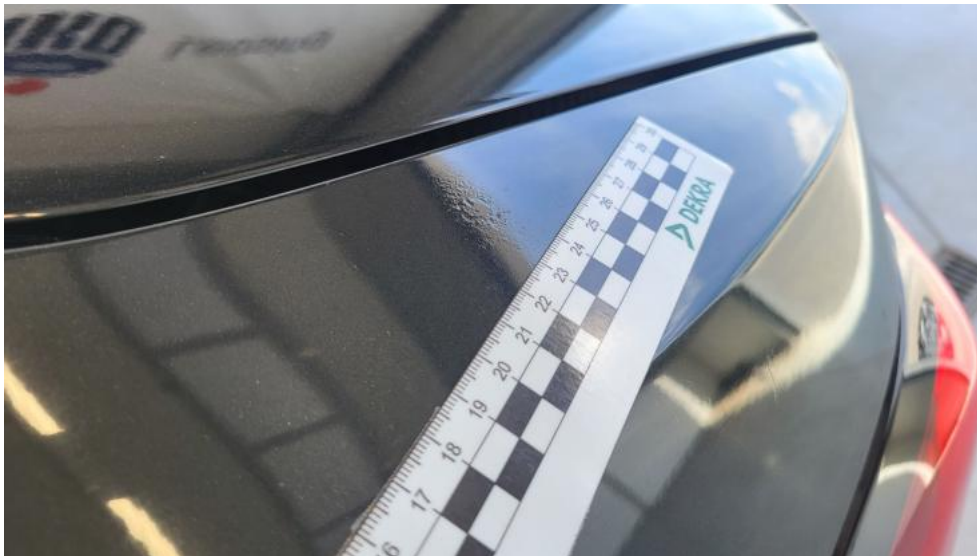
**Photo 75.**

Błotnik tylny L / Ściana boczna L - Inne 1

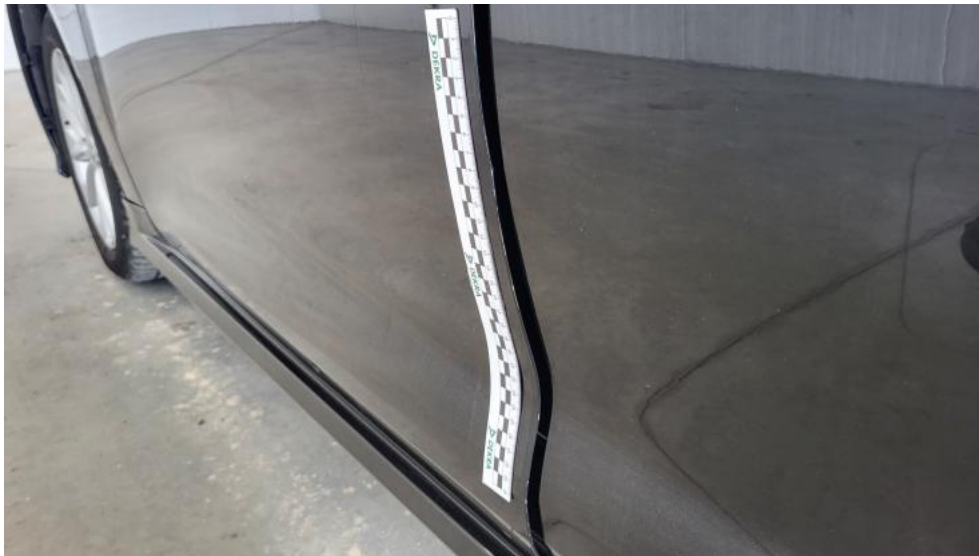
**Photo 77.**

Drzwi przed L - Rysa/odprysk 1

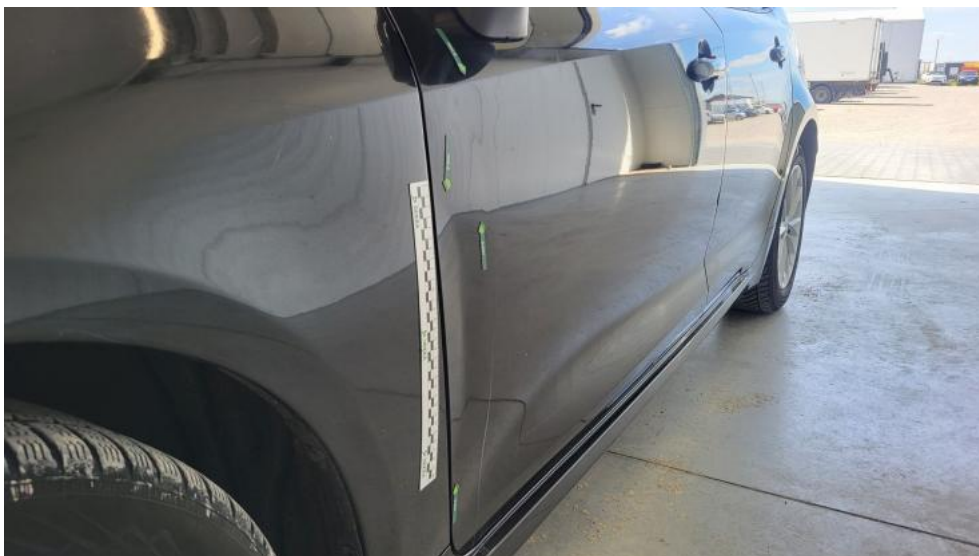
**Photo 78.**

Drzwi przed L - Wgniecenie/odkształcenie 1

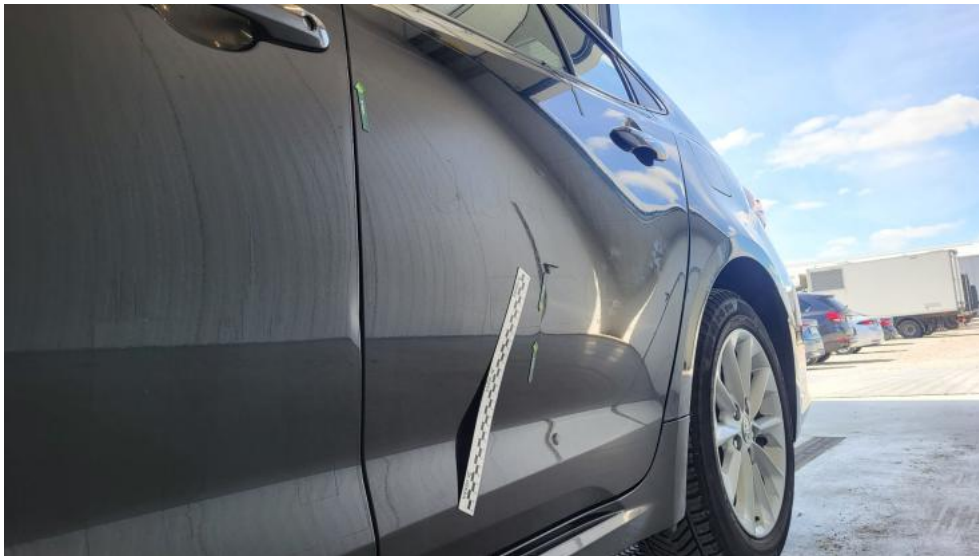
**Photo 81.**

Drzwi tylne L - Wgniecenie/odkształcenie 1

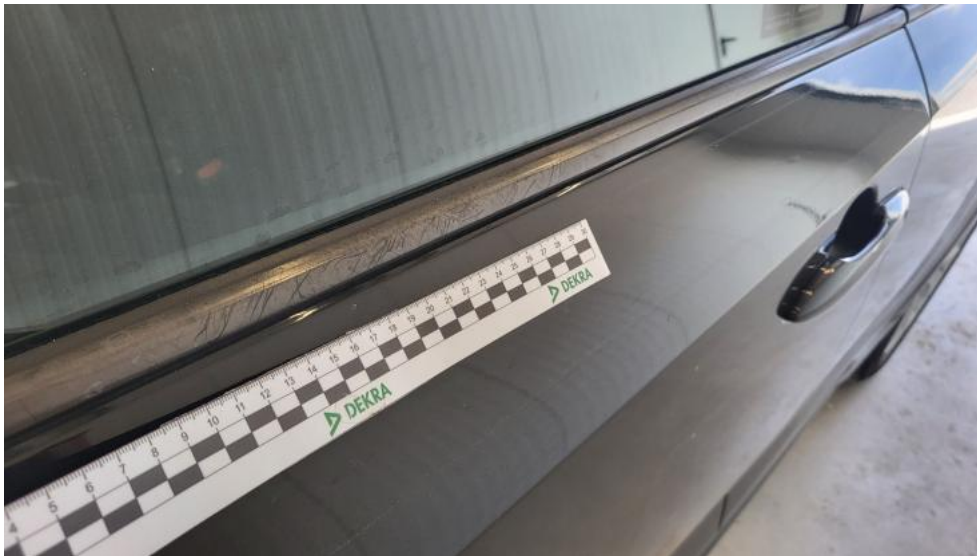
**Photo 83.**

Listwa drzwi przednich L - Rysa/odprysk 1

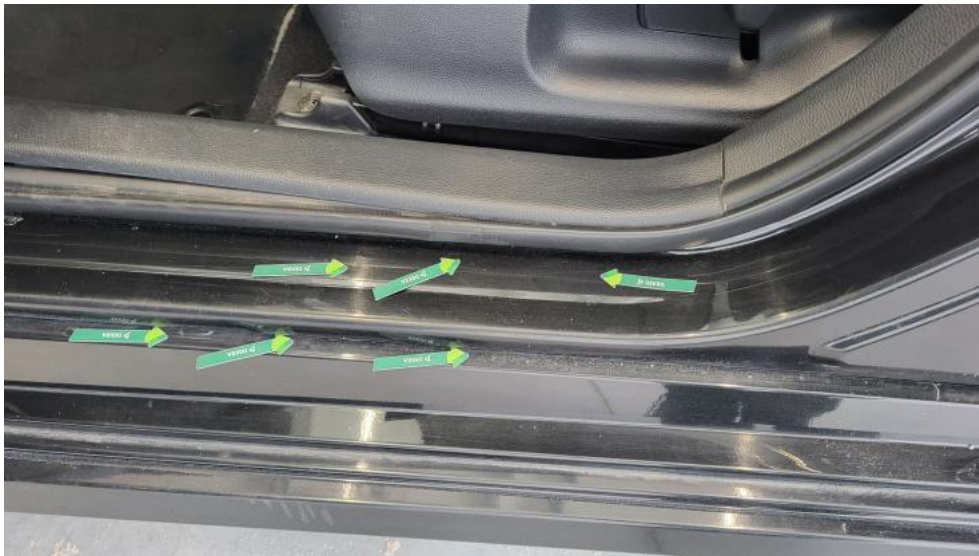
**Photo 87.**

Próg L - Wgniecenie/odkształcenie 2

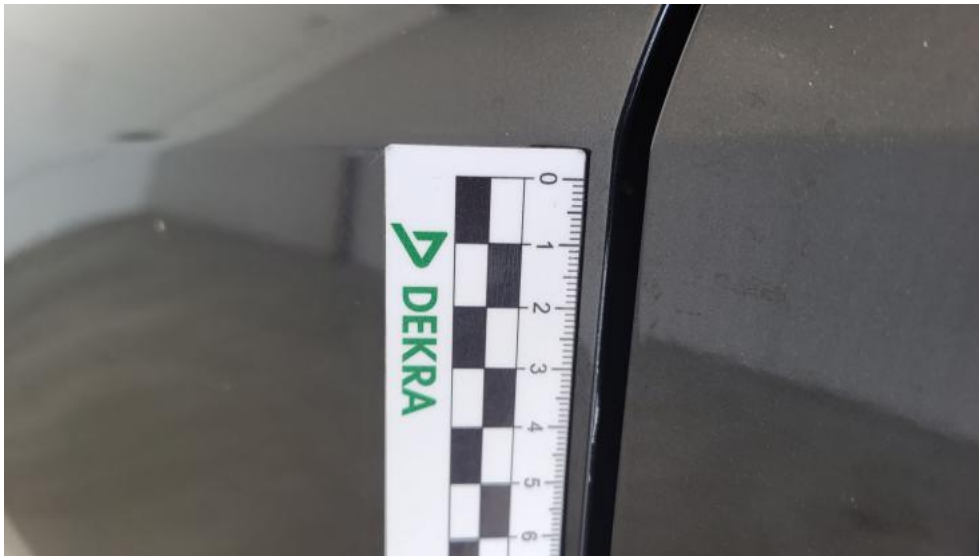
**Photo 89.**

Błotnik przedni L - Rysa/odprysk 1

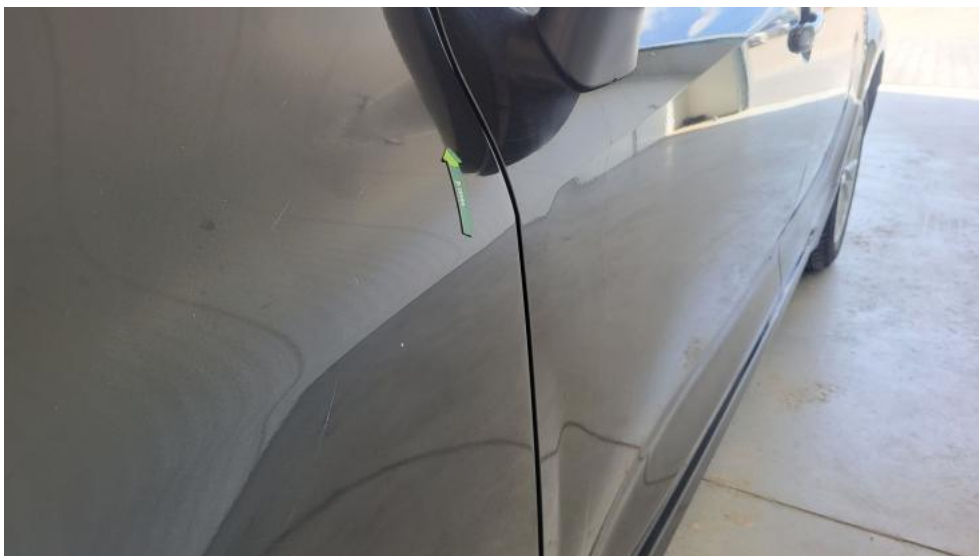
**Photo 90.**

Błotnik przedni L - Wgniecenie/odkształcenie 1

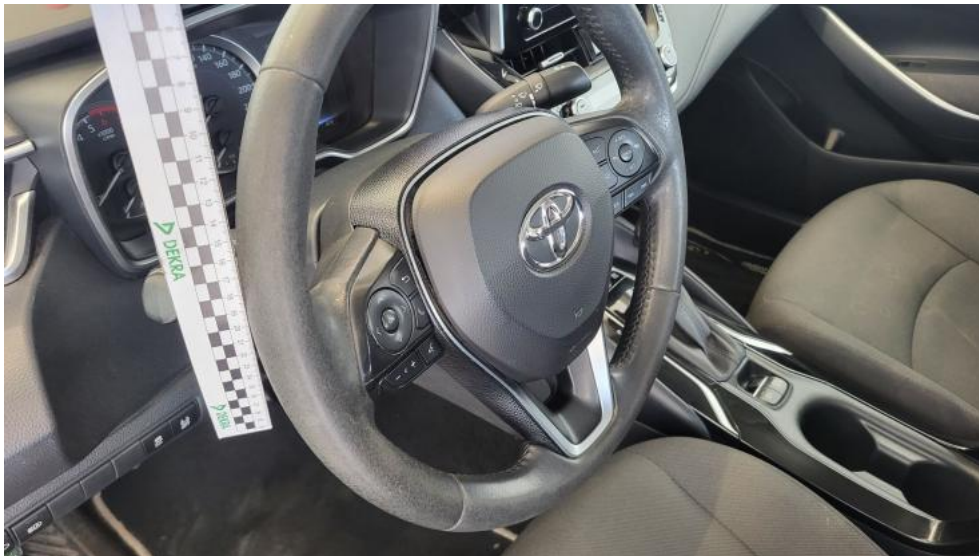
**Photo 93.**

Koło kierownicy - Inne 1

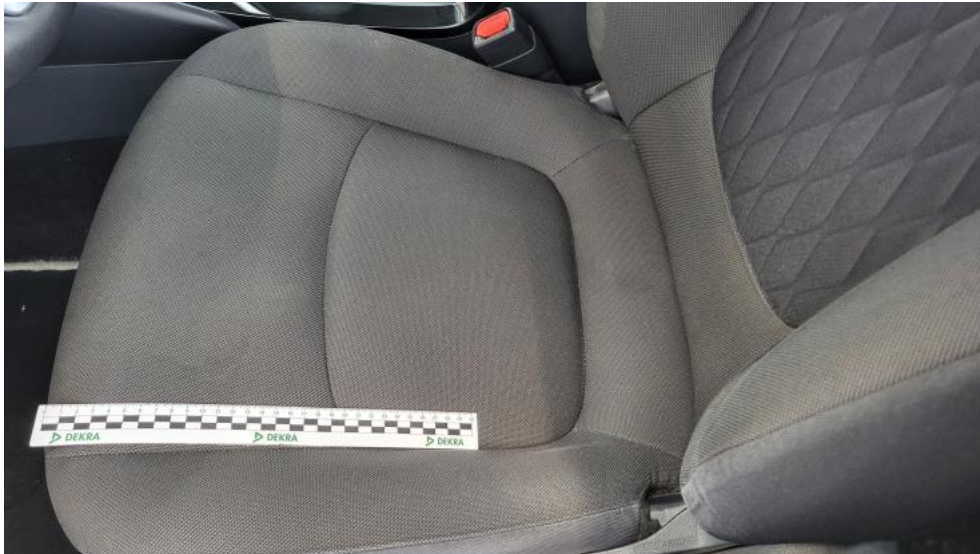
**Photo 95.**

Fotel prz. lew. - Inne 1

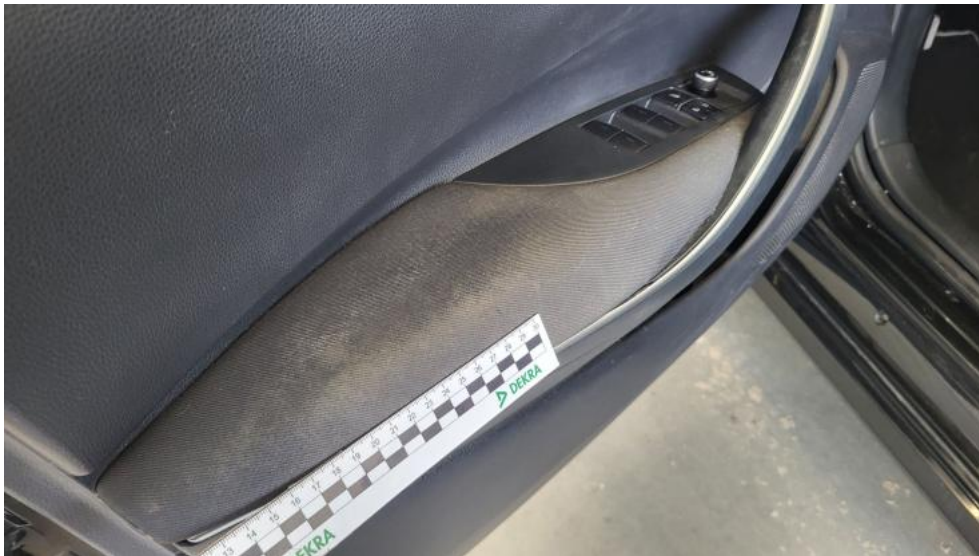
**Photo 99.**

Tapicerka drzwi przednich L - Inne 1

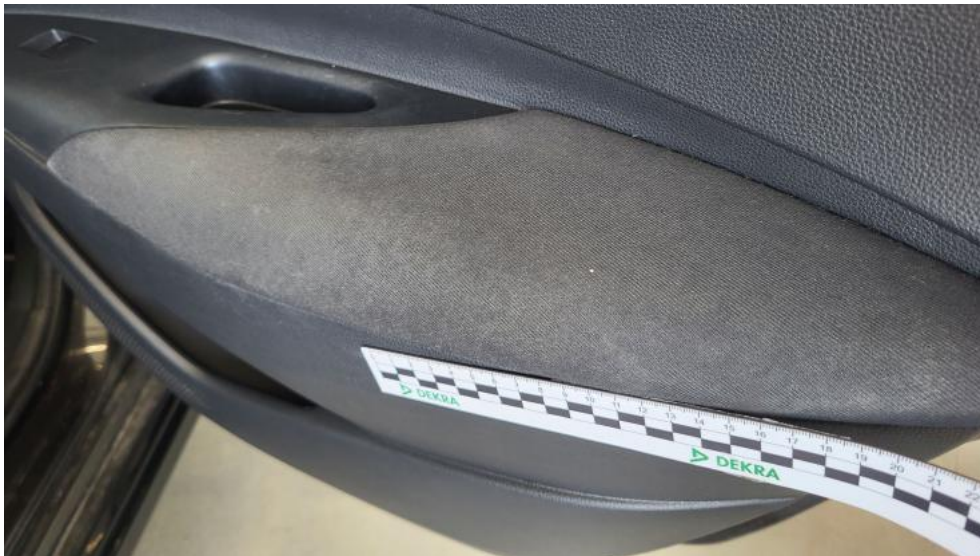
**Photo 101.**

Tapicerka drzwi tylnych P - Inne 1

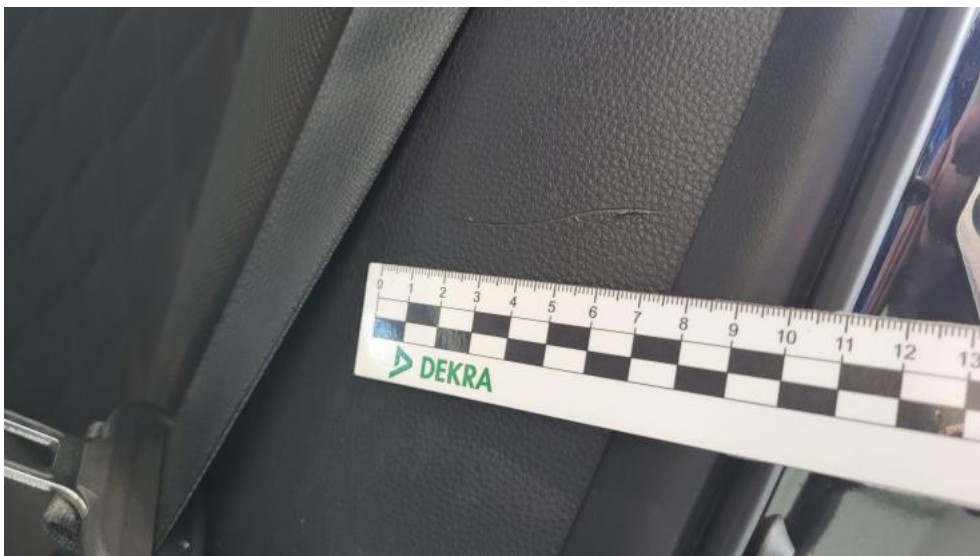
**Photo 106.**

Wykładzina(y) słupka tylnego L - Rysa/odprysk 1
