DEKRA's commission No. : PKOL(W)/LODZ/26418/25/04/10  
commission/ damage No. : Futura  
Date of commission: 10-04-2025

| Manufacturer | PEUGEOT |
| Model | 308 SW 17-21 |
| Registration /record No. | WD9726P |

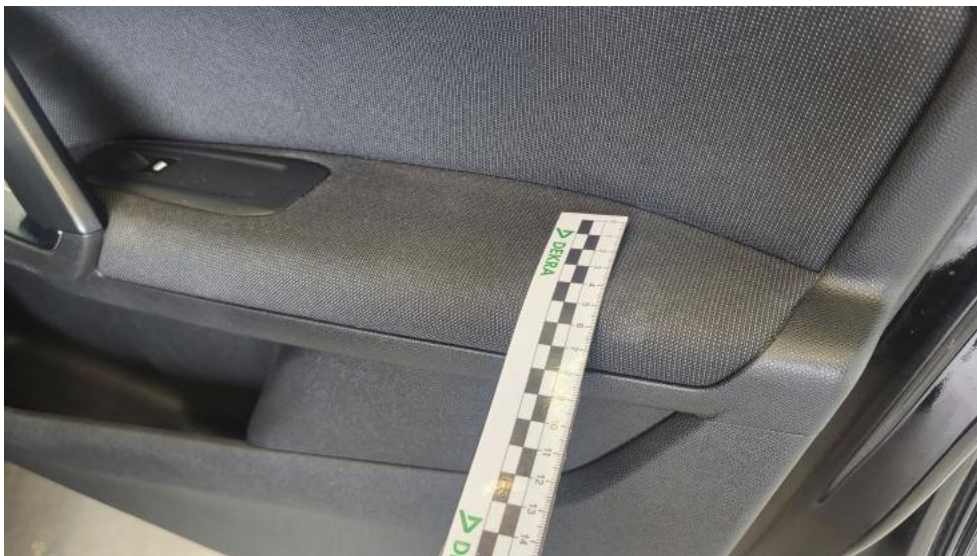
**Photo 69.**

Tapicerka drzwi przednich P - Inne 1
