DEKRA's commission No. : PKOL(W)/LODZ/11137/26/02/11  
commission/ damage No. : 20/053881  
Date of commission: 11-02-2026

**DEKRA Poland - Headquarters**  
02-673 Warszawa, ul. Konstruktorska 12A

Group of objects (Eurotax)	cars
EC code (Eurotax)	0145353
Manufacturer	BMW
Model	Seria 5 [G30/F90] 20-23
Type / version	520d xDrive mHEV M Sport sport-aut
Body type	sedan
Number of doors / seats	4/5
Curb weight [kg]	1735
Gross vehicle weight [kg]	2405
Wheelbase 1/2	2975
Engine type	Automatic ignition
Pollution reduction system	KSC
Engine capacity [ccm]	1995
Engine Power [hp/kW]	190/140
Gearbox	automatic
Registration /record No.	PO9SN61
VIN / serial number	WBA51BL000WX07510
Date of first registration	30-12-2020
Date of next. tech. test	23-12-2026
Year of manufacture	2020 (year has been verified with the manufacturer's base)
Readout [km]	272 823 (read)
Body color / type of coating	black/double-layered, metallized

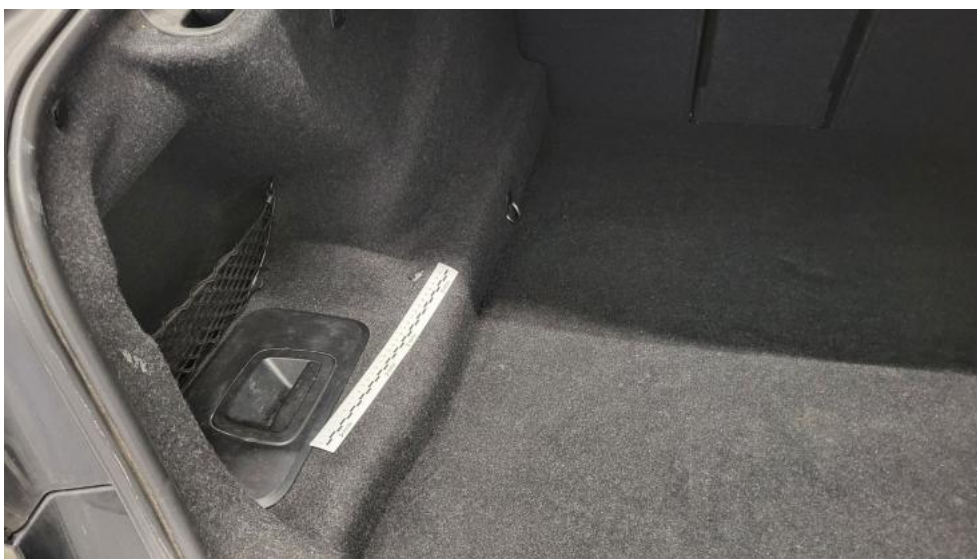
**Photo 75.**

Wykładzina podłogi bagażnika - zdjęcie poglądowe 1
