DEKRA's commission No. : PKOL(W)/LODZ/20588/26/03/09
 commission/ damage No. : 23/013831
 Date of commission: 09-03-2026

Vehicle data

Measurement of thickness of the vehicle lacquer coating

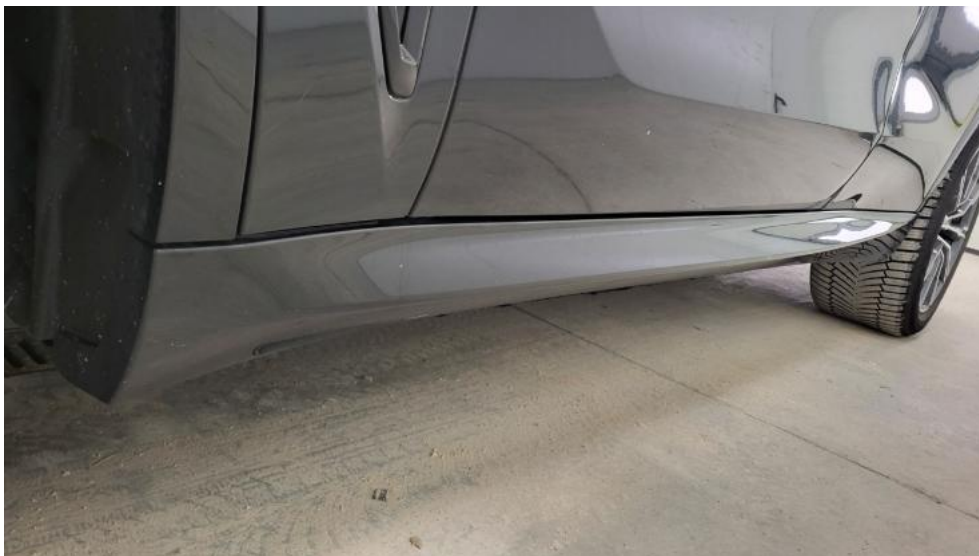
Photo 11.
Próg lewy (widok od przodu)

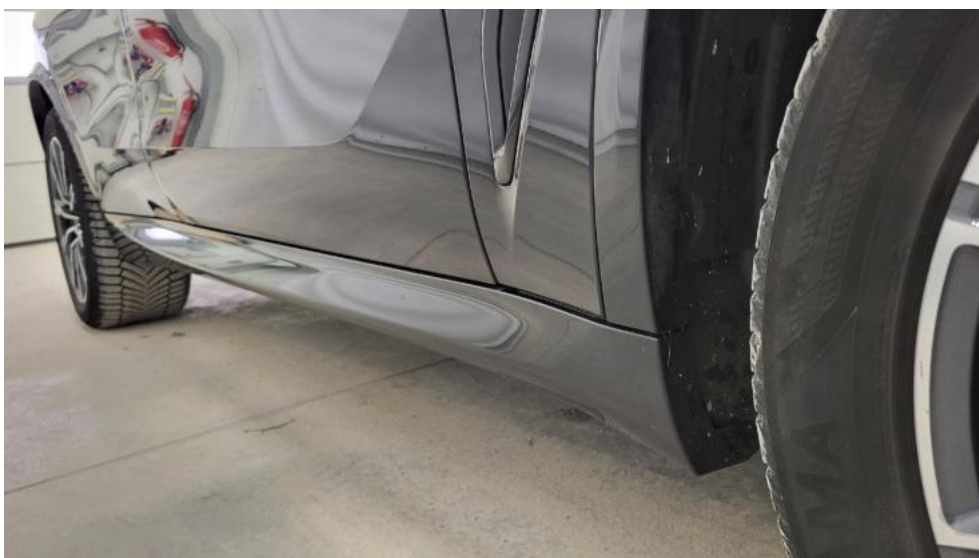
Photo 12.
Próg prawy (widok od przodu)

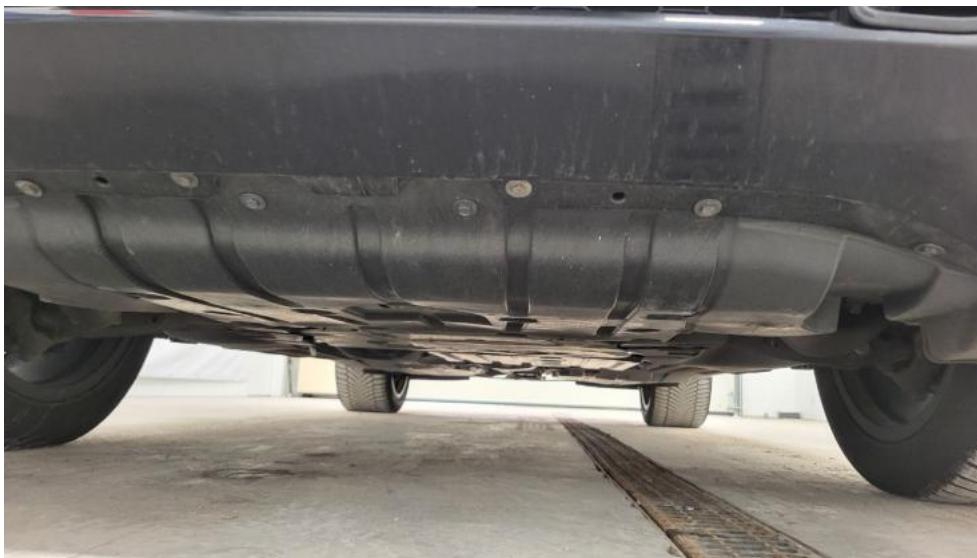
Photo 13.
Spód pojazdu przód

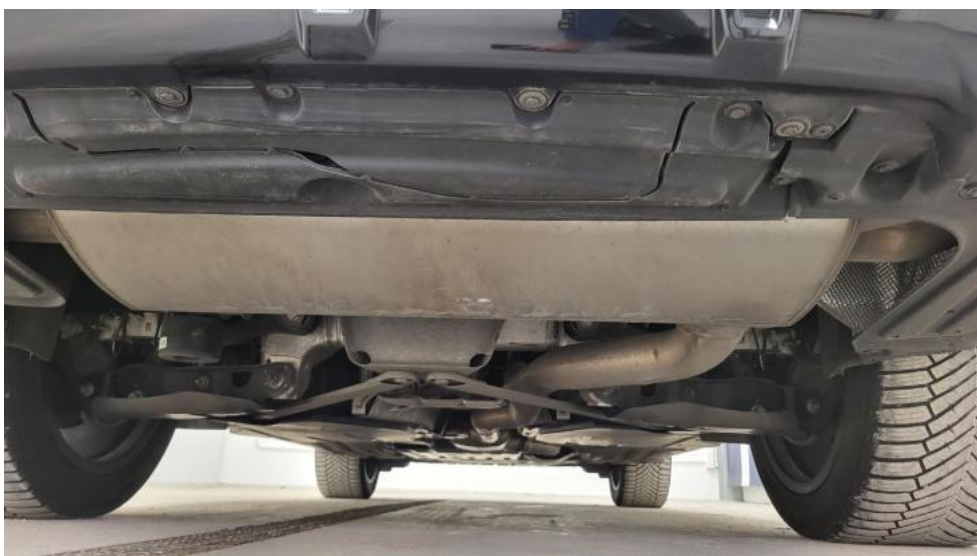
Photo 14.
Spód pojazdu tył

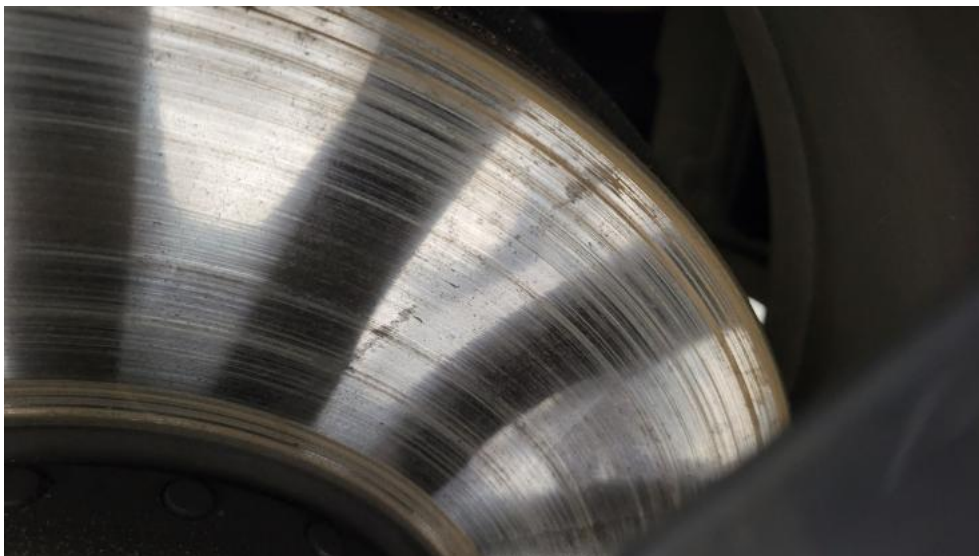
Photo 15.

Tarcza hamulcowa przednia prawa

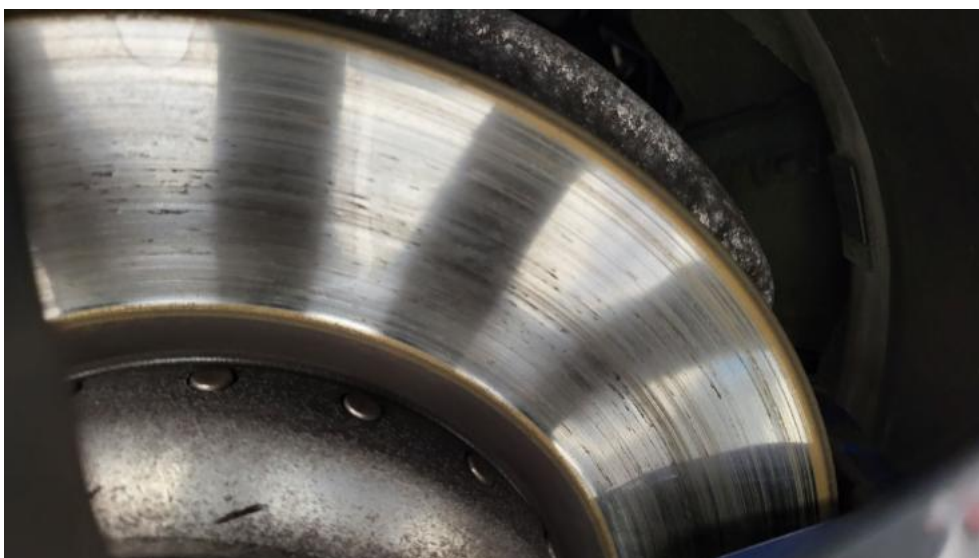
Photo 16.

Tarcza hamulcowa tylna prawa

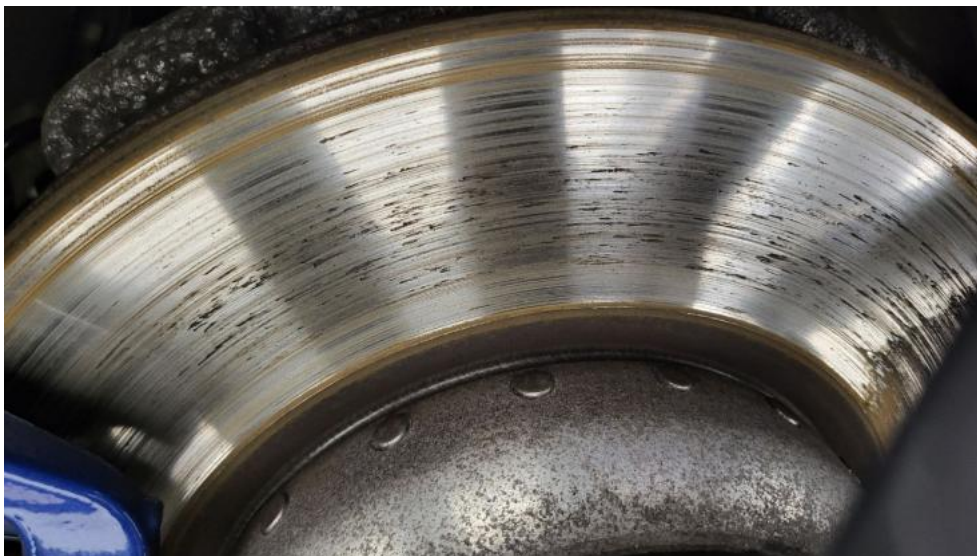
Photo 17.
Tarcza hamulcowa tylna lewa

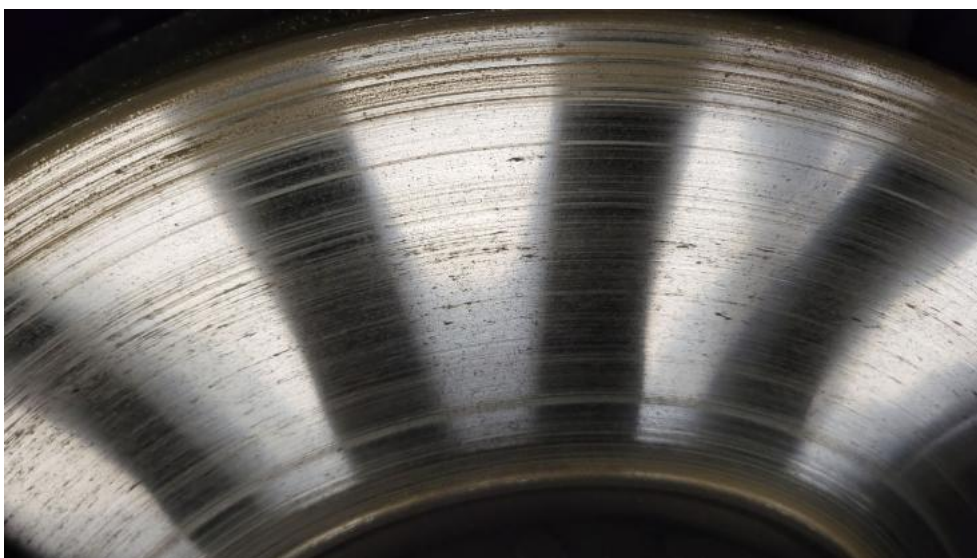
Photo 18.
Tarcza hamulcowa przednia lewa

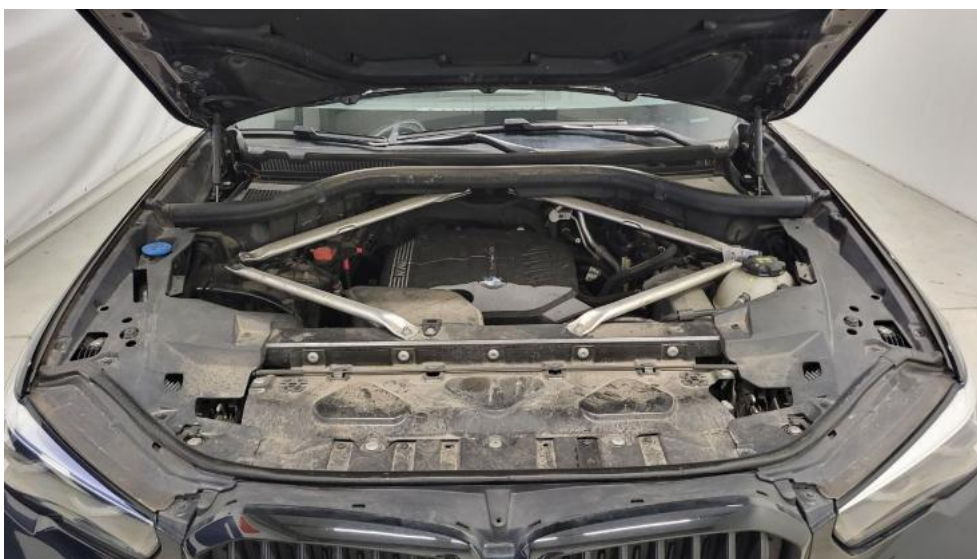
Photo 21.
Komora silnika

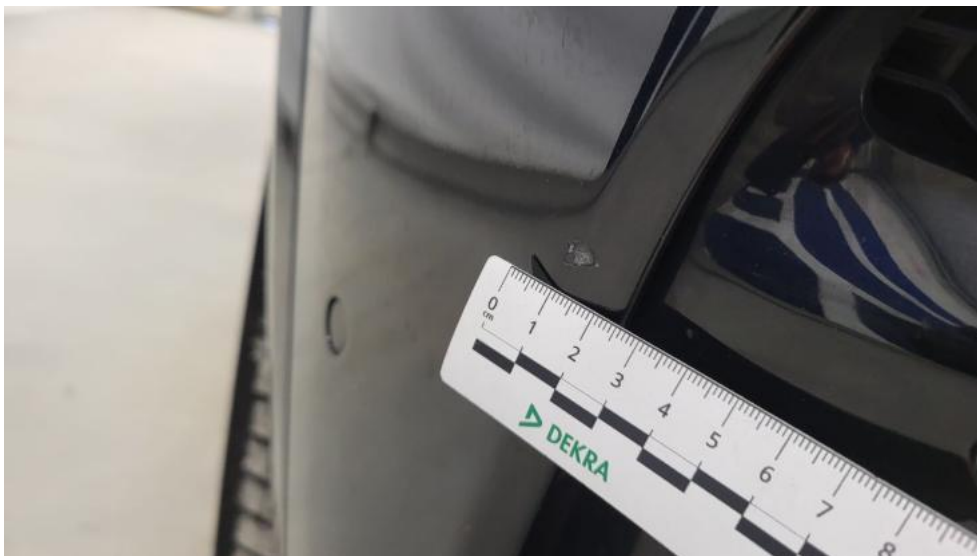
Photo 47.
Zderzak - Rysa/odprysk 2

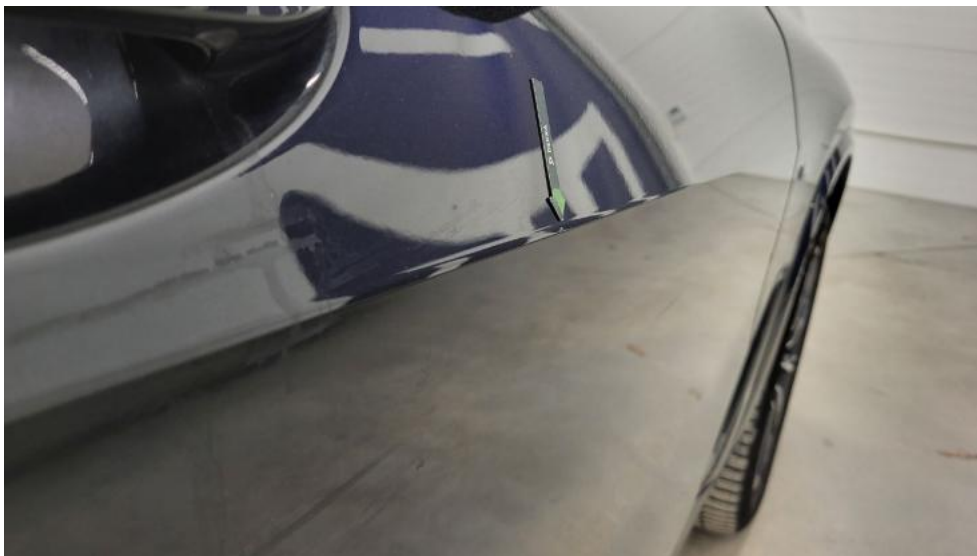
Photo 55.
Drzwi przednie P - Wgniecenie/odkształcenie 1
