DEKRA's commission No. : PKOL(W)/LODZ/52276/25/07/16  
commission/ damage No. : 23/000171  
Date of commission: 16-07-2025

**Vehicle data**

| Manufacturer | BMW |
| Model | Seria 7 [G11, G12] 15-19 |

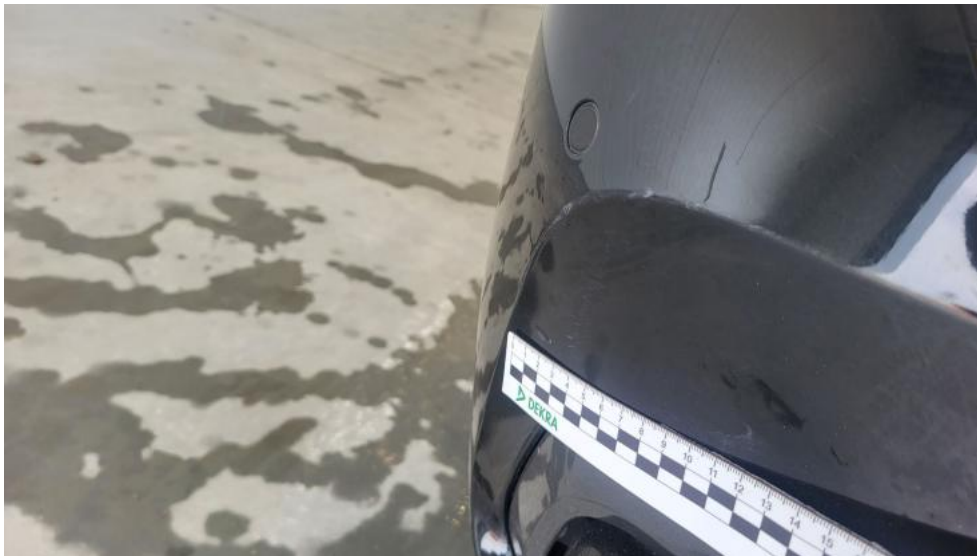
**Photo 59.**

Zderzak tylny() - Rysa/odprysk 3

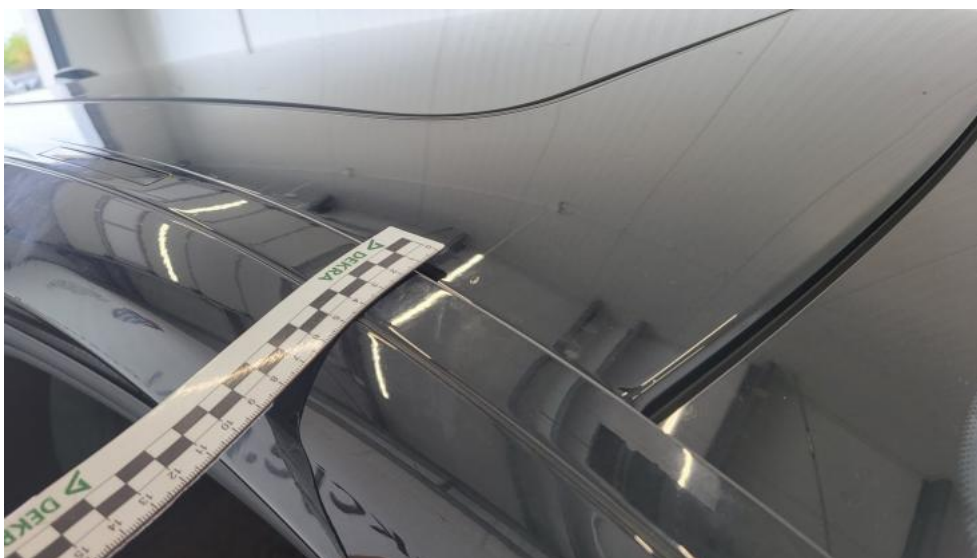
**Photo 62.**

Dach - zdjęcie poglądowe 1

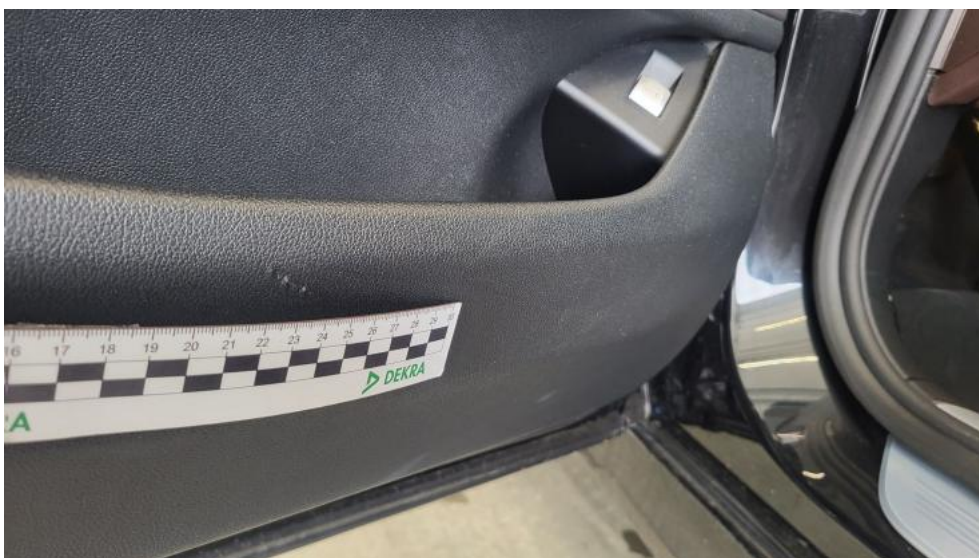
**Photo 76.**

Tapicerka drzwi przednich L - zdjęcie poglądowe 1
