DEKRA's commission No. : PKOL(W)/LODZ/73874/25/09/30  
commission/ damage No. : 22/013785  
Date of commission: 30-09-2025

| Manufacturer | BMW |
| Model | Seria 6 Gran Turismo [G32] 17-20 |
| Registration /record No. | D8ZENON |

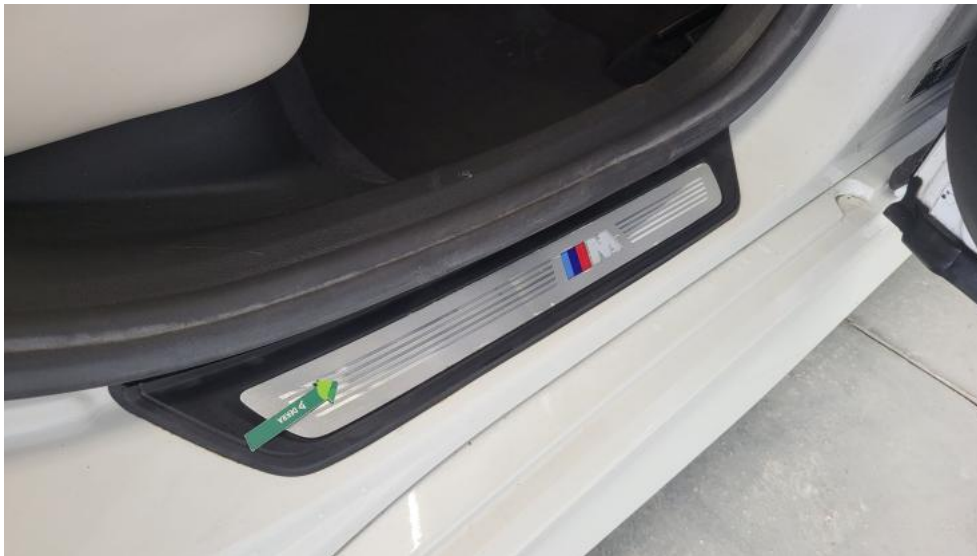
**Photo 47.**

Próg P - Wgniecenie/odkształcenie 1

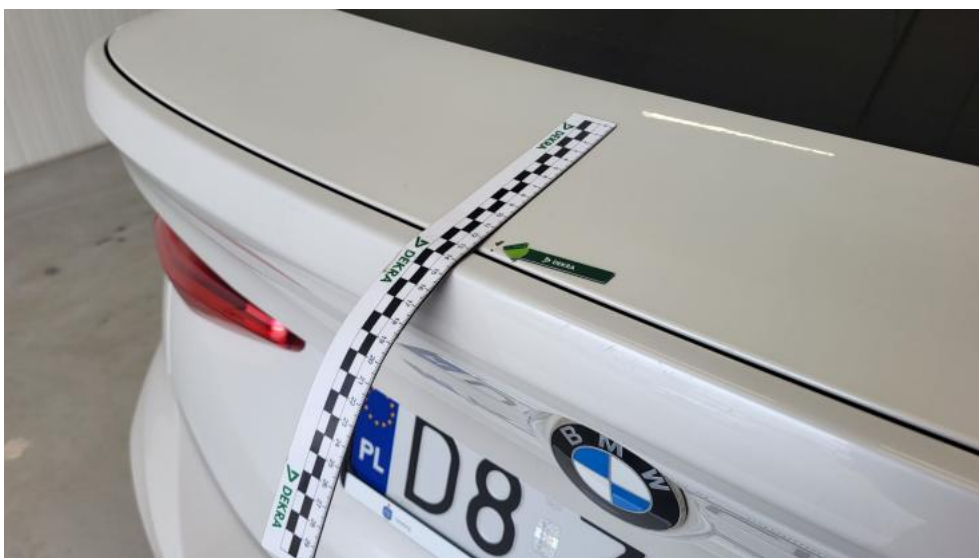
**Photo 52.**

Pokrywy bagażnika - zdjęcie poglądowe 1

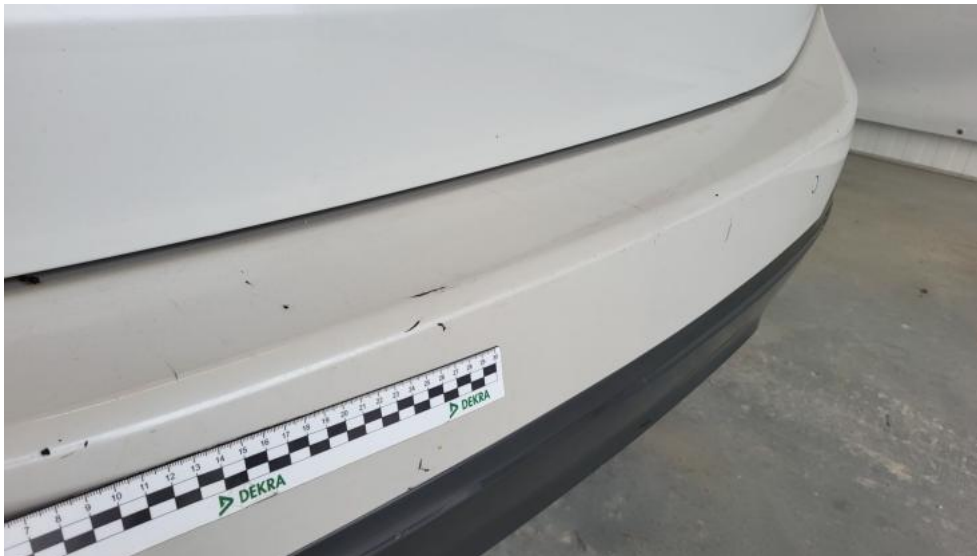
**Photo 55.**

Zderzak tylny - Rysa/odprysk 2

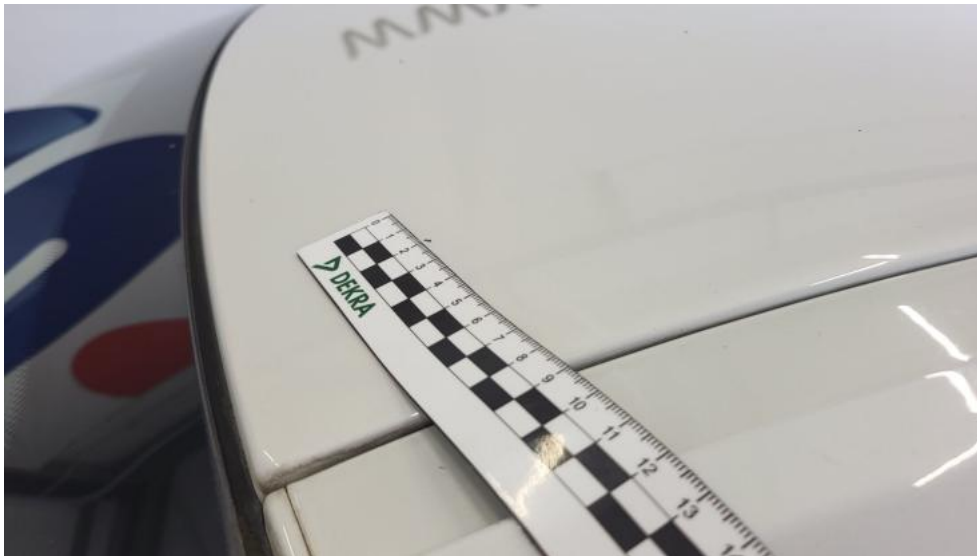
**Photo 61.**

Dach - Rysa/odprysk 1

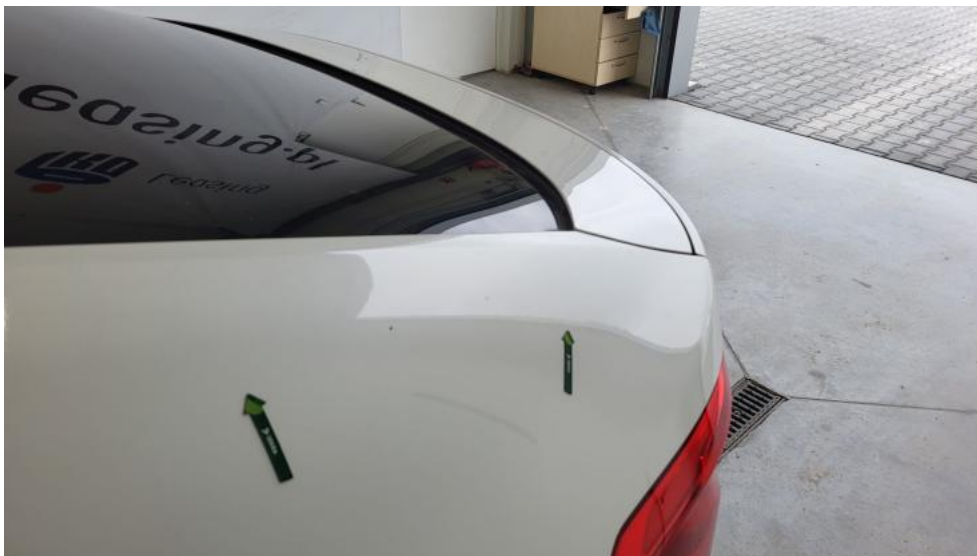
**Photo 63.**

Błotnik tylny L / Ściana boczna L - Wgniecenie/odkształcenie 1

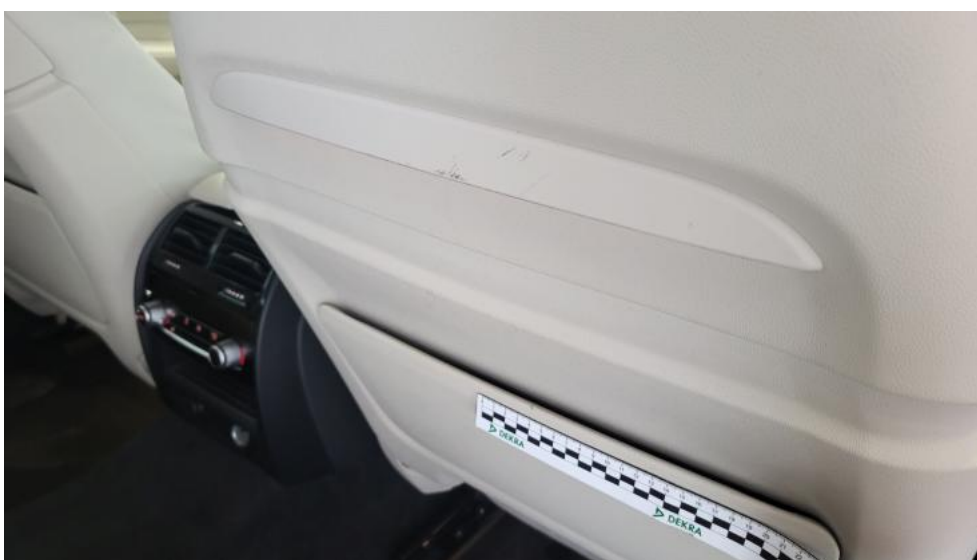
**Photo 72.**

Fotel prz. praw. - zdjęcie poglądowe 1

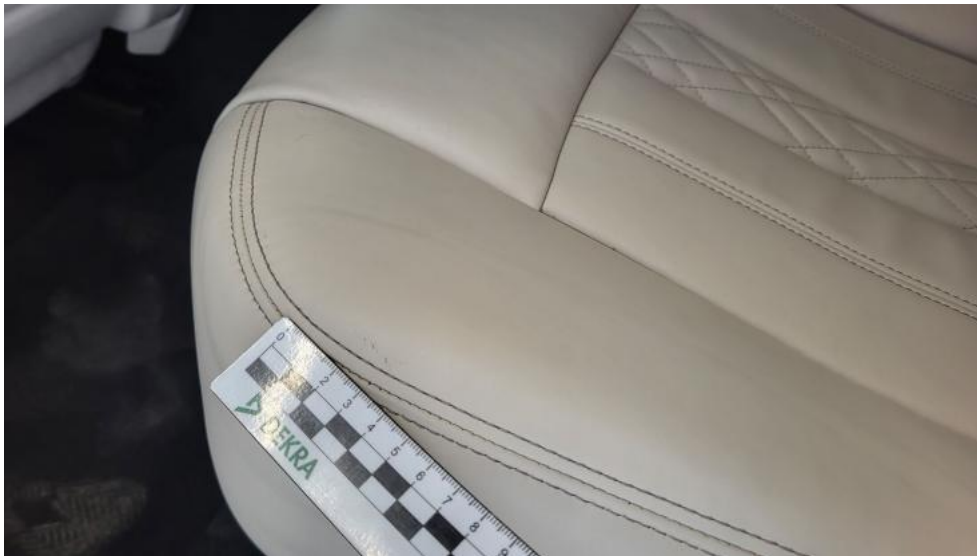
**Photo 75.**

Kanapa tyl. - Rysa/odprysk 1
