DEKRA's commission No. : PKOL(W)/LODZ/27086/25/04/14  
commission/ damage No. : FUTURA  
Date of commission: 14-04-2025

| Manufacturer | HYUNDAI |
| Model | i30 20-24 |
| Registration /record No. | WD9075S |

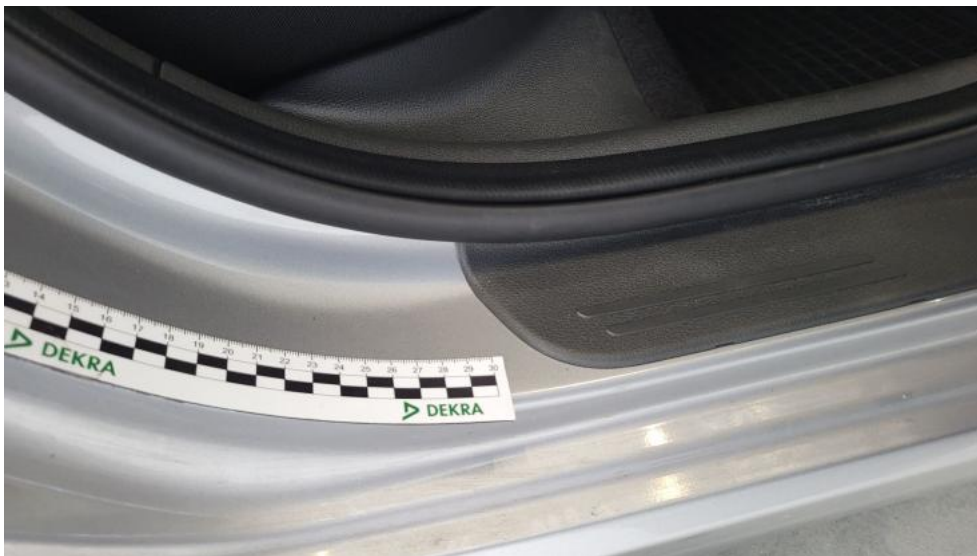
**Photo 47.**

Próg P - Rysa/odprysk 1

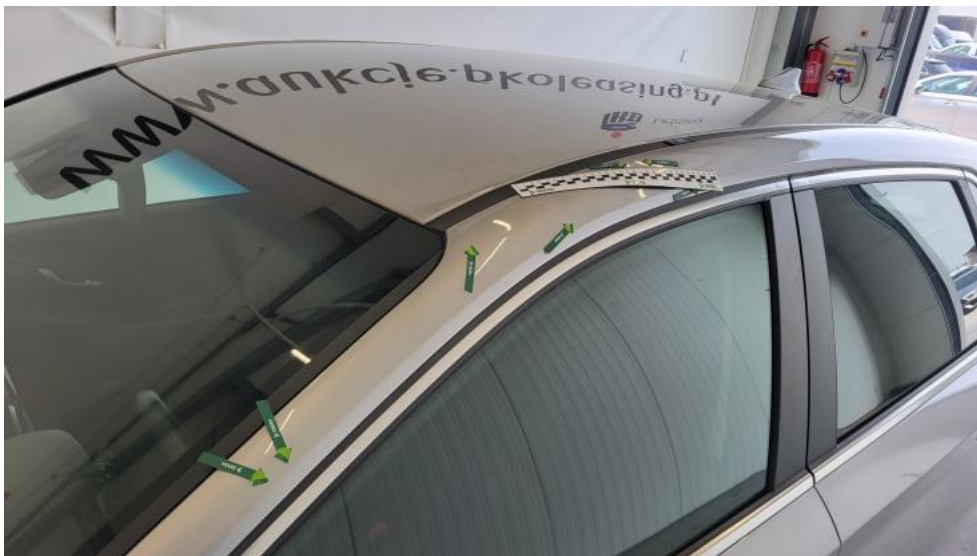
**Photo 65.**

Śłupek przedni L - Wgniecenie/odkształcenie 1

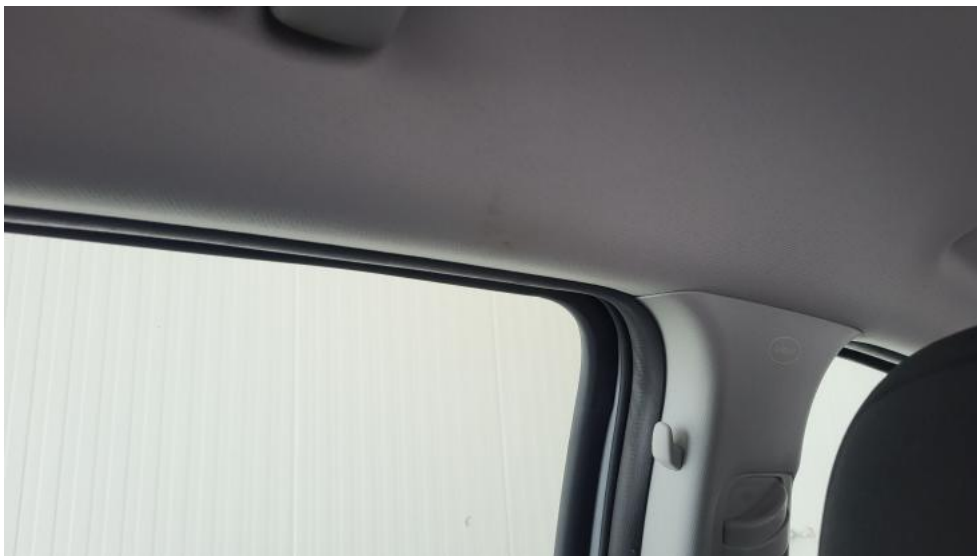
**Photo 71.**

Podsufitka - Inne 1
