DEKRA's commission No. : PKOL(W)/LODZ/69483/26/07/27  
commission/ damage No. : 23/030243  
Date of commission: 27-07-2026

**Vehicle data**

| Manufacturer | BMW |
| Type / version | 330d xDrive M Sport sport-aut |

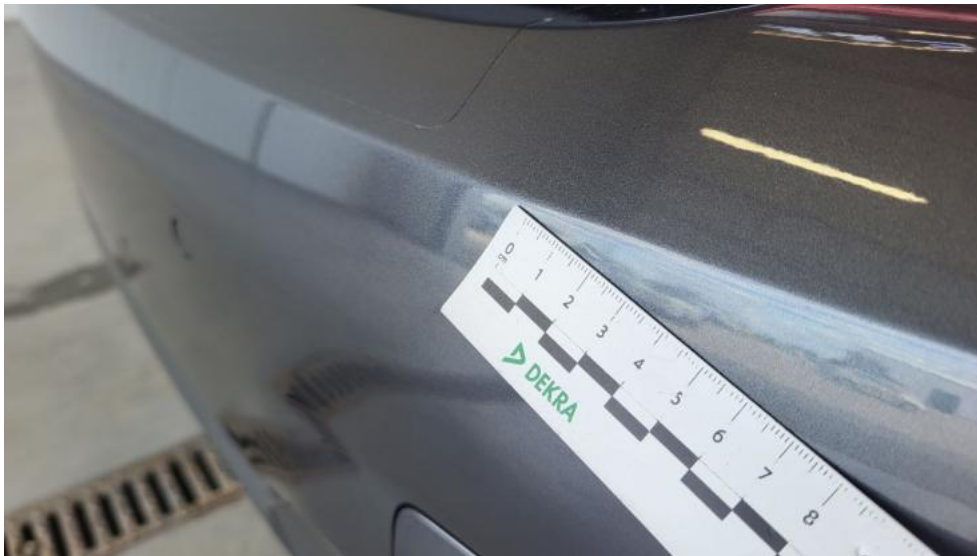
**Photo 57.**

Zderzak tylny - Wgniecenie/odkształcenie 1

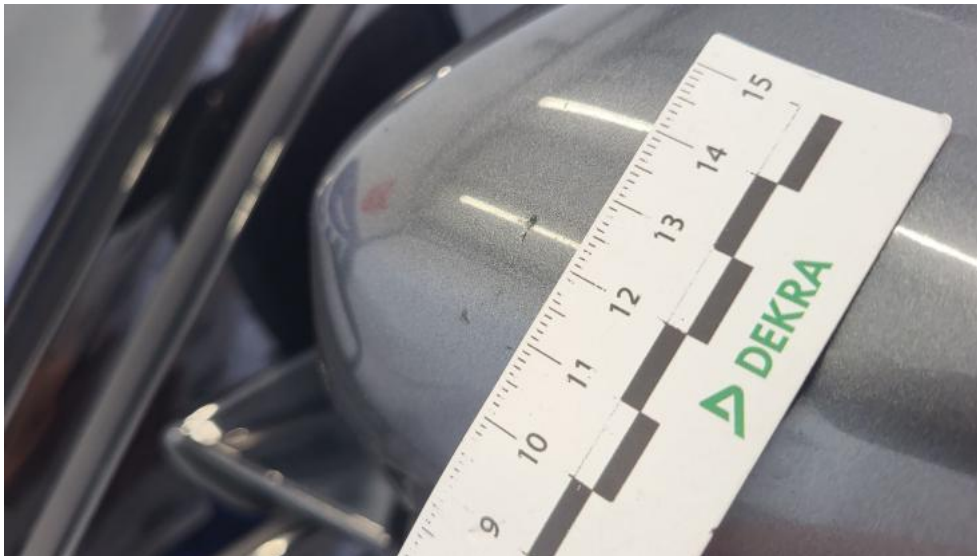
**Photo 67.**

Lusterko zew L - Rysa/odprysk 1
