DEKRA's commission No. : PKOL(W)/LODZ/58982/26/06/26  
 commission/ damage No. : 00452/EO/23  
 Date of commission: 26-06-2026

| Manufacturer | PORSCHE |
| Type / version | Taycan Turbo S |
| Registration /record No. | KR9XY71 |

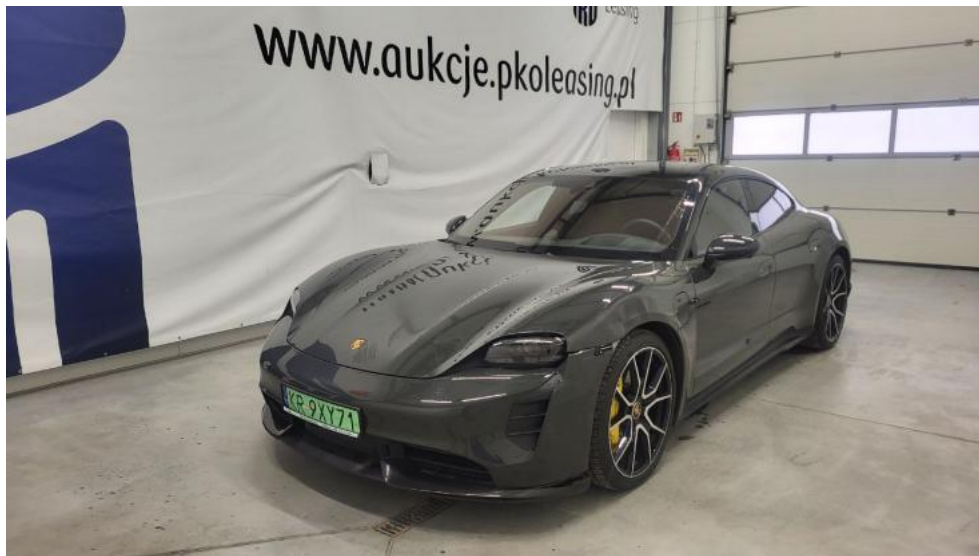
**Photo 1.**

Przekątna przednia lewa

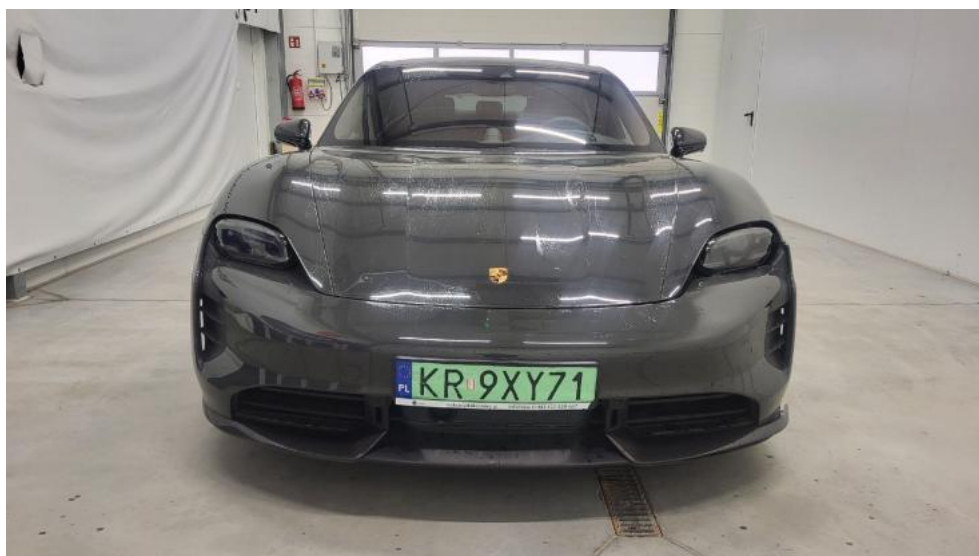
**Photo 2.**

Przód

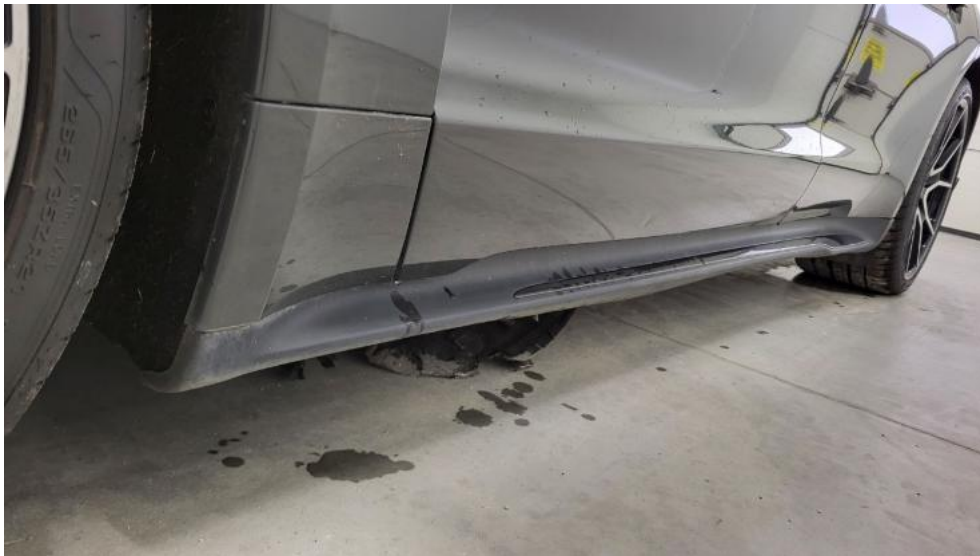
**Photo 11.**

Próg lewy (widok od przodu)

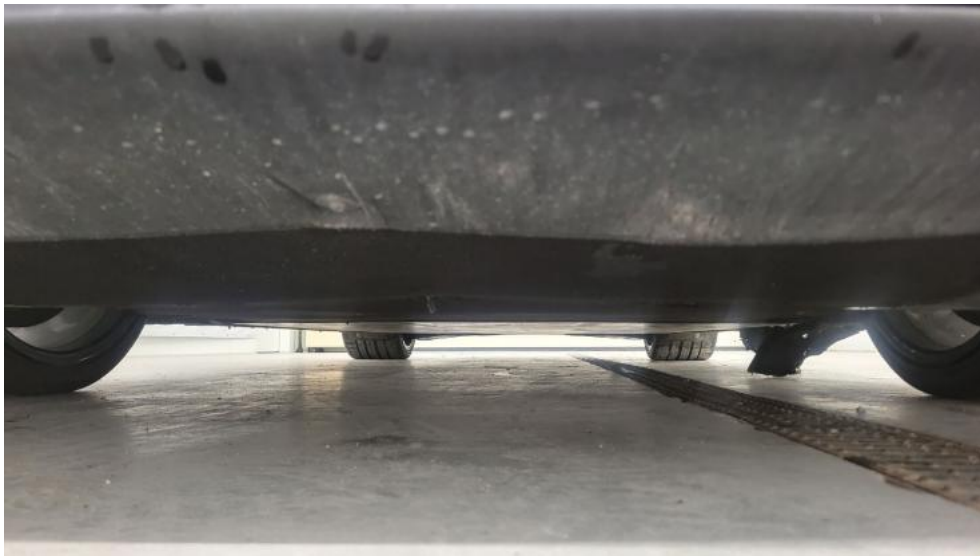
**Photo 13.**  
Spód pojazdu przód

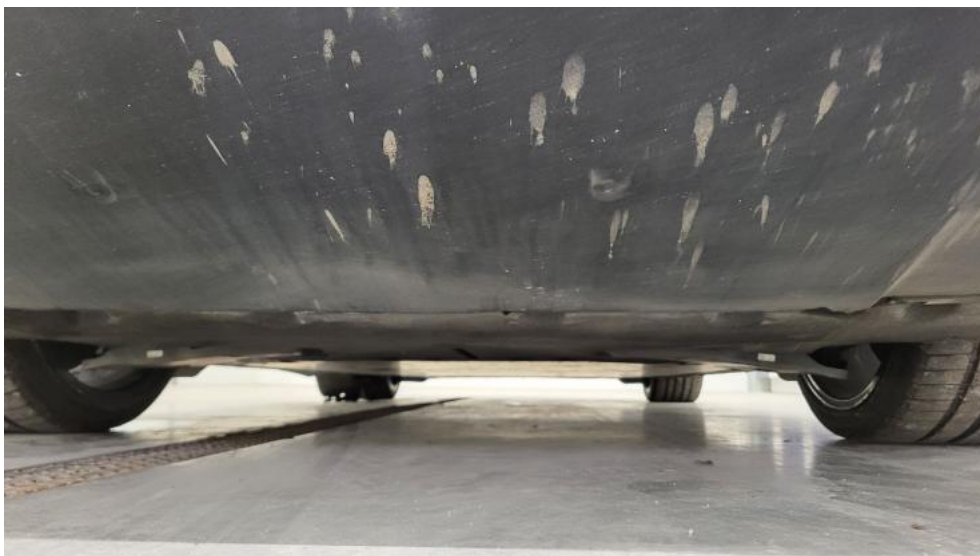
**Photo 14.**  
Spód pojazdu tył

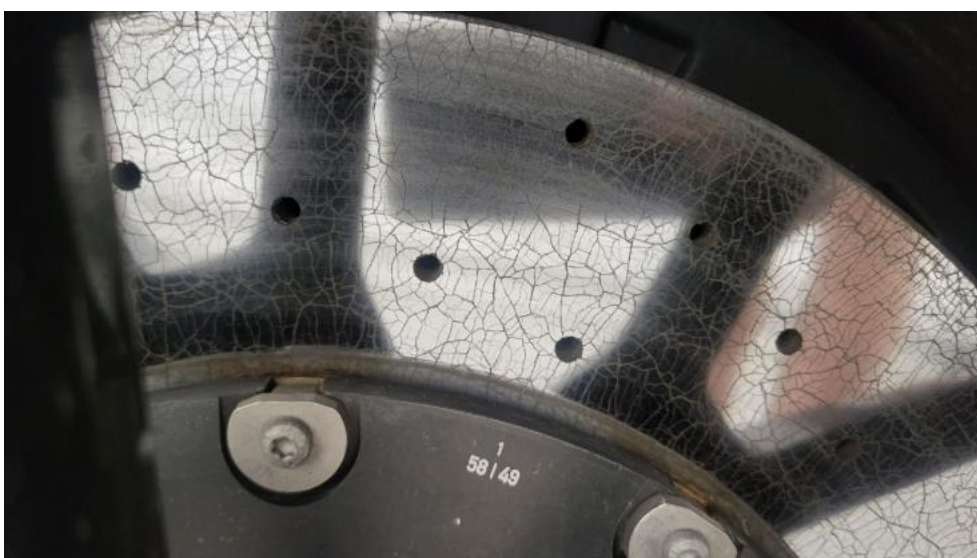
**Photo 16.**

Tarcza hamulcowa tylna prawa

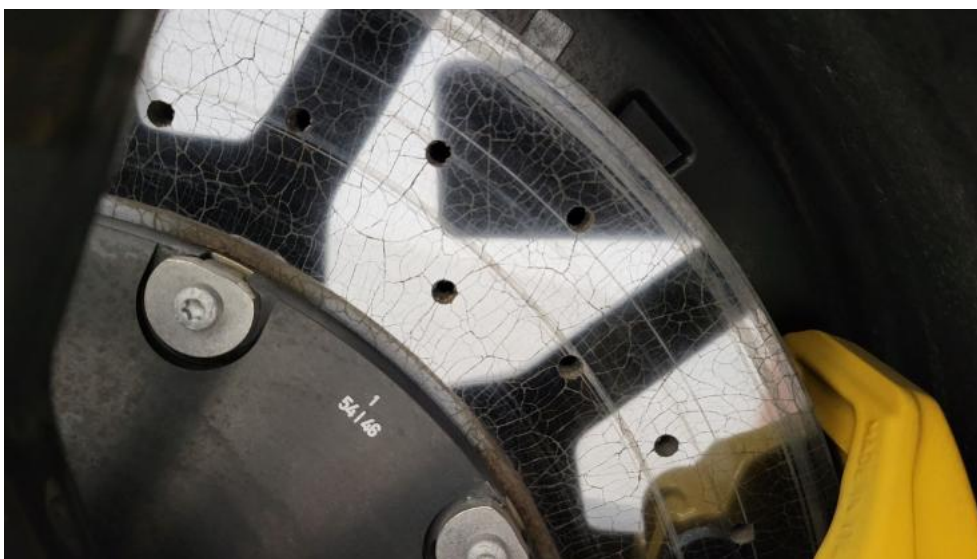
**Photo 17.**

Tarcza hamulcowa tylna lewa

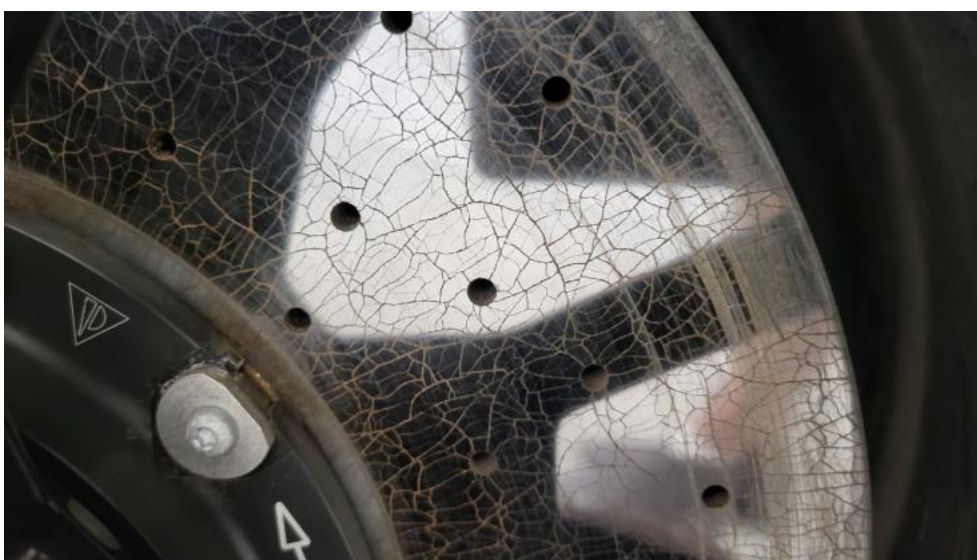
**Photo 18.**

Tarcza hamulcowa przednia lewa

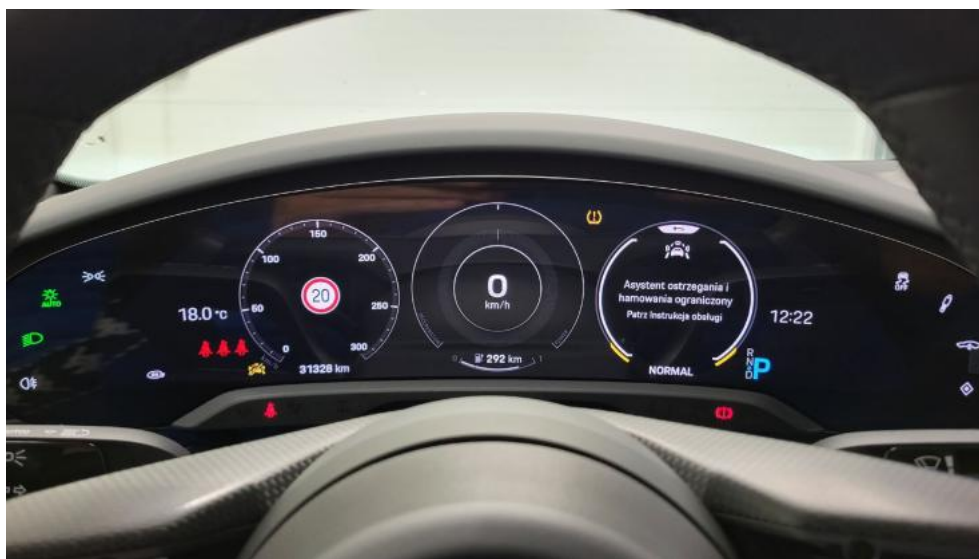
**Photo 23.**

Zestaw wskaźników - przebieg

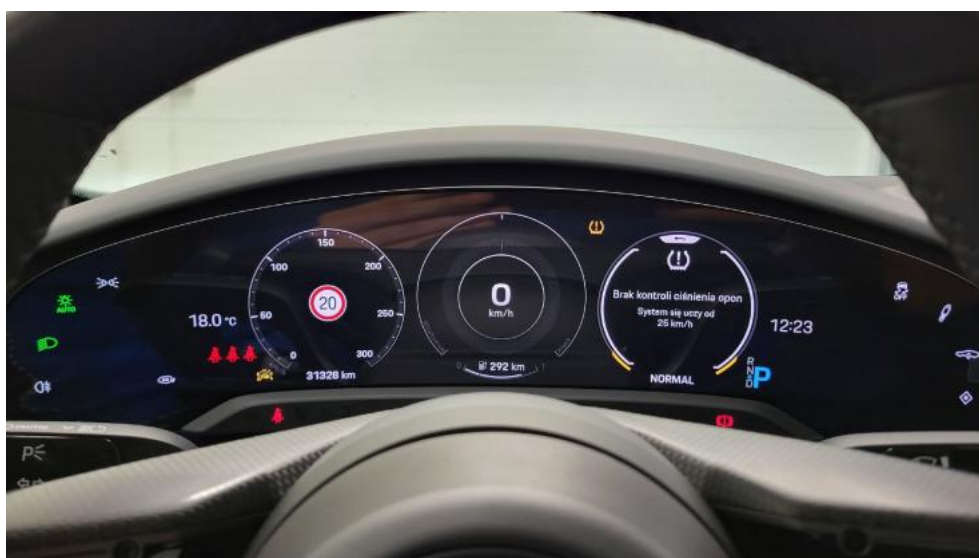
**Photo 24.**

Zestaw wskaźników - serwis

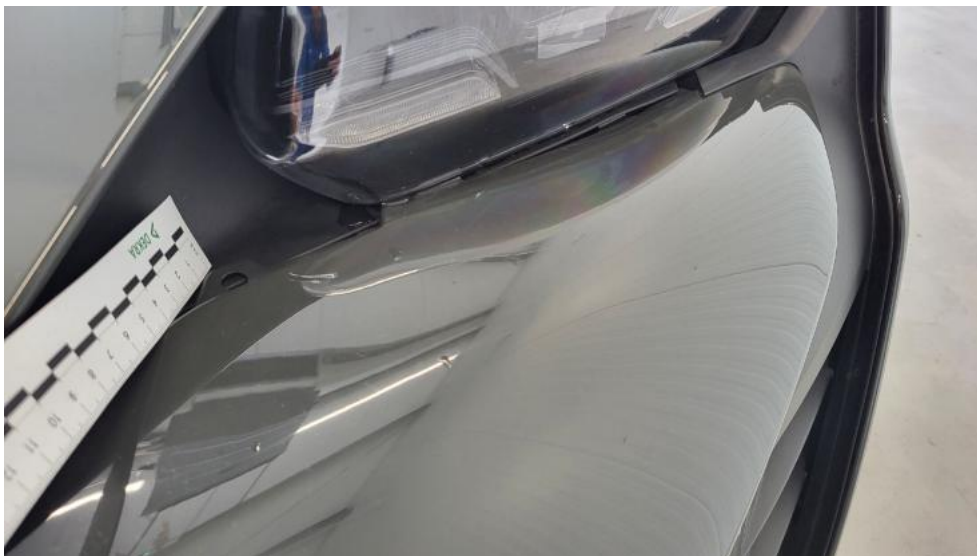
**Photo 68.**

Zderzak - Inne 1

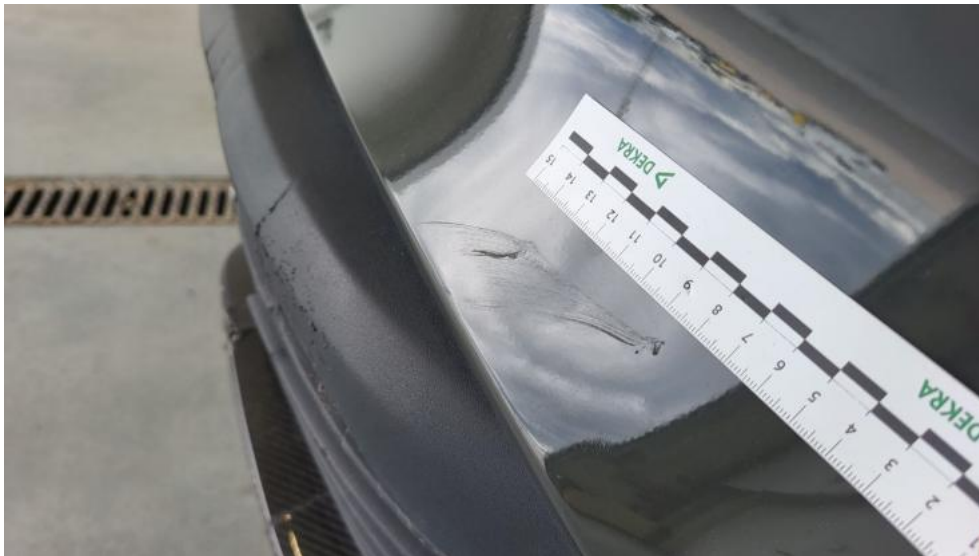
**Photo 78.**

Zderzak tylny - Rysa/odprysk 1

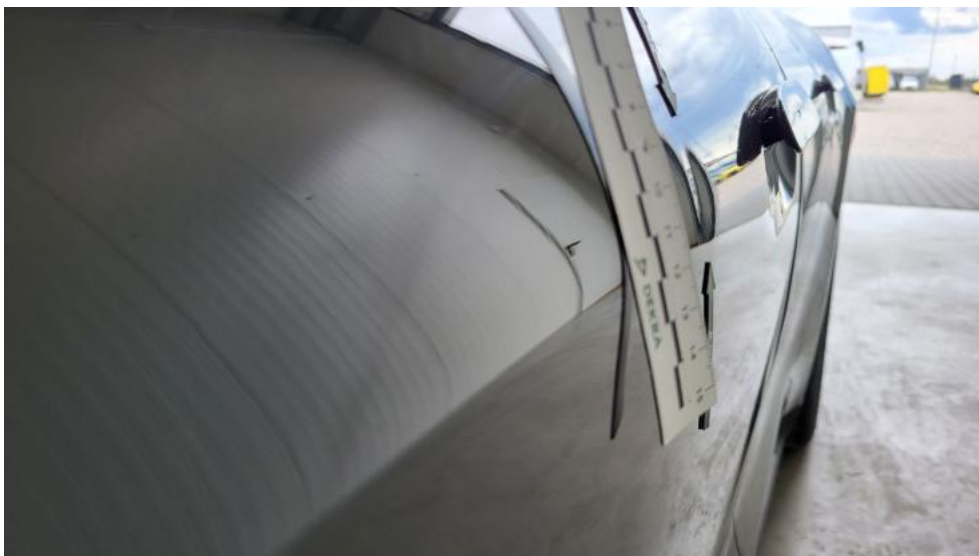
**Photo 85.**

Drzwi przed L - Rysa/odprysk 1
