DEKRA's commission No. : PKOL(W)/LODZ/07113/26/01/28
commission/ damage No. : 25/036819
Date of commission: 28-01-2026

Group of objects (Eurotax)	jeeps
EC code (Eurotax)	0148414
Manufacturer	AUDI
Model	Q7 19-24
Type / version	Q7 50 TDI mHEV Quattro Tiptr.
Body type	KOM
Number of doors / seats	5/5
Curb weight [kg]	2296
Gross vehicle weight [kg]	2850
Wheelbase 1/2	2995
Engine type	Automatic ignition
Pollution reduction system	KSC
Engine capacity [ccm]	2967
Engine Power [hp/kW]	286/210
Gearbox	automatic
Registration /record No.	FZ7666V
VIN / serial number	WAUZZZ4M1LD006964
Date of first registration	31-12-2020
Date of next. tech. test	29-01-2027
Year of manufacture	2019
Readout [km]	149 140 (read)
Body color / type of coating	granatowy/double-layered, metallized

Measurement of thickness of the vehicle lacquer coating

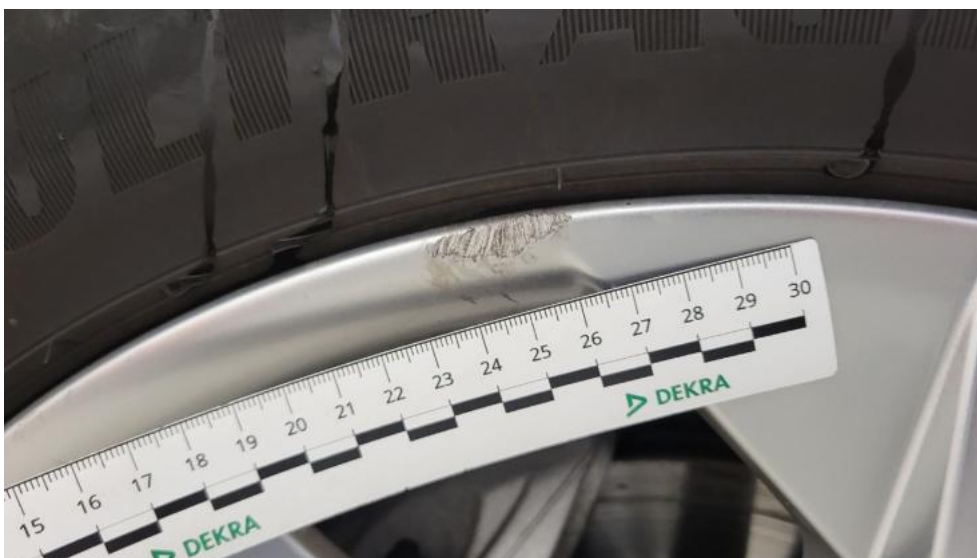
Photo 66.
Felga aluminiowa przednia P - Rysa/odprysk 1

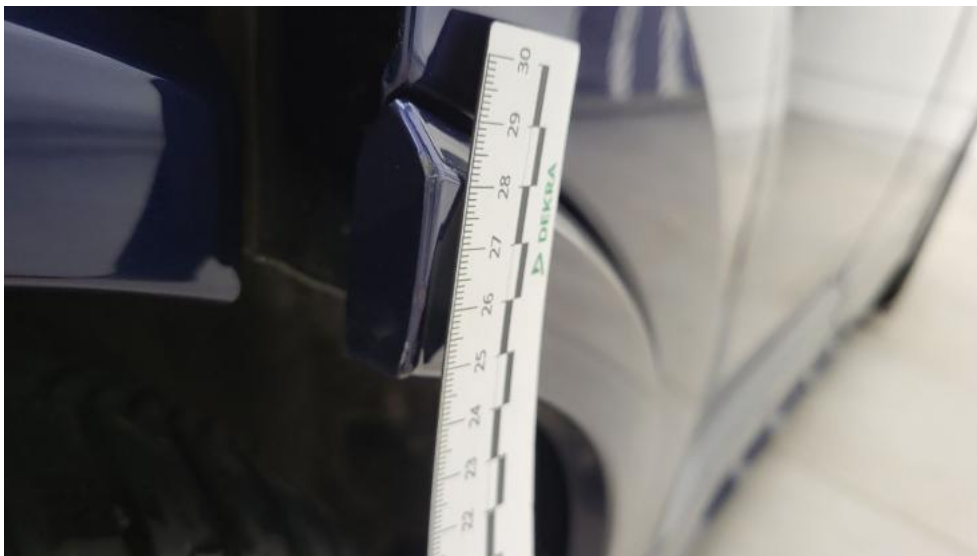
Photo 71.

Listwa drzwi tylnych P - Rysa/odprysk 1

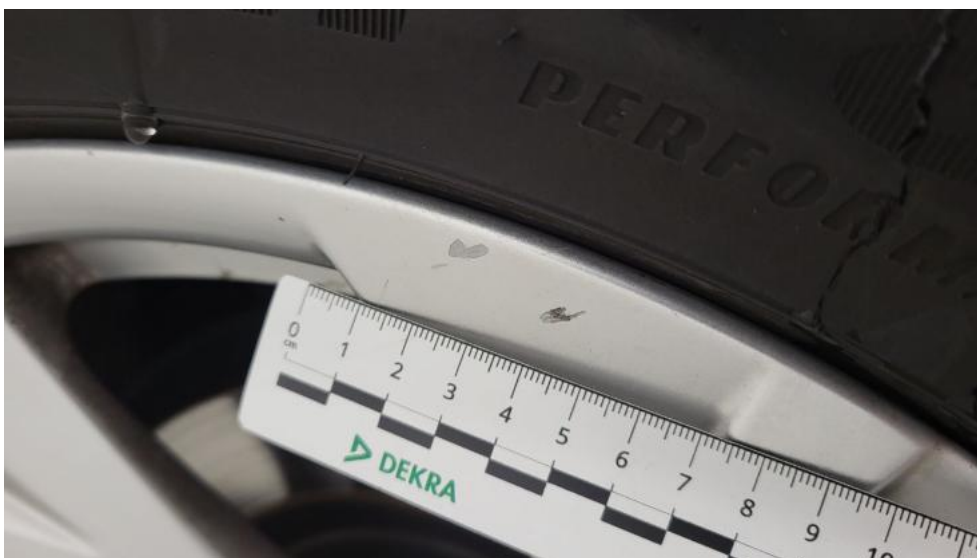
Photo 72.

Felga aluminiowa tylna P - Rysa/odprysk 1

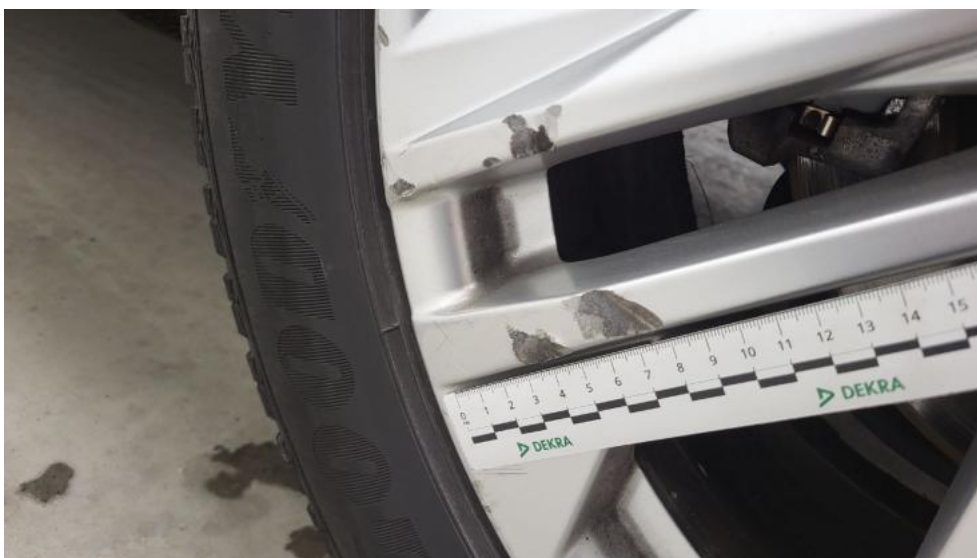
Photo 78.
Felga aluminiowa tylna L - Rysa/odprysk 1

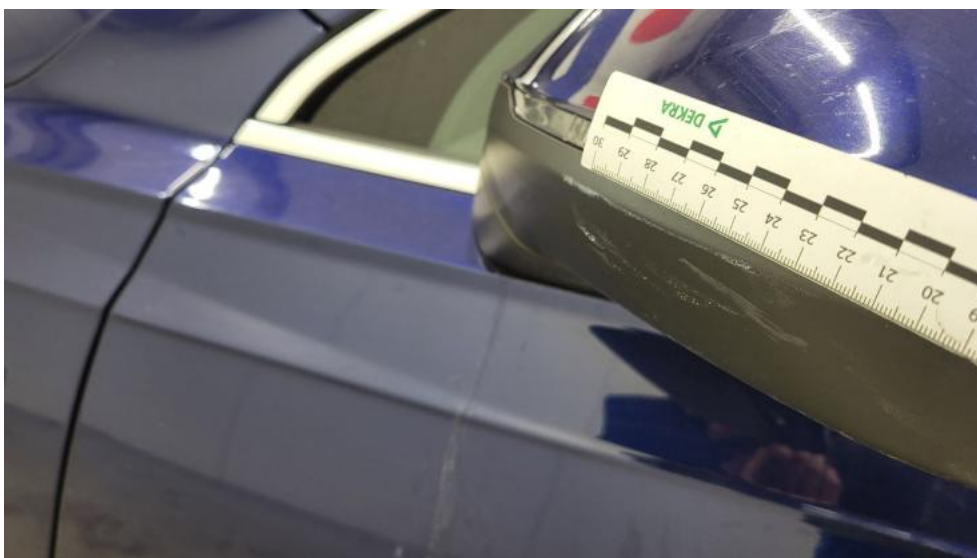
Photo 84.
Lusterko zew L - Rysa/odprysk 1

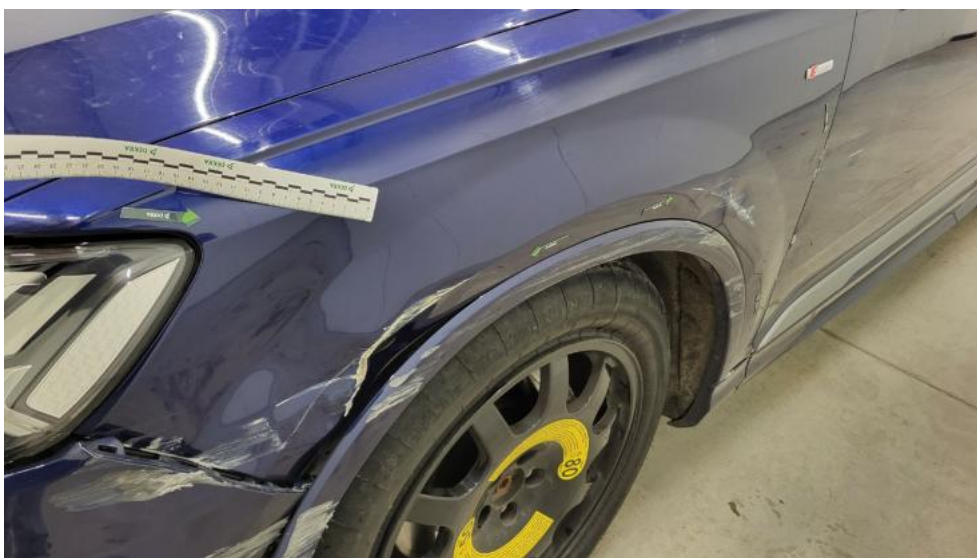
Photo 86.
Błotnik przedni L - Wgniecenie/odkształcenie 1

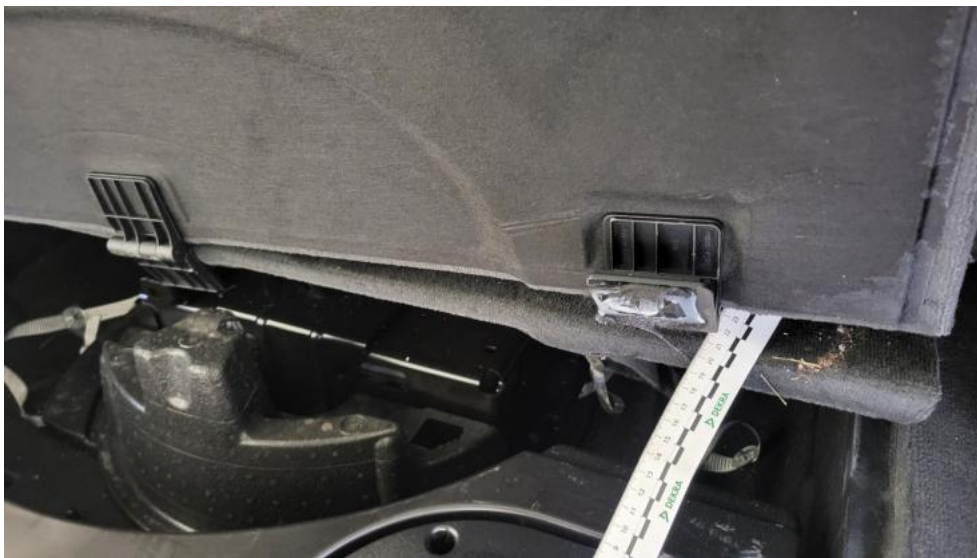
Photo 93.

Wykładzina podłogi bagażnika - Inne 1
