DEKRA's commission No. : PKOL(W)/LODZ/100054/24/12/30  
commission/ damage No. : 50598  
Date of commission: 30-12-2024

**Vehicle data**

Group of objects (Eurotax)	jeeps
EC code (Eurotax)	0135296
Manufacturer	LEXUS
Model	UX 18-24
Type / version	UX 250h GPF Prestige AWD
Body type	KOM
Number of doors / seats	5/5
Curb weight [kg]	1629
Gross vehicle weight [kg]	2110
Wheelbase 1/2	2640
Engine type	spark ignition
Pollution reduction system	GPF
Engine marking	hybrydowy
Engine capacity [ccm]	1987
Engine Power [hp/kW]	152/112
Gearbox	automatic
Registration /record No.	WR369AY
VIN / serial number	JTHU95BHX02008729
Date of first registration	24-06-2019
Date of next. tech. test	28-06-2025
Year of manufacture	2019 (year has been verified with the manufacturer's base)
Readout [km]	107 000 (read)
Body color / type of coating	green/double-layered, metallized

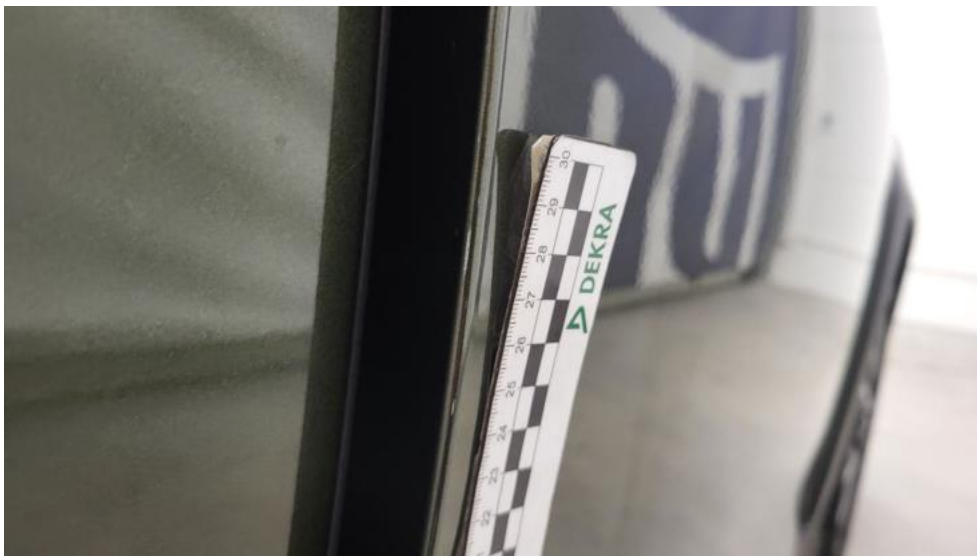
**Photo 45.**

Drzwi przednie P - Rysa/odprysk 2

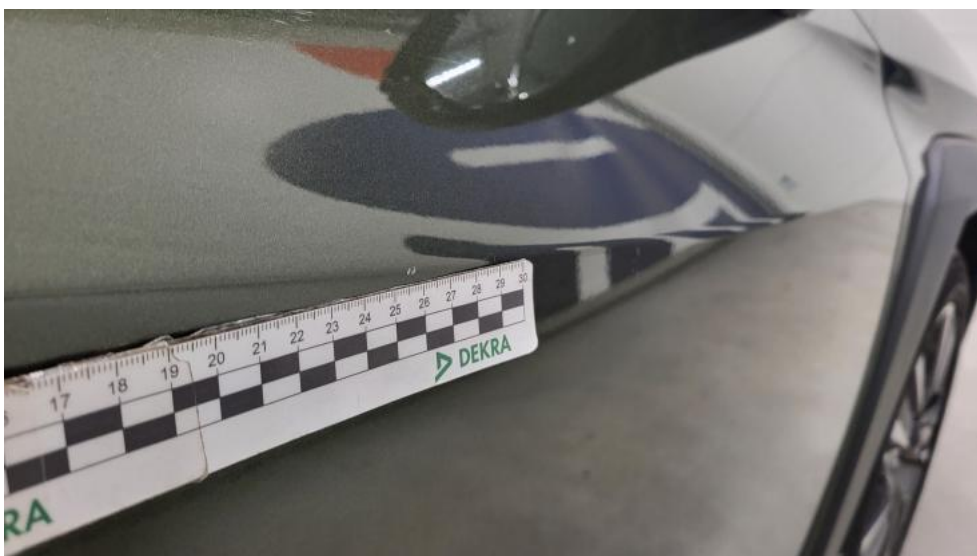
**Photo 46.**

Drzwi przednie P() - Rysa/odprysk 3

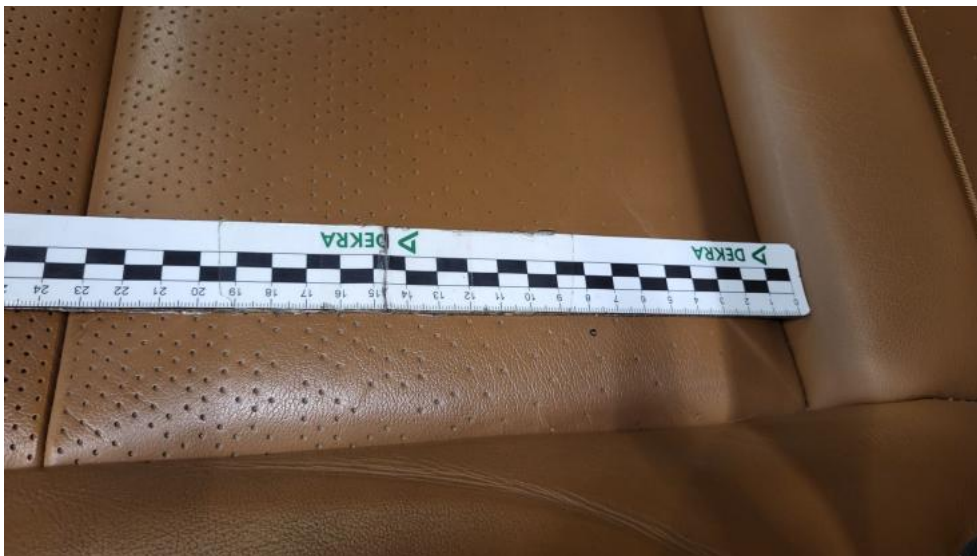
**Photo 73.**  
Fotel prz. lew. - Inne 1

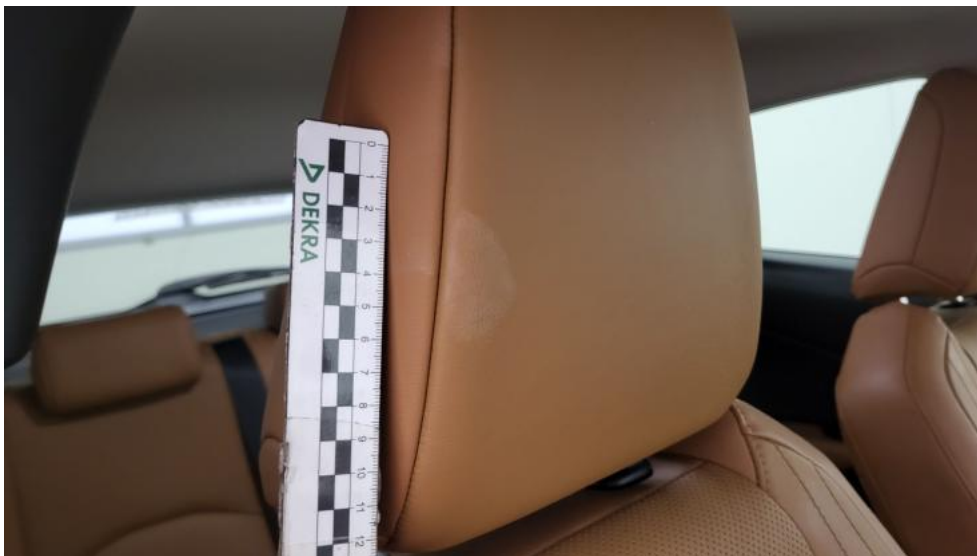
**Photo 77.**  
Zaglówek fotela prz. P - Inne 1
