DEKRA's commission No. : PKOL(W)/LODZ/19375/25/03/17  
commission/ damage No. : Futura  
Date of commission: 17-03-2025

PKO Leasing SA  
Świętokrzyska 36  
00-116 Warszawa

Group of objects (Eurotax)	cars
EC code (Eurotax)	0137057
Manufacturer	FORD
Model	Mondeo Kombi 19-21
Type / version	Mondeo 2.0 EcoBlue Titanium AWD aut
Body type	KOM
Number of doors / seats	5/5
Curb weight [kg]	1797
Gross vehicle weight [kg]	2365
Wheelbase 1/2	2850
Engine type	Automatic ignition
Supercompression	turbocompressor with intercooler
Pollution reduction system	KSC
Emission standard	EURO 6
Engine capacity [ccm]	1997
Engine Power [hp/kW]	190/140
Gearbox	automatic 8- gear
Registration /record No.	WD2087N
VIN / serial number	WF0FXXWPCFKU82228
Date of first registration	11-12-2019
Date of next. tech. test	27-11-2025
Year of manufacture	2019 (year has been verified with the manufacturer's base)
Readout [km]	123 600 (read)
Body color / type of coating	black/2-warstwowy uni

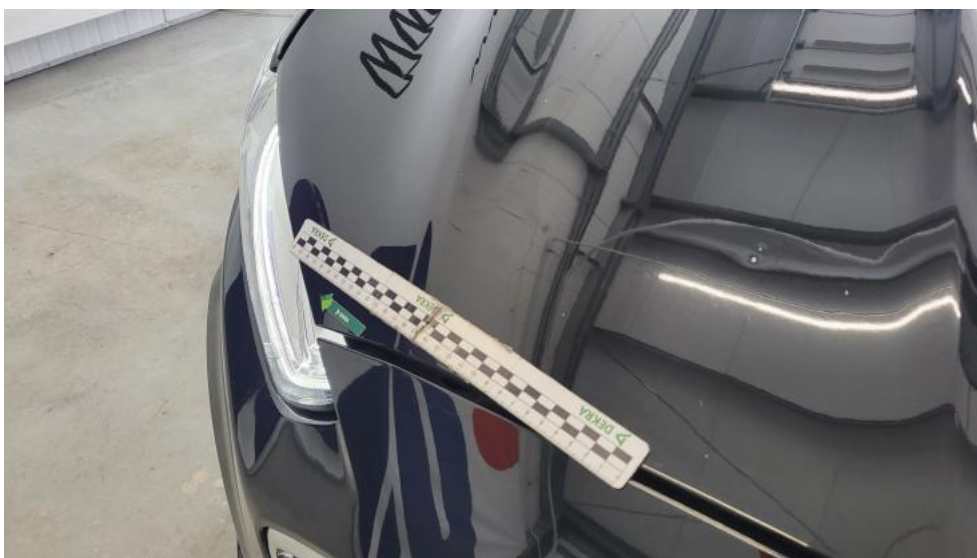
**Photo 38.**  
Pokrywa komory silnika - zdjęcie poglądowe 1

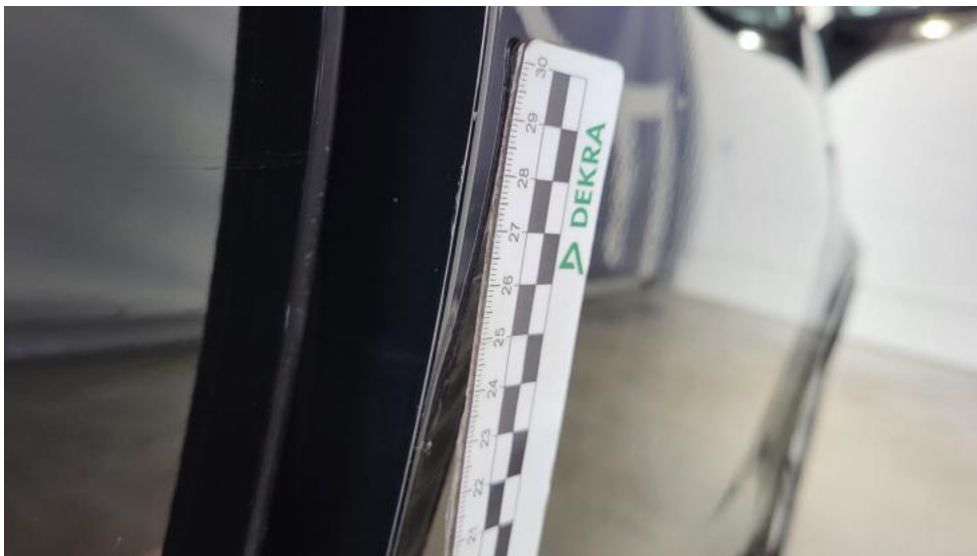
**Photo 45.**

Drzwi przednie P - Rysa/odprysk 1
