DEKRA's commission No. : PKOL(W)/LODZ/16793/26/02/24
commission/ damage No. : 21/059163
Date of commission: 24-02-2026

Vehicle data

Description of the technical condition

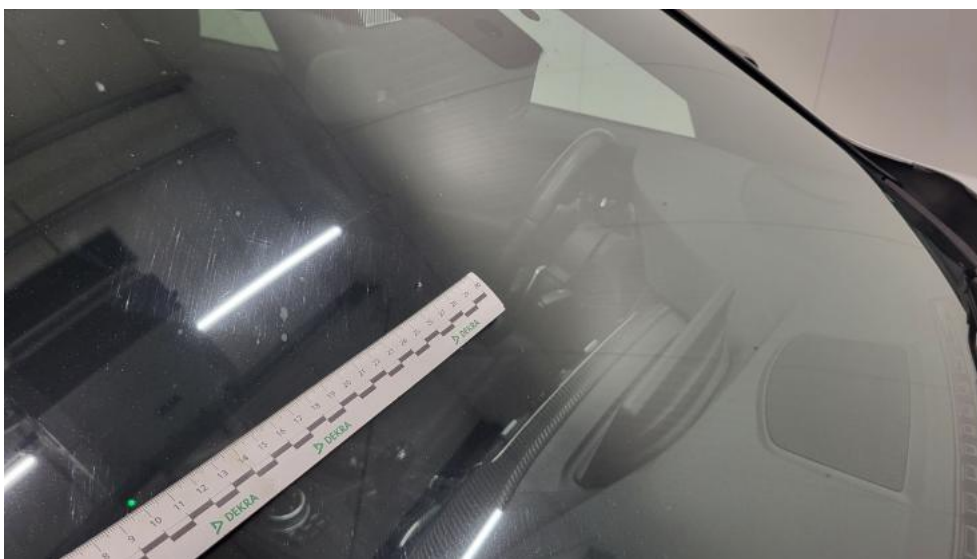
Photo 47.

Szyba czołowa - zdjęcie pogładowe 1

Szyba czołowa - Pęknięcie/rozerwanie 1

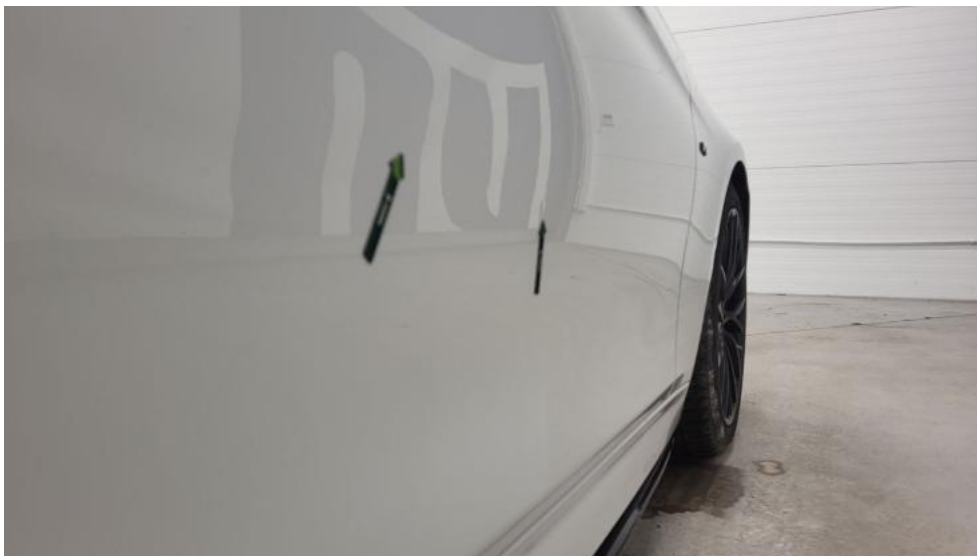
Photo 53.

Drzwi przednie P - Wgniecenie/odkształcenie 1

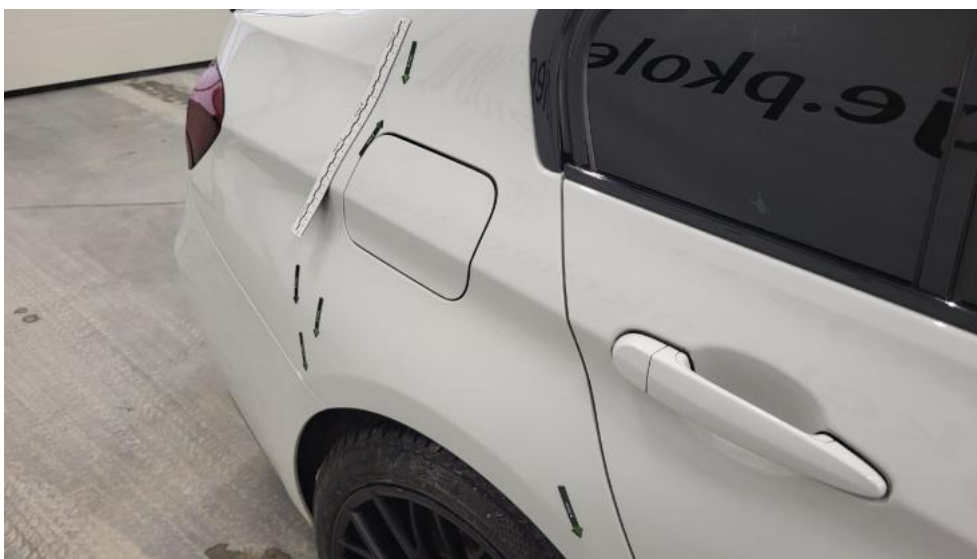
Photo 57.

Błotnik tylny P / Ściana boczna P - zdjęcie pogładowe 1

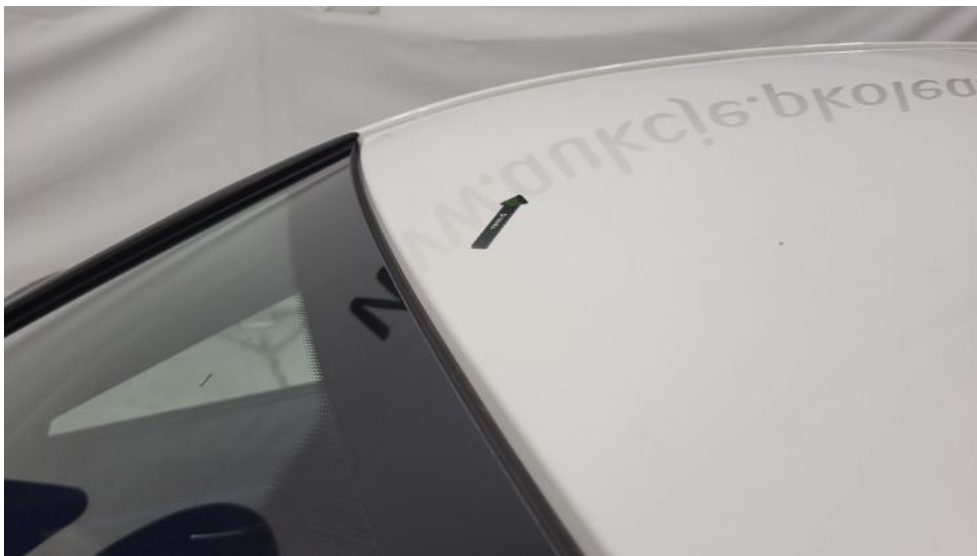
Photo 61.

Dach - Wgniecenie/odkształcenie 1

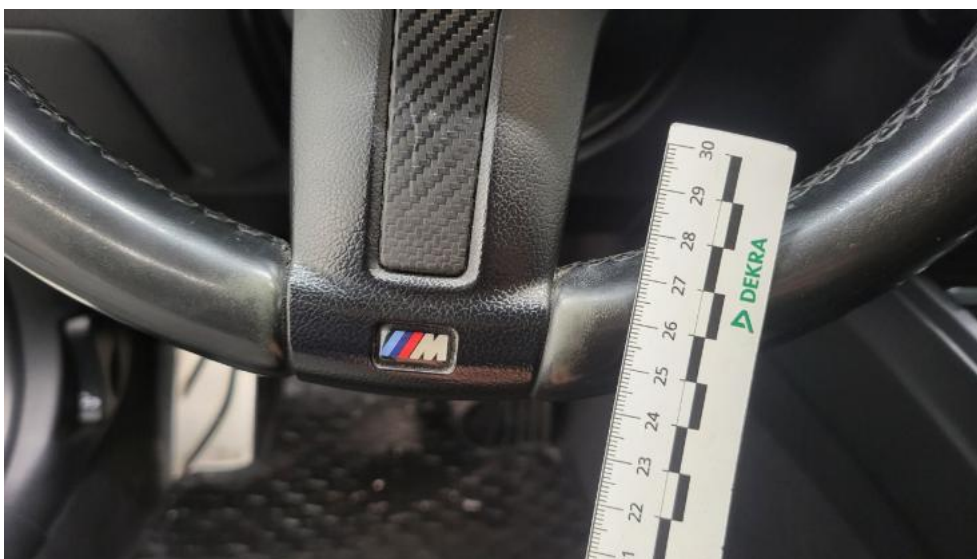
Photo 73.
Koło kierownicy - Inne 1

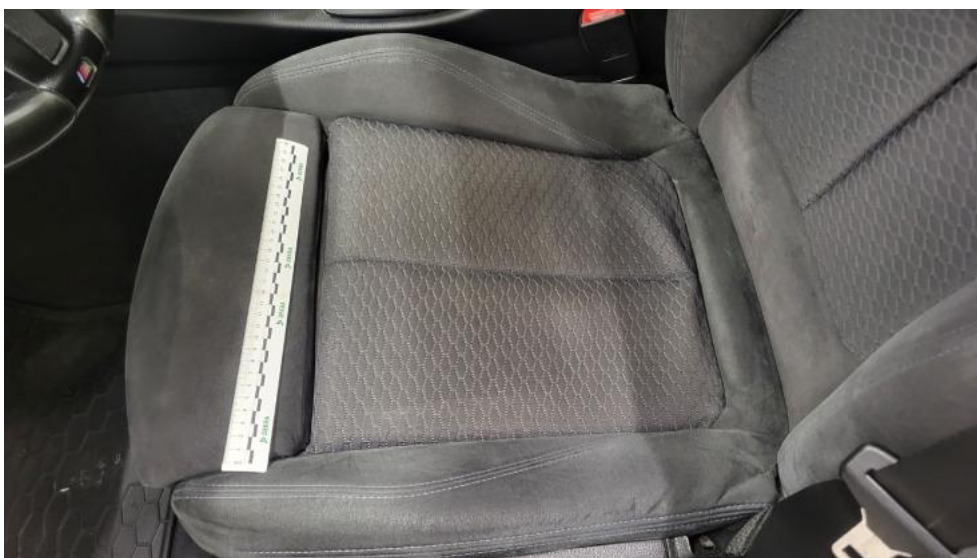
Photo 74.
Fotel prz. lew. - Inne 1

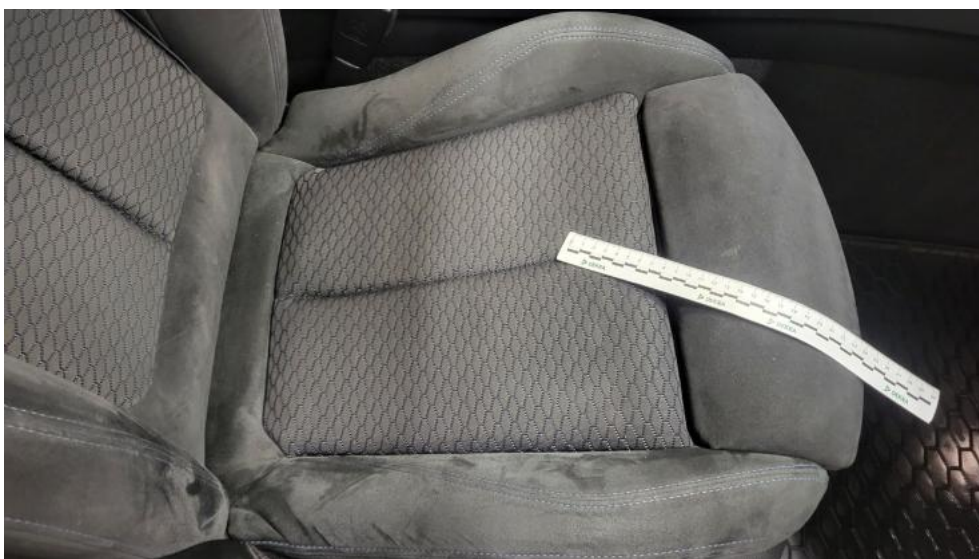
Photo 75.
Fotel prz. praw. - Inne 1

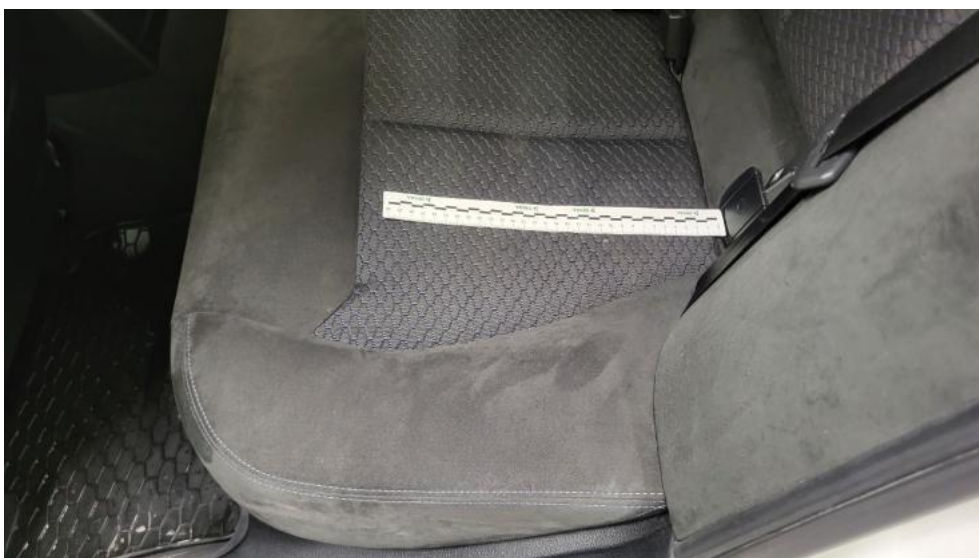
Photo 76.
Kanapa tyl. - Inne 1

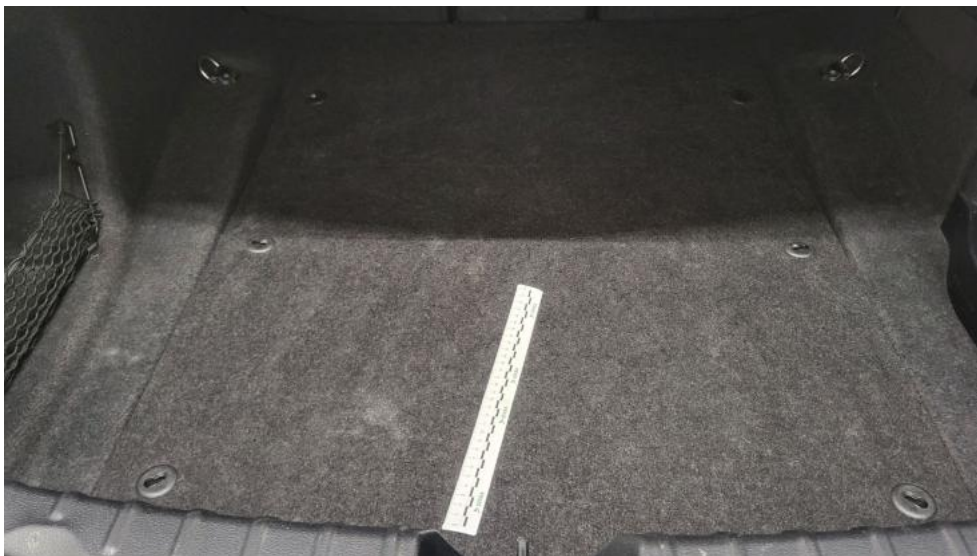
Photo 79.

Wykładzina podłogi bagażnika - Inne 1

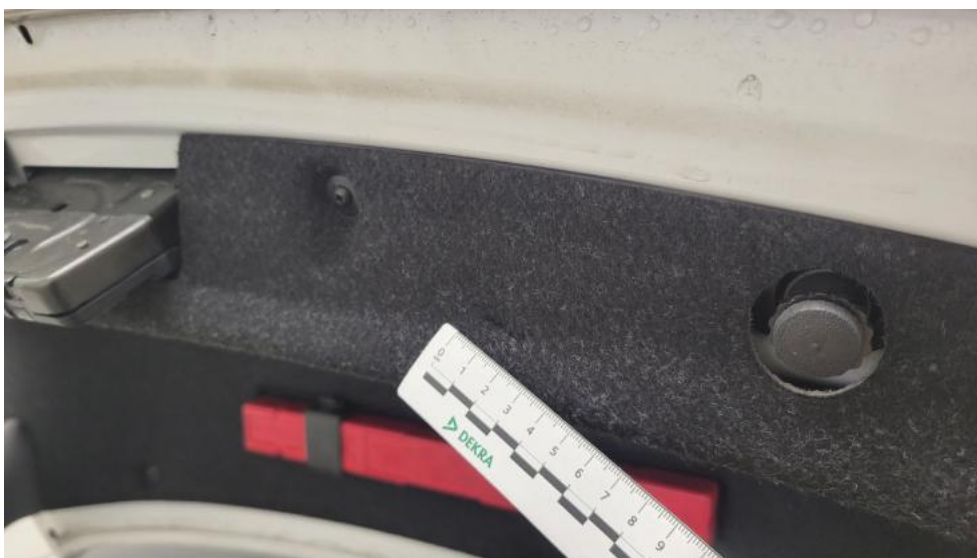
Photo 80.

Wykładzina pokrywy tylnej - zdjęcie poglądowe 1
