DEKRA's commission No. : PKOL(W)/LODZ/39987/26/05/07
 commission/ damage No. : 24/043425
 Date of commission: 07-05-2026

Vehicle data

Group of objects (Eurotax)	cars
EC code (Eurotax)	0135214
Manufacturer	SEAT
Model	Arona 17-21
Type / version	Arona 1.0 TSI GPF FR S&S DSG
Body type	hatchback
Number of doors / seats	5/5
Curb weight [kg]	1162
Gross vehicle weight [kg]	1630
Wheelbase 1/2	2566
Engine type	spark ignition
Pollution reduction system	GPF
Engine capacity [ccm]	999
Engine Power [hp/kW]	115/85
Gearbox	automatic
Registration /record No.	SG583EA
VIN / serial number	VSSZZZKJZMR034421
Date of first registration	08-12-2020
Date of next. tech. test	11-12-2026
Year of manufacture	2020 (year has been verified with the manufacturer's base)
Readout [km]	127 417 (read)
Body color / type of coating	white/UNI

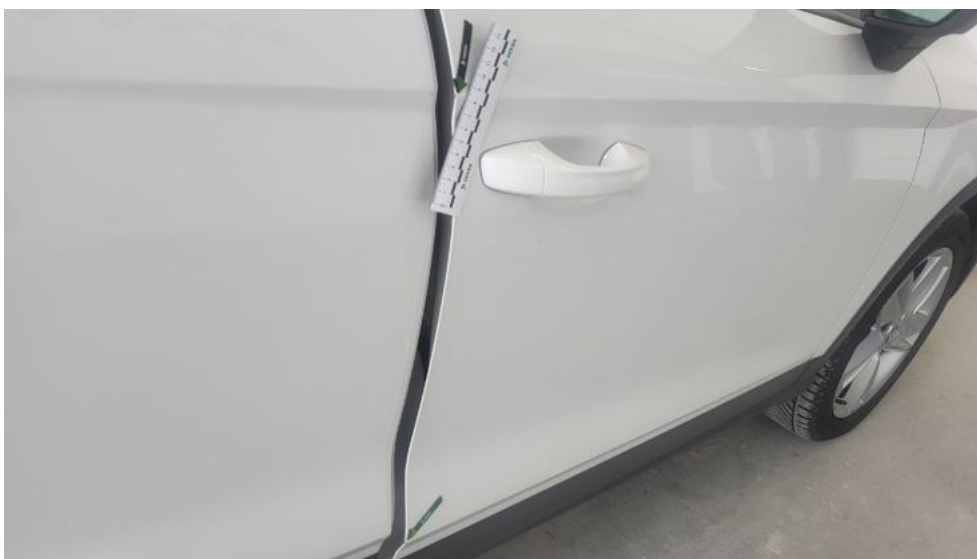
Photo 43.

Drzwi przednie P - zdjęcie poglądowe 1

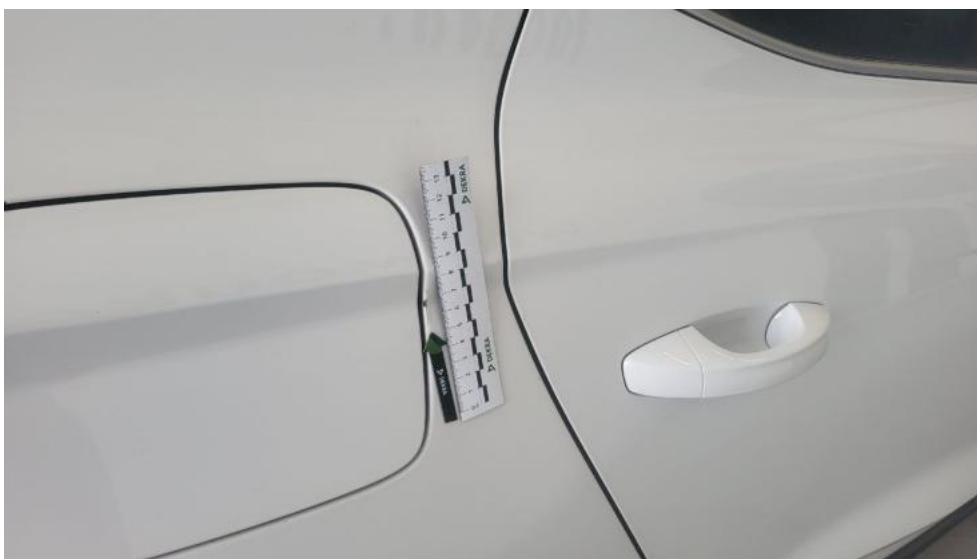
Photo 49.

Błotnik tylny P / Ściana boczna P - zdjęcie poglądowe 1
