DEKRA's commission No. : PKOL(W)/LODZ/55150/25/07/28  
commission/ damage No. : 22/032797  
Date of commission: 28-07-2025

**DEKRA Poland - Headquarters**  
02-673 Warszawa, ul. Konstruktorska 12A

| Manufacturer | HYUNDAI |
| Type / version | Ioniq 5 73kWh Executive 4WD |

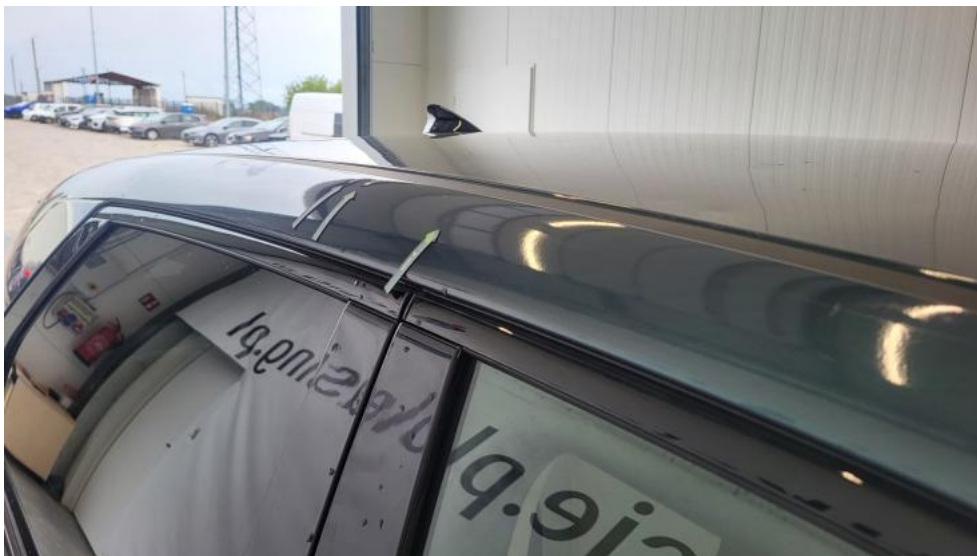
**Photo 59.**

Słupek przedni P - Wgniecenie/odkształcenie 1

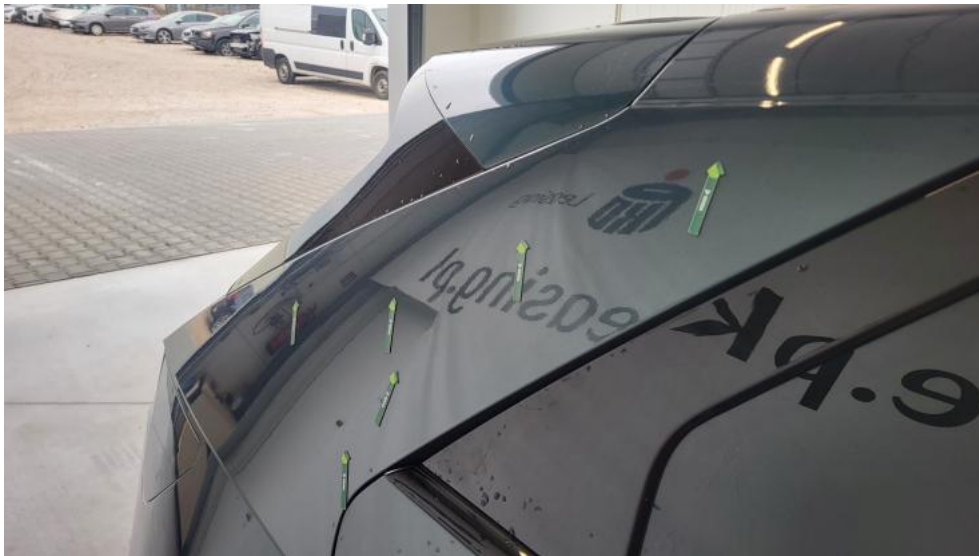
**Photo 61.**

Ścianka tylna P / Ścianka boczna P - Wgniecenie/odkształcenie 2

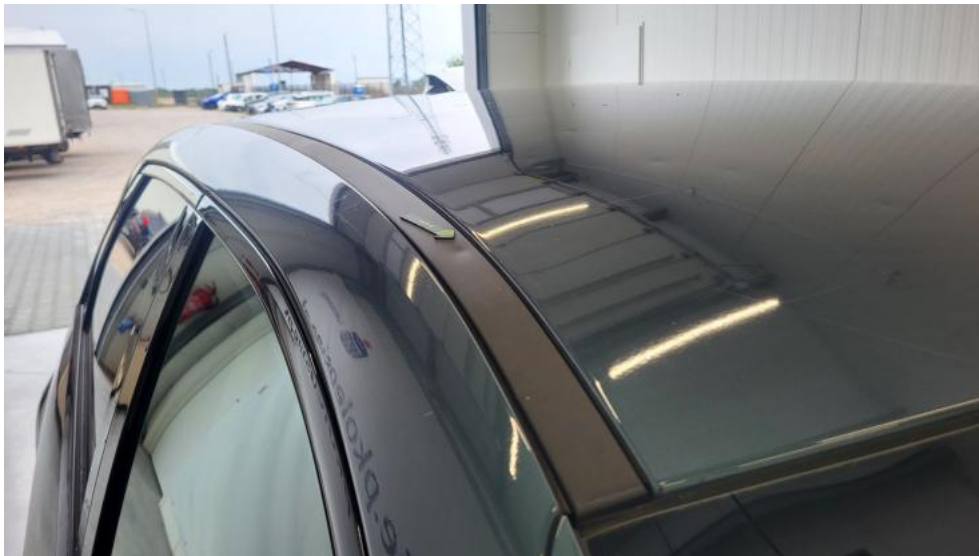
**Photo 67.**

Listwy dachu praw. - Wgniecenie/odkształcenie 1

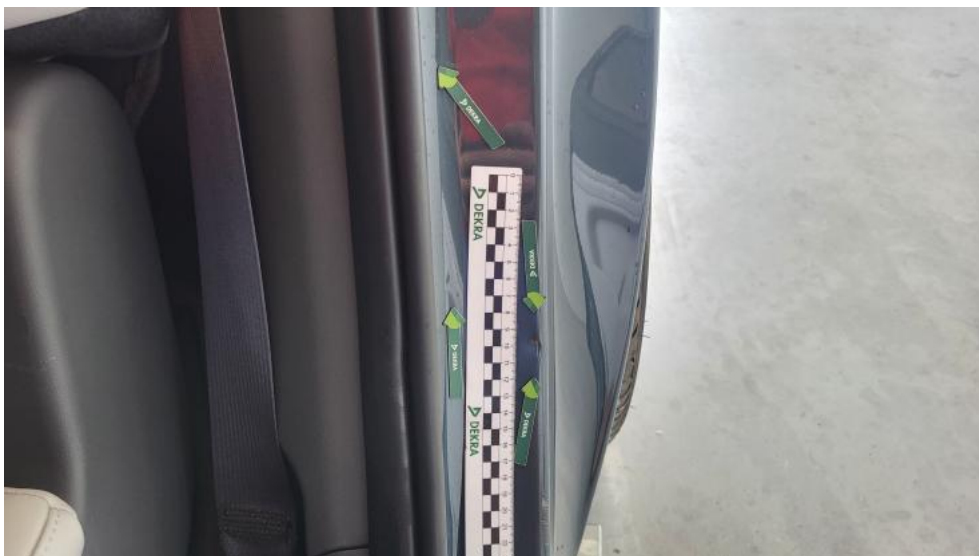
**Photo 68.**

Łotnik tylny L / Ściana boczna L - Wgniecenie/odkształcenie 1

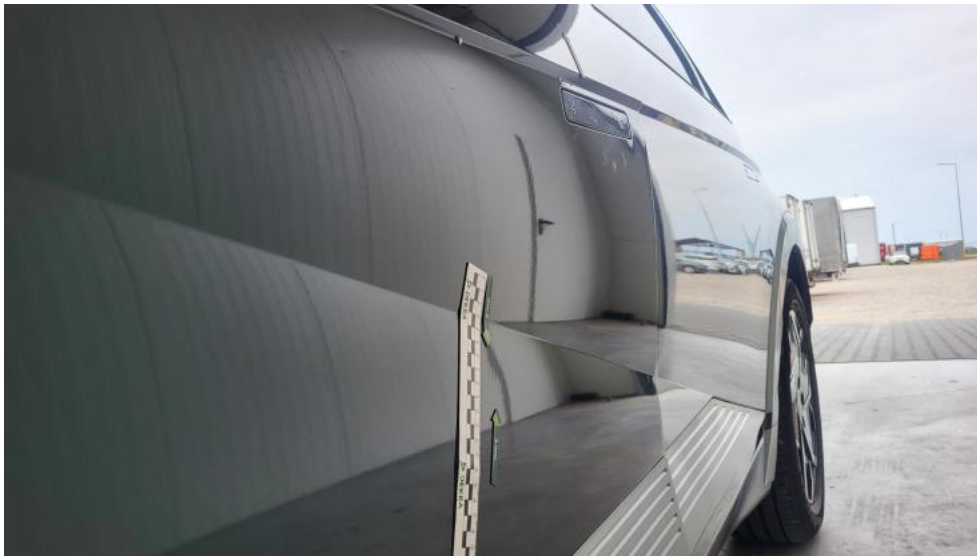
**Photo 71.**

Drzwi przed L - Wgniecenie/odkształcenie 1

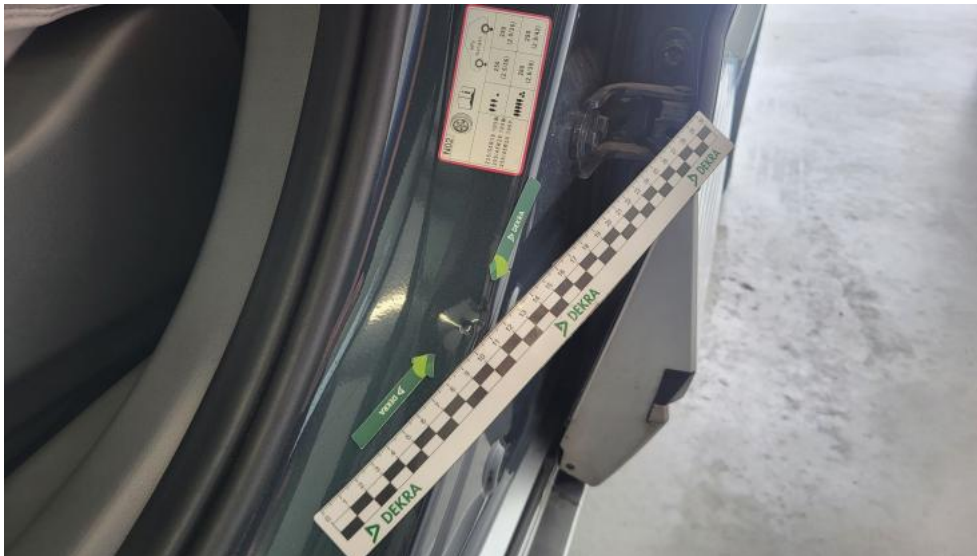
**Photo 77.**

Słupek środkowy L - Wgniecenie/odkształcenie 1

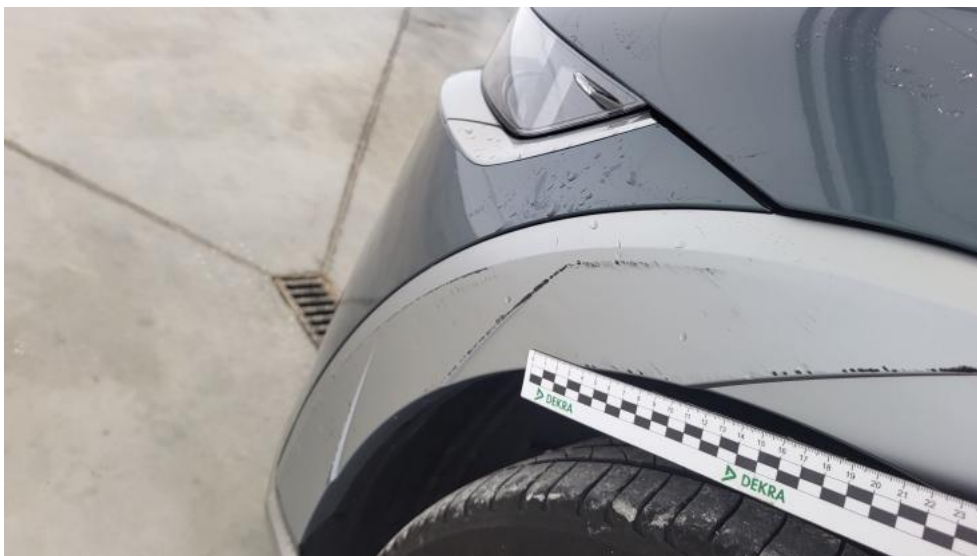
**Photo 78.**

Listwa błotnika przedniego L - Rysa/odprysk 1

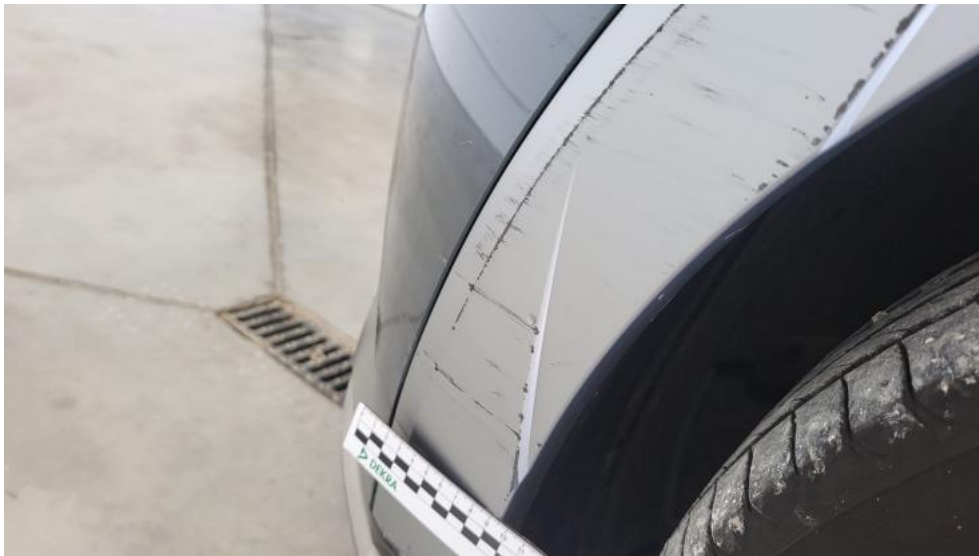
**Photo 79.**

Listwa błotnika przedniego L - Rysa/odprysk 2
