DEKRA's commission No. : PKOL(W)/LODZ/89683/25/11/19  
commission/ damage No. : 20/043709  
Date of commission: 19-11-2025

| Manufacturer | AUDI |
| Type / version | A4 2.0 TDI S tronic |
| Registration /record No. | WZ095CA |

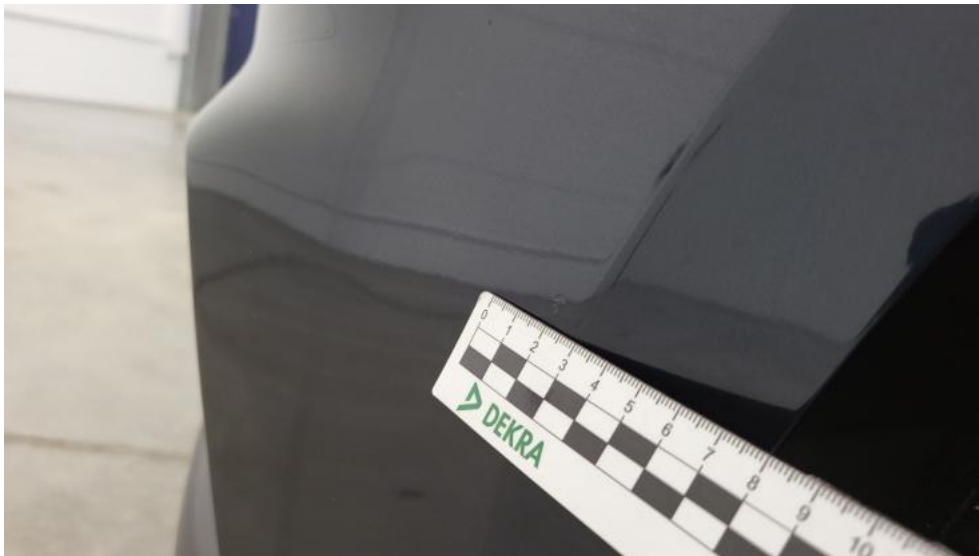
**Photo 41.**

Zderzak - Wgniecenie/odkształcenie 1

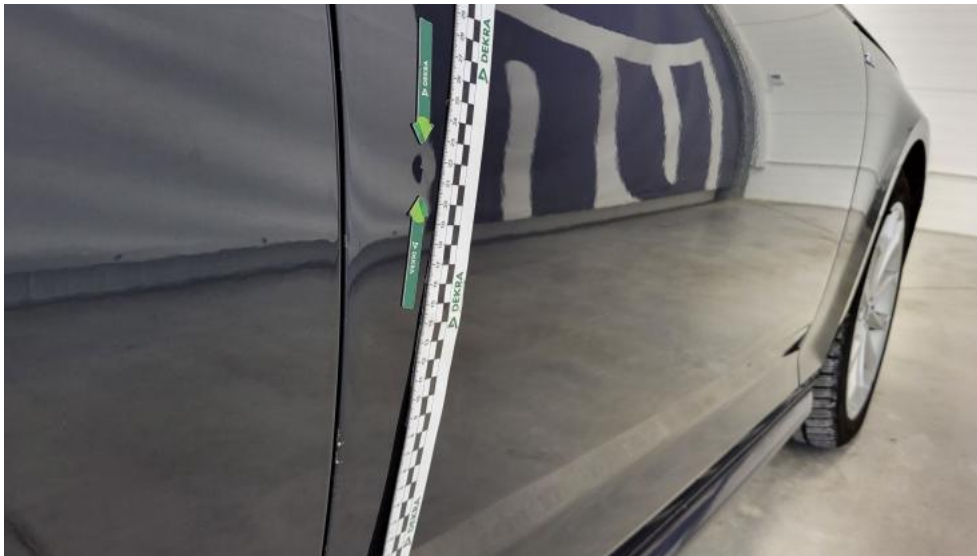
**Photo 47.**

Drzwi przednie P - Wgniecenie/odkształcenie 1

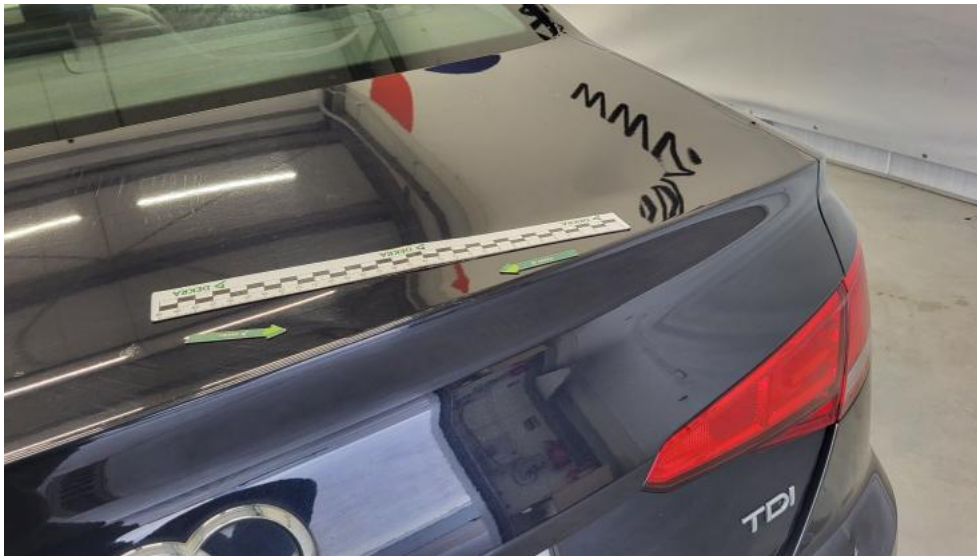
**Photo 63.**

Pokrywy bagażnika - Wgniecenie/odkształcenie 1

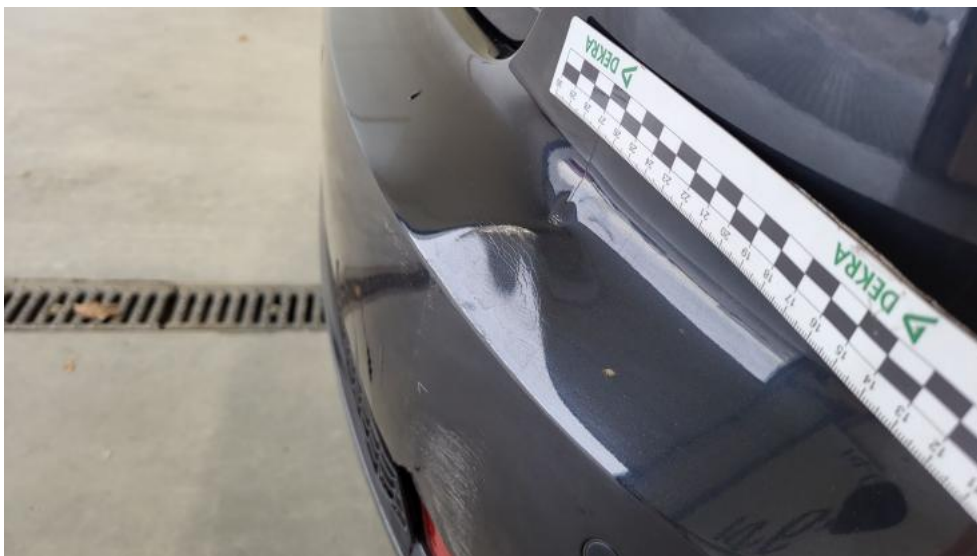
**Photo 64.**

Zderzak tylny - Wgniecenie/odkształcenie 1

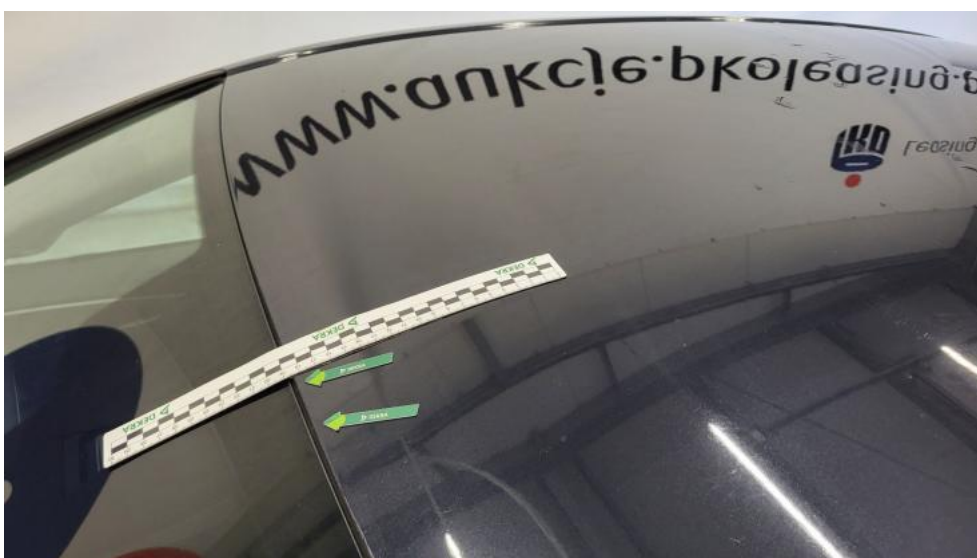
**Photo 68.**

Dach - zdjęcie poglądowe 1

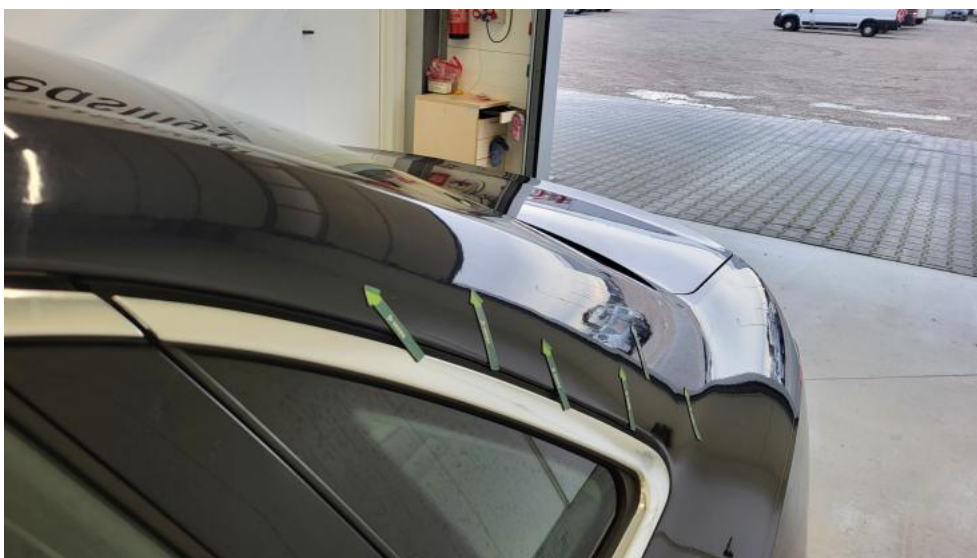
**Photo 72.**

Błotnik tylny L / Ściana boczna L - Wgniecenie/odkształcenie 1

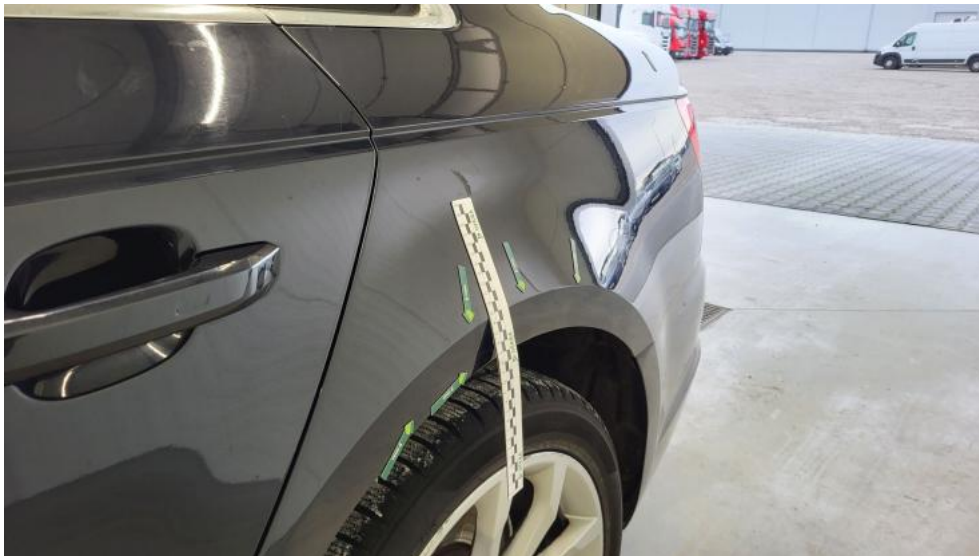
**Photo 73.**

Błotnik tylny L / Ściana boczna L - Wgniecenie/odkształcenie 2

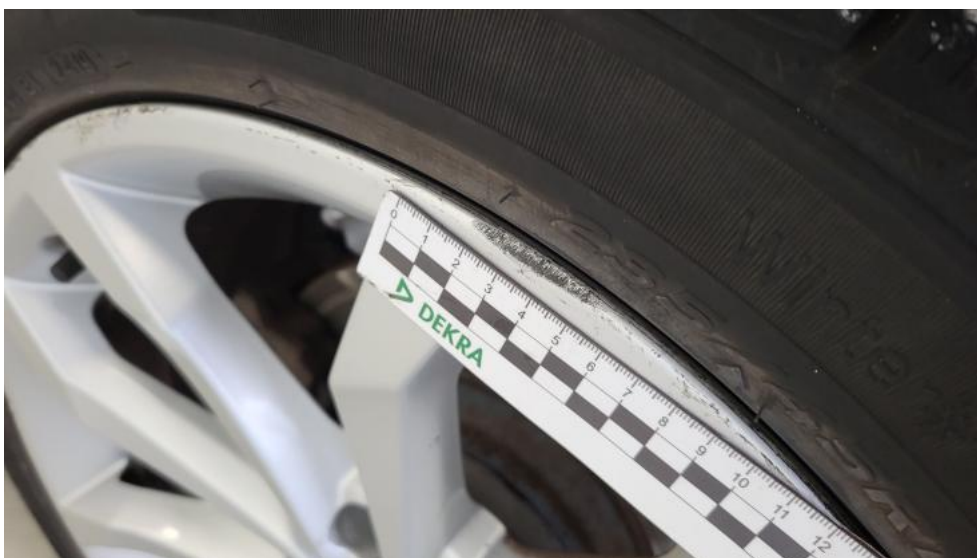
**Photo 76.**

Felga aluminiowa tylna L - Rysa/odprysk 1

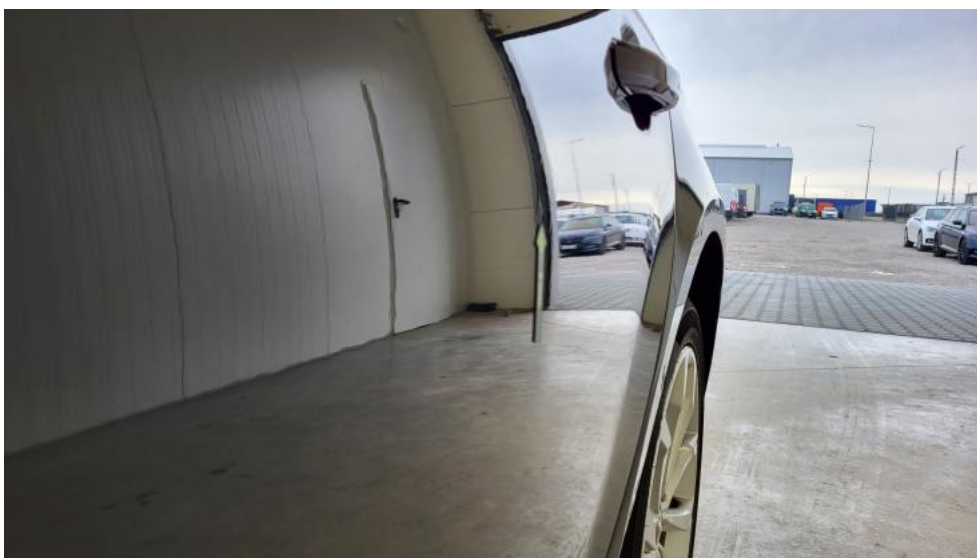
**Photo 80.**

Drzwi tylne L - Wgniecenie/odkształcenie 1

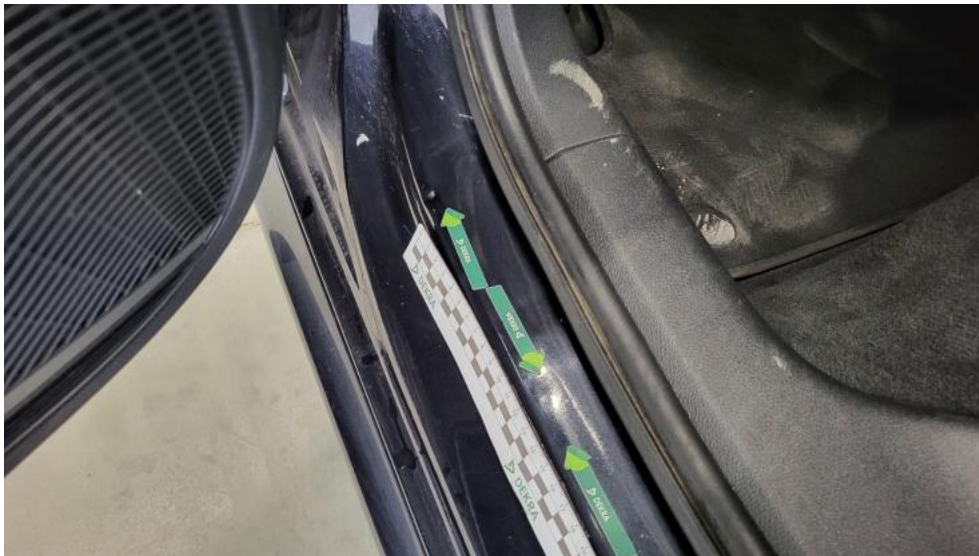
**Photo 81.**

Próg L - Wgniecenie/odkształcenie 1

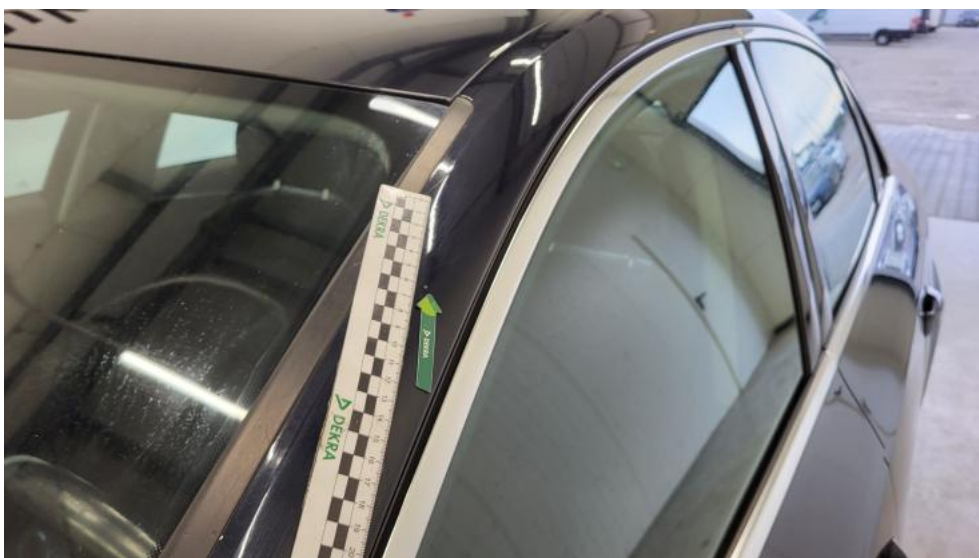
**Photo 82.**

Słupiek przedni L - zdjęcie poglądowe 1

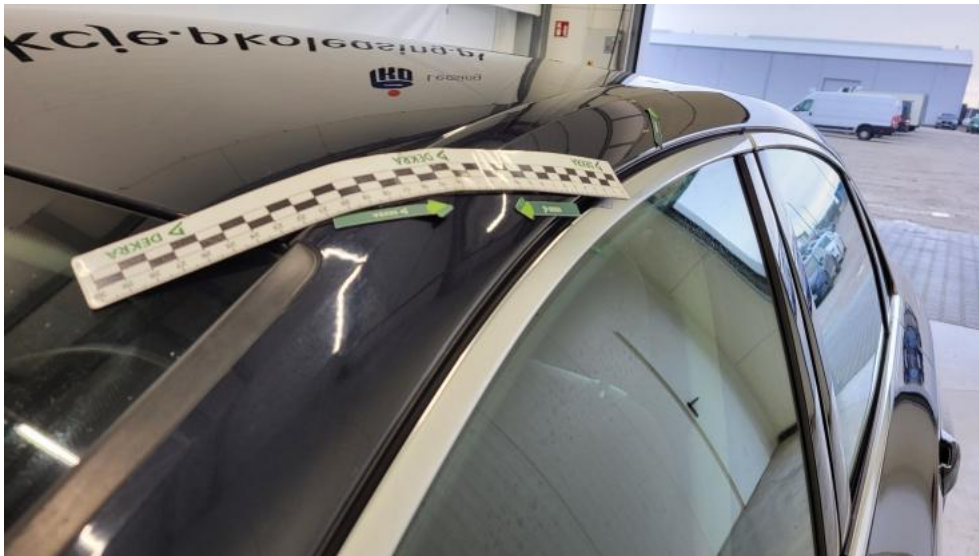
**Photo 83.**

Słupek przedni L - Wgniecenie/odkształcenie 1

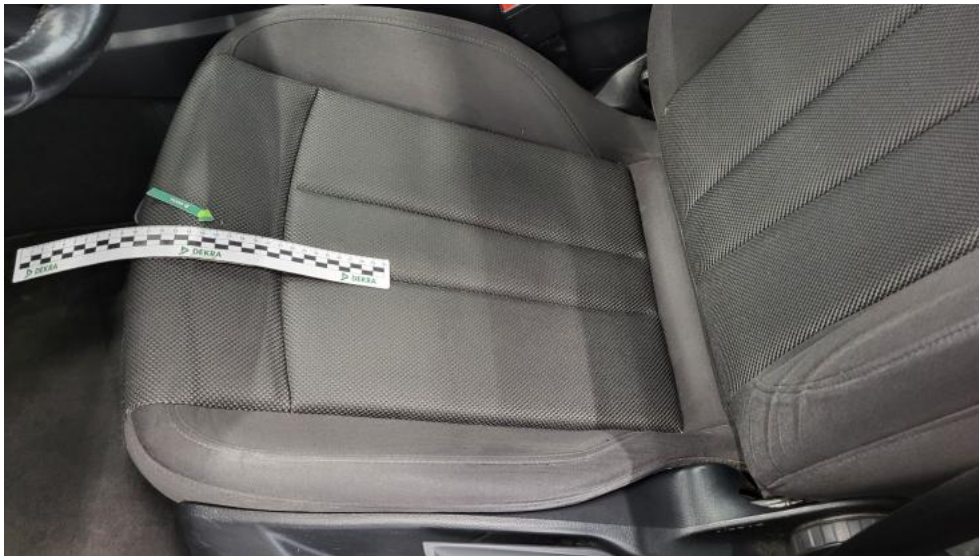
**Photo 89.**

Fotel prz. lew. - zdjęcie poglądowe 1

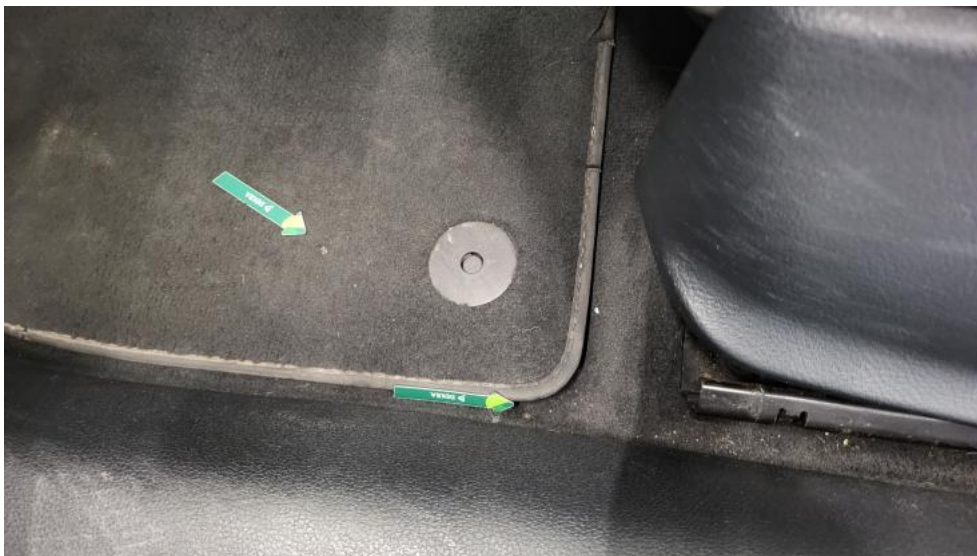
**Photo 95.**

Wykładzina podłogi - Inne 1
