DEKRA's commission No. : PKOL(W)/LODZ/95545/26/10/12  
commission/ damage No. : 21/044246  
Date of commission: 12-10-2026

**DEKRA Poland - Headquarters**  
02-673 Warszawa, ul. Konstruktorska 12A

| Model | X7 [G07] 18-22 |
| Registration /record No. | LU343MM |

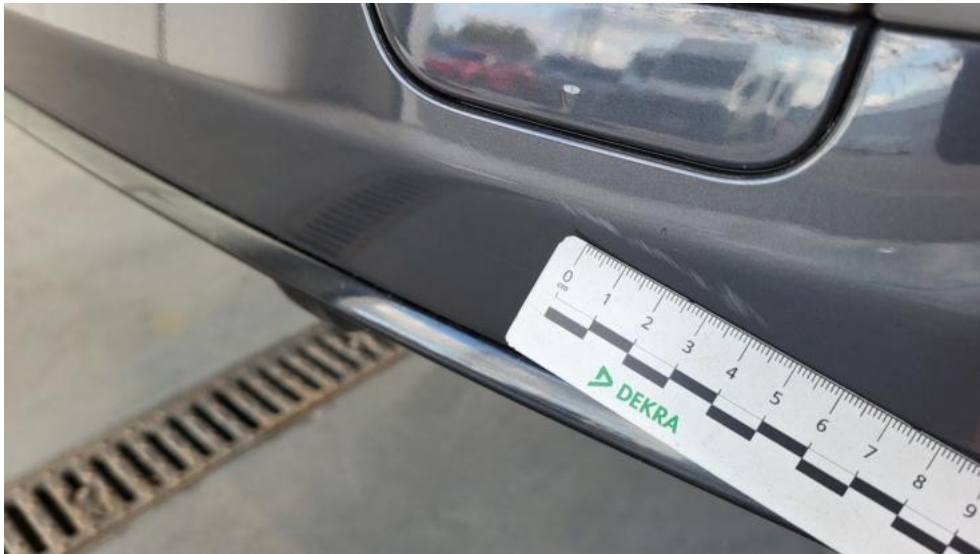
**Photo 69.**

Zderzak tylny cz dolna - Rysa/odprysk 1

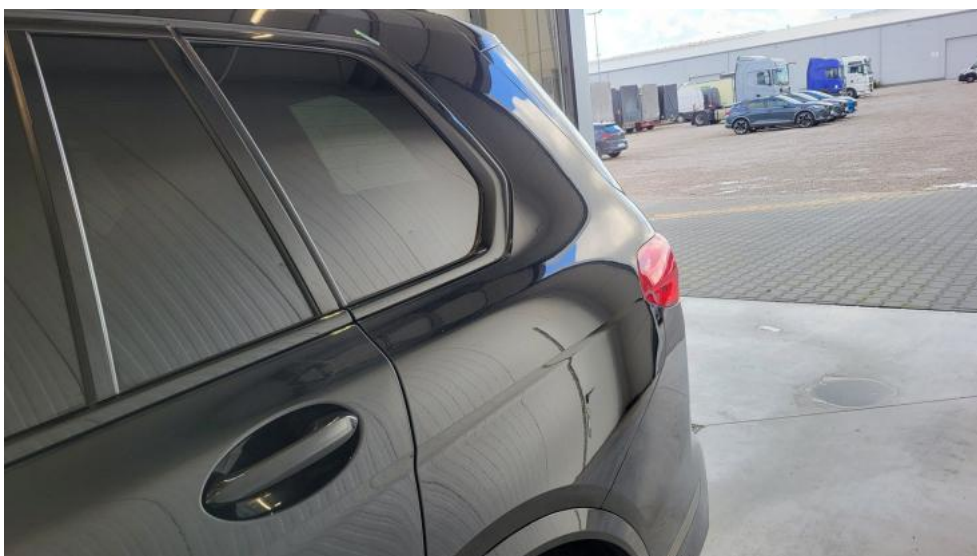
**Photo 74.**

Błotnik tylny L / Ściana boczna L - Wgniecenie/odkształcenie 1

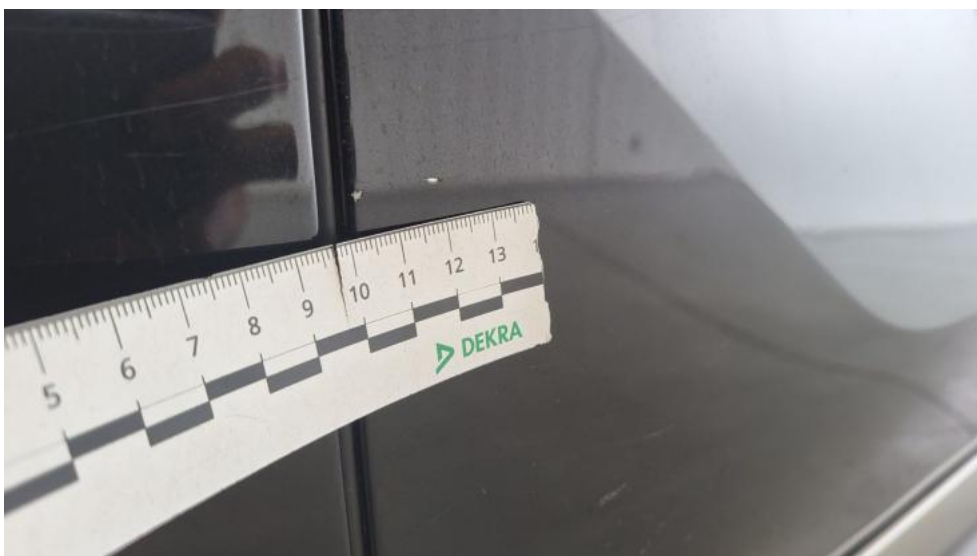
**Photo 78.**

Drzwi przed L - Rysa/odprysk 2

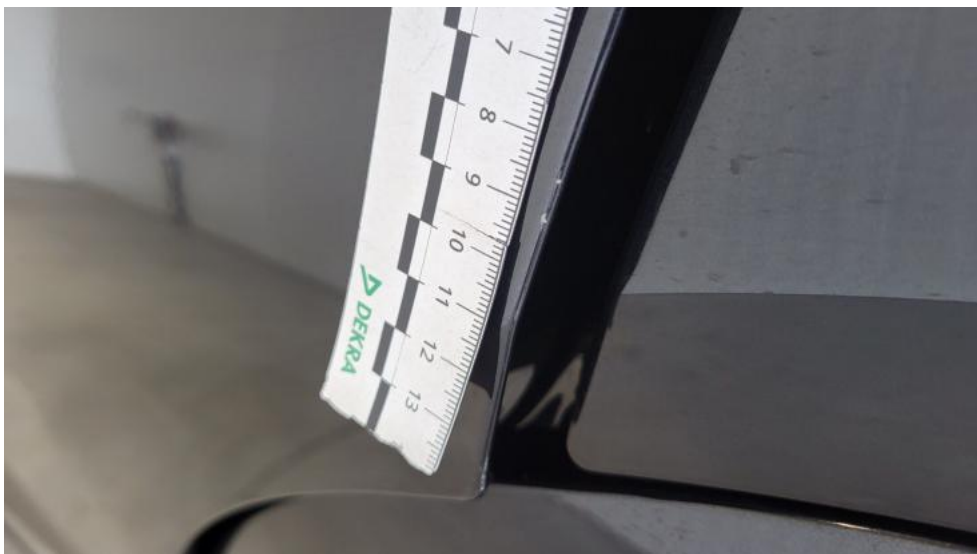
**Photo 79.**

Drzwi tylne L - Rysa/odprysk 1

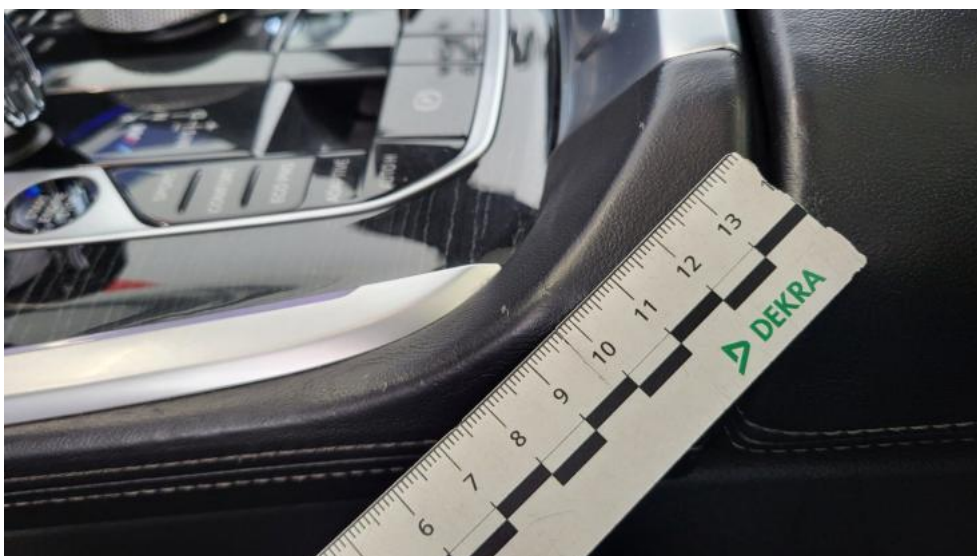
**Photo 90.**

Konsola tunelu śr. - Rysa/odprysk 1

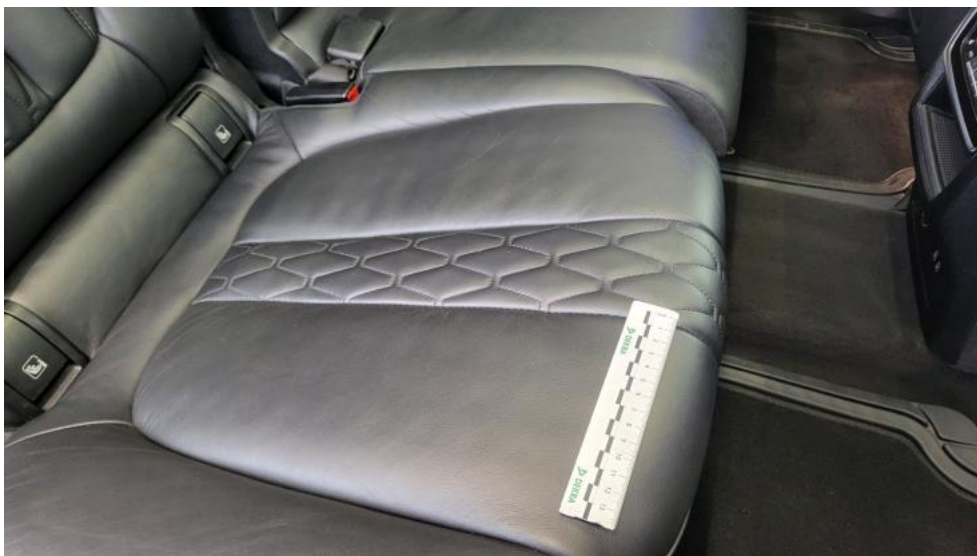
**Photo 93.**

Kanapa tyl. - Rysa/odprysk 1
