DEKRA's commission No. : PKOL(W)/LODZ/29122/26/04/01
commission/ damage No. : 23/007802
Date of commission: 01-04-2026

Vehicle data

Group of objects (Eurotax)	cars
EC code (Eurotax)	0154158
Manufacturer	AUDI
Model	A8 [4N] 21-
Type / version	A8 50 TDI mHEV Quattro Tiptr.
Body type	sedan
Number of doors / seats	4/5
Curb weight [kg]	2160
Gross vehicle weight [kg]	2710
Wheelbase 1/2	2998
Engine type	Automatic ignition
Pollution reduction system	KSC
Engine capacity [ccm]	2967
Engine Power [hp/kW]	286/210
Gearbox	automatic
Registration /record No.	GA874KG
VIN / serial number	WAUZZZF82NN000894
Date of first registration	27-06-2022
Date of next. tech. test	24-02-2027
Year of manufacture	2022
Readout [km]	174 060 (read)
Body color / type of coating	black/double-layered, metallized

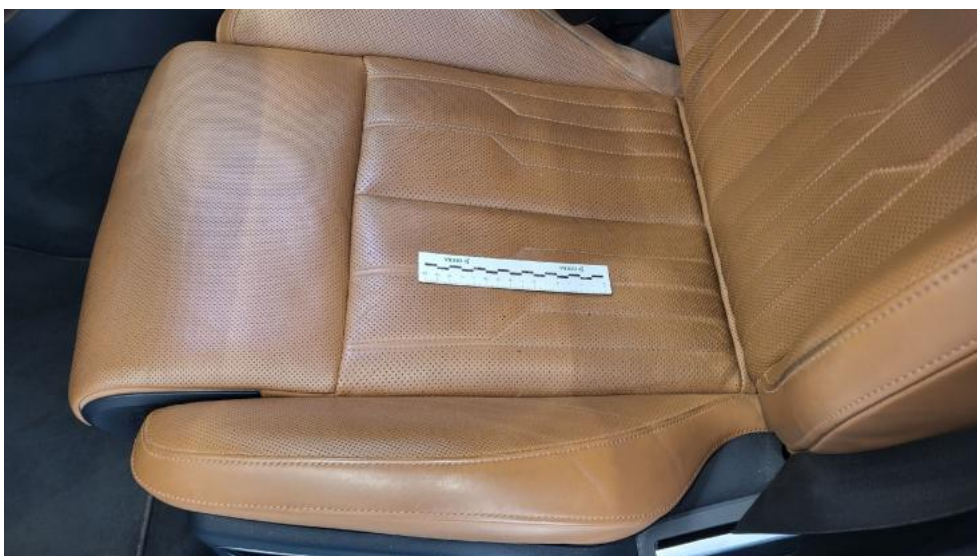
Photo 70.
Fotel prz. lew. - Inne 1

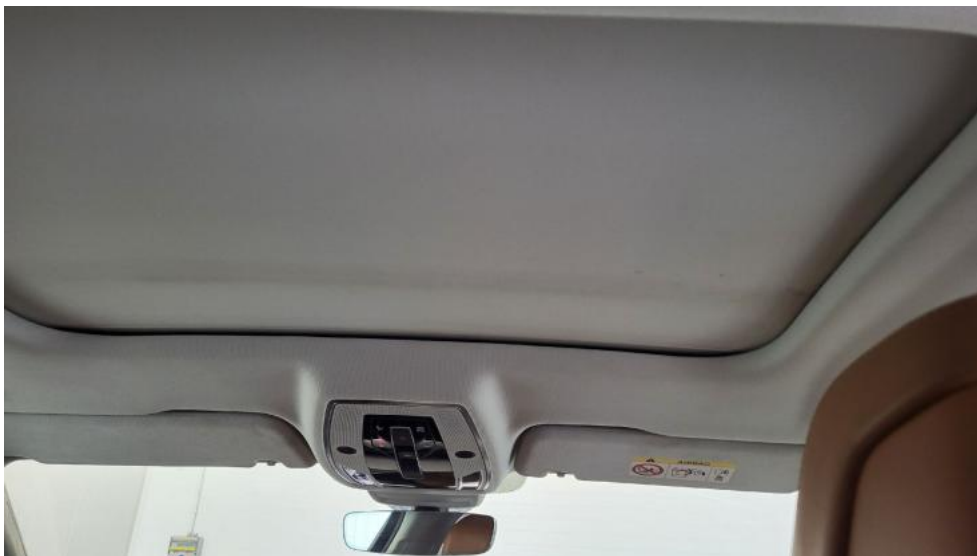
Photo 75.
Podsufitka - Inne 2
