DEKRA's commission No. : PKOL(W)/LODZ/91452/26/09/30  
commission/ damage No. : 23/013596  
Date of commission: 30-09-2026

| Manufacturer | CADILLAC |
| Model | XT6 |
| Registration /record No. | SK318XS |

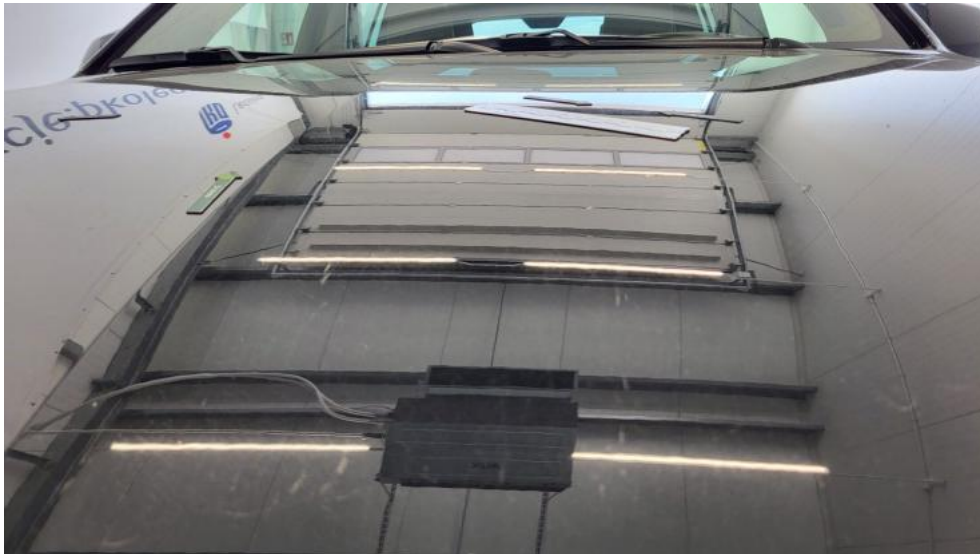
**Photo 50.**

Pokrywa komory silnika - Rysa/odprysk 1

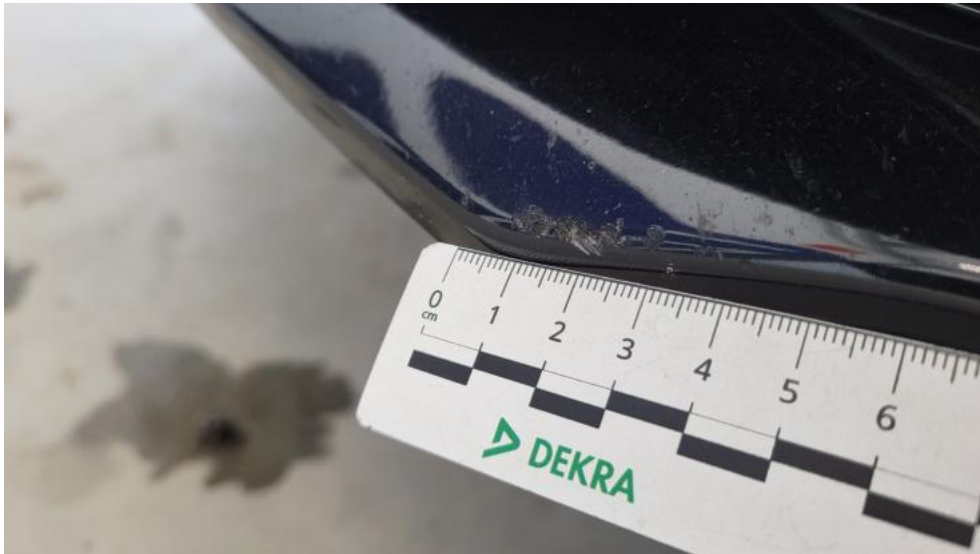
**Photo 56.**

Zderzak przedni cz dolna - Rysa/odprysk 1

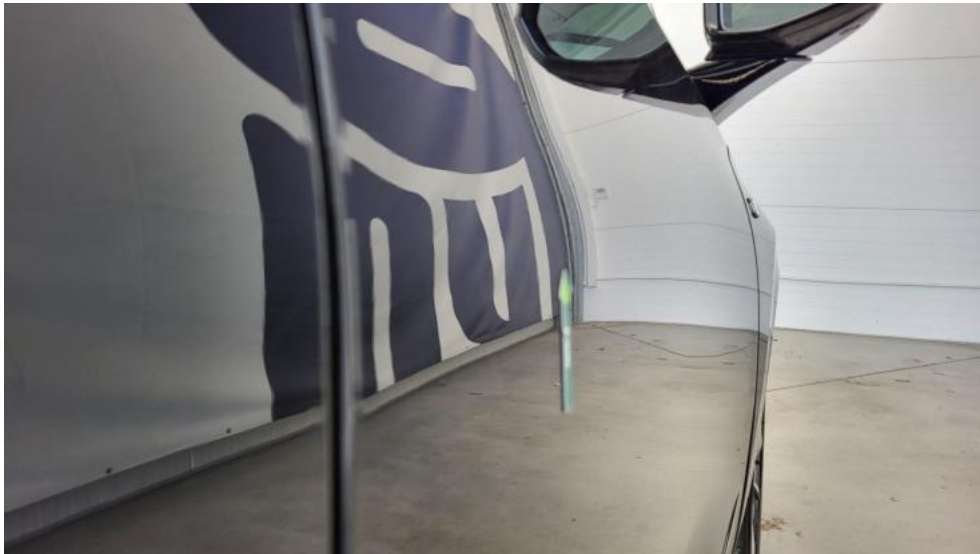
**Photo 62.**  
Drzwi przednie P - Rysa/odprysk 1

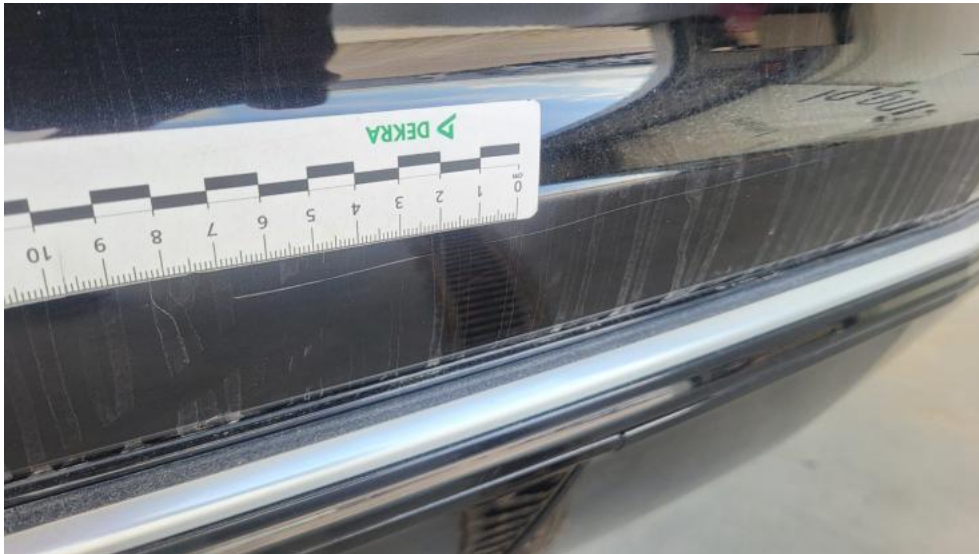
**Photo 74.**

Zderzak tylny - Rysa/odprysk 2

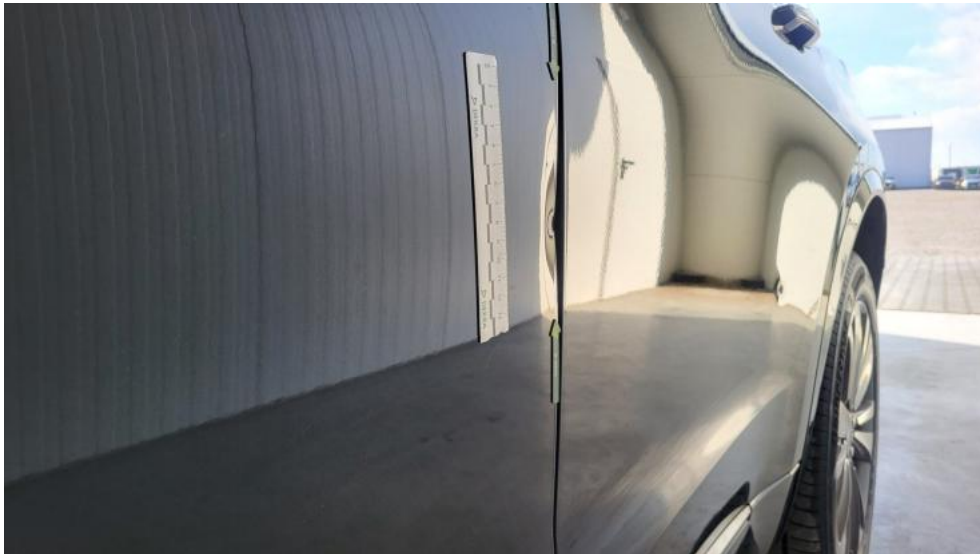
**Photo 84.**

Drzwi przed L - Rysa/odprysk 1

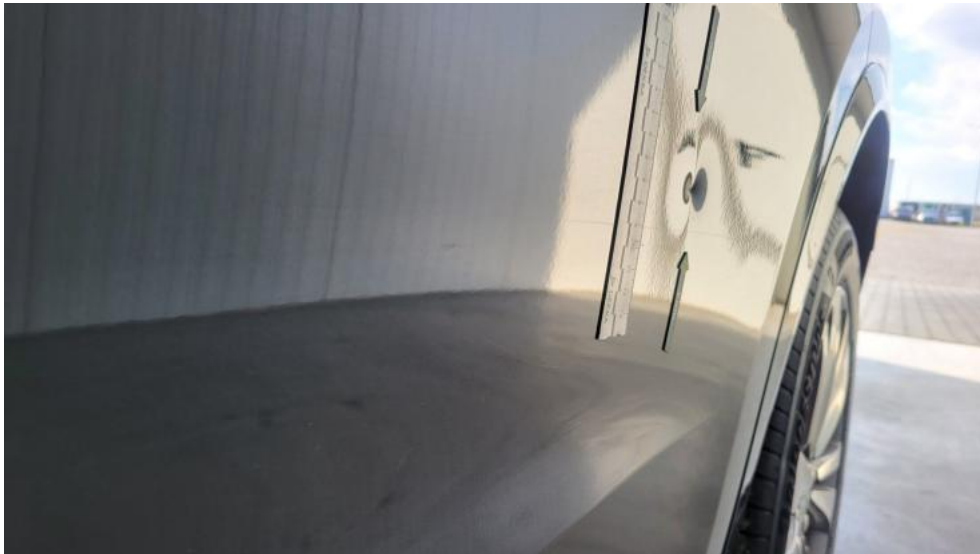
Drzwi tylne L - Rysa/odprysk 1
