DEKRA's commission No. : PKOL(W)/LODZ/57946/26/06/24  
commission/ damage No. : PS24/043321  
Date of commission: 24-06-2026

**DEKRA Poland - Headquarters**  
02-673 Warszawa, ul. Konstruktorska 12A

| Manufacturer | TOYOTA |
| Type / version | Camry 2.5 Hybrid Comfort CVT |

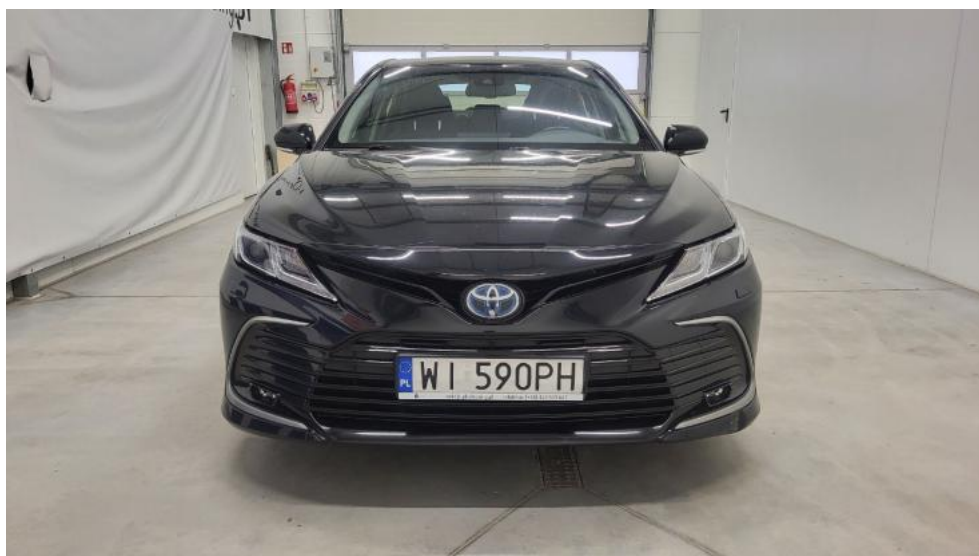
**Photo 2.**

Przód

Zderzak - Pęknięcie/rozerwanie 1

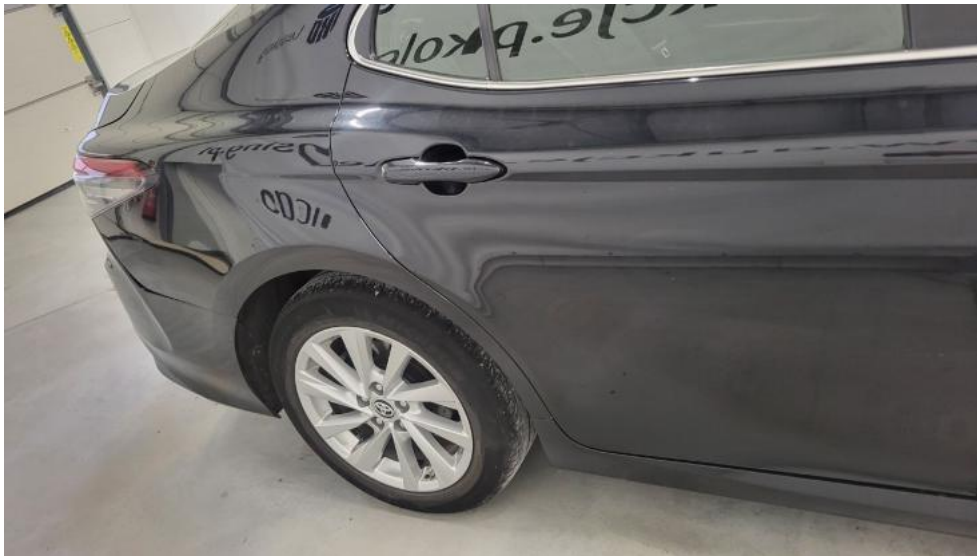
**Photo 5.**

Bok prawy z tyłu

Błotnik tylny P / Ściana boczna P - Rysa/odprysk 2

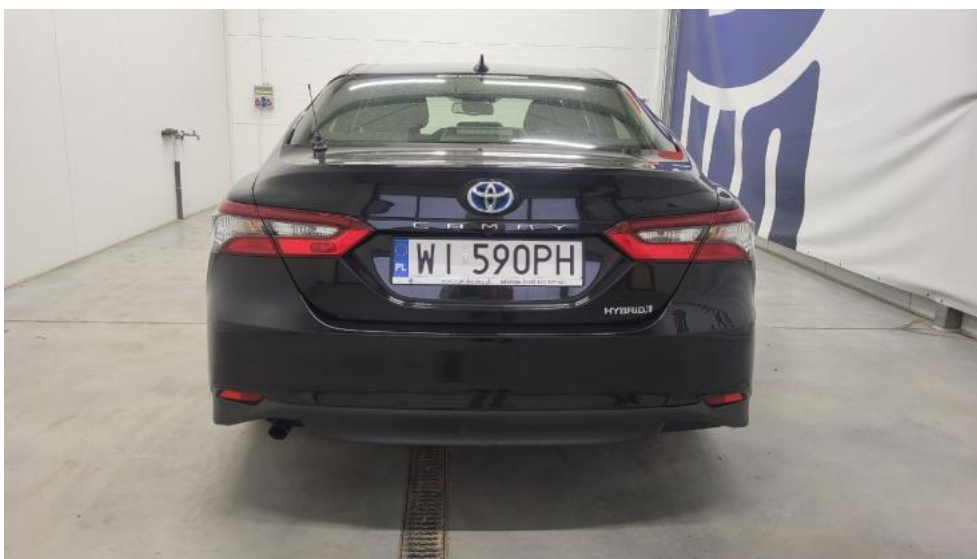
**Photo 7.**

Tył

Zderzak tylny - Pęknięcie/rozerwanie 1

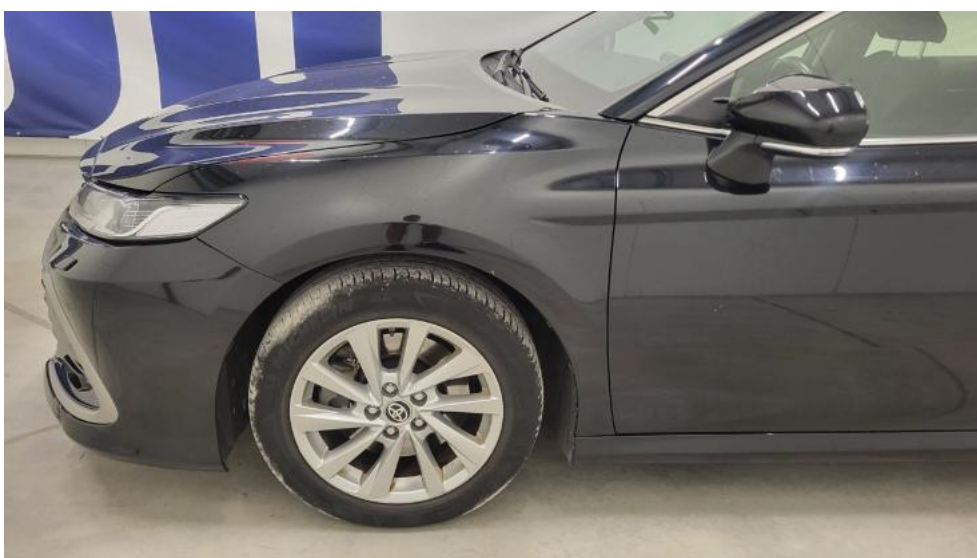
**Photo 10.**

Bok lewy z przodu

Drzwi przed L - Rysa/odprysk 2

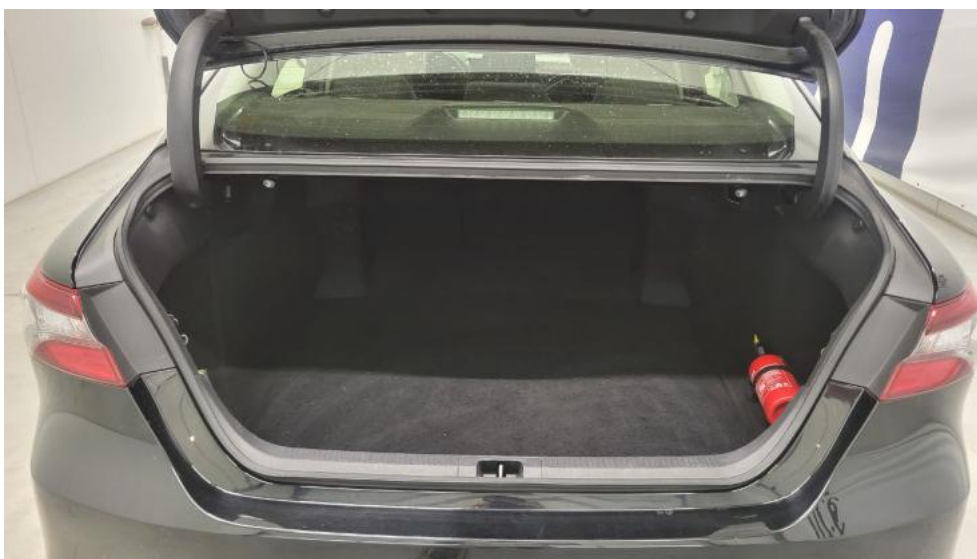
**Photo 19.**  
Bagażnik

Wykładzina podłogi bagażnika - Pęknięcie/rozerwanie 1
