DEKRA's commission No. : PKOL(W)/LODZ/78916/24/10/11  
 commission/ damage No. : 18/041768  
 Date of commission: 11-10-2024

**Vehicle data**

Group of objects (Eurotax)	jeeps
EC code (Eurotax)	0133281
Manufacturer	LAND ROVER
Model	Range Rover Sport 17-22
Type / version	Range Rover S 2.0Si4 GPF HSE
Body type	KOM
Number of doors / seats	5/5
Curb weight [kg]	2386
Gross vehicle weight [kg]	2900
Wheelbase 1/2	2923
Engine type	spark ignition
Supercompression	turbocompressor with intercooler
Pollution reduction system	GPF
Emission standard	EURO 6
Engine capacity [ccm]	1997
Engine Power [hp/kW]	300/221
Gearbox	automatic 8- gear
Registration /record No.	GD595SN
VIN / serial number	SALWA2BX9KA828941
Date of first registration	06-12-2018
Date of next. tech. test	19-05-2024
Year of manufacture	2018
Readout [km]	134 726 (read)
Body color / type of coating	black/METALIK

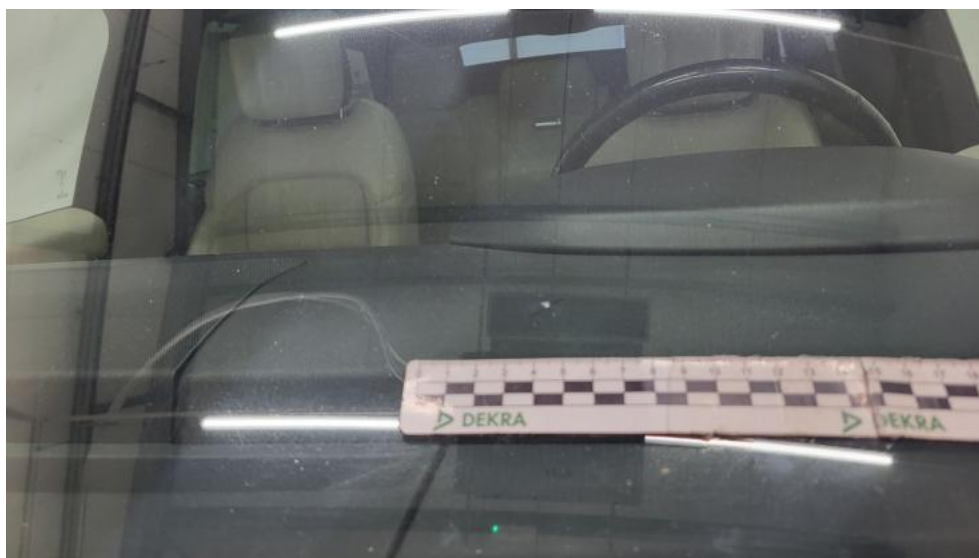
**Photo 38.**  
Szyba czołowa ogrzewana - zdjęcie poglądowe 1

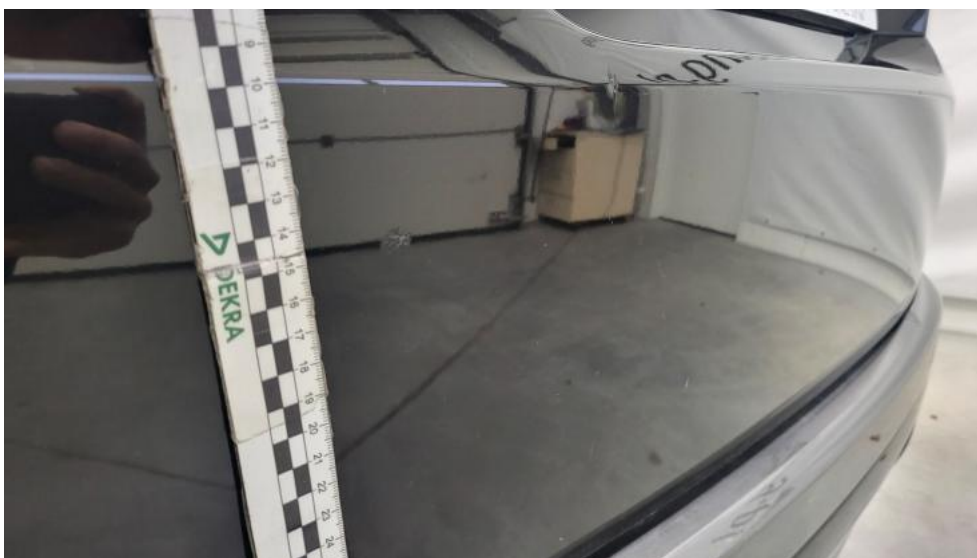
**Photo 46.**  
Pokrywy bagażnika - zdjęcie pogładowe 1

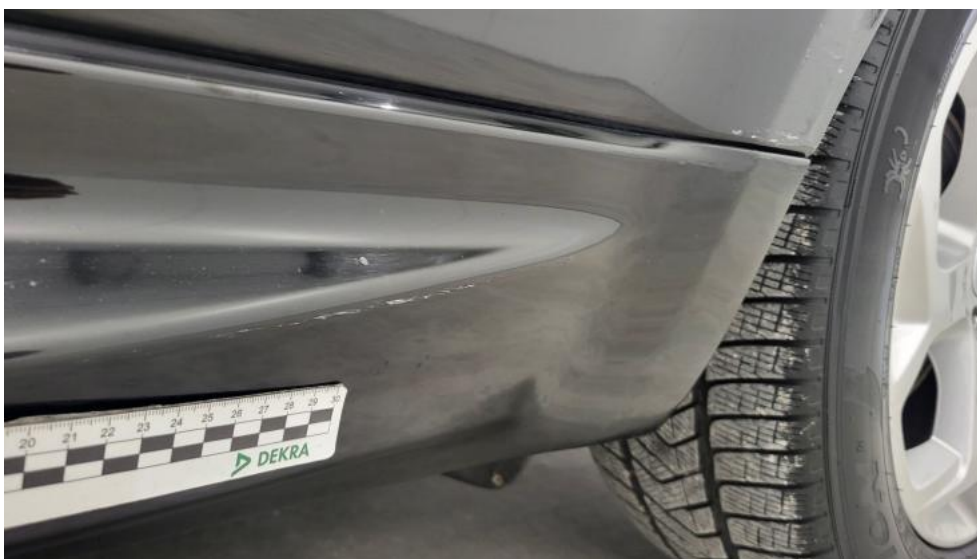
**Photo 63.**  
Drzwi tylne L - zdjęcie poglądowe 1
