DEKRA's commission No. : PKOL(W)/LODZ/03715/26/01/16  
commission/ damage No. : 03477/EO/22  
Date of commission: 16-01-2026

| Manufacturer | BMW |
| Model | X7 [G07] 18-22 |
| Registration /record No. | ZK5721J |

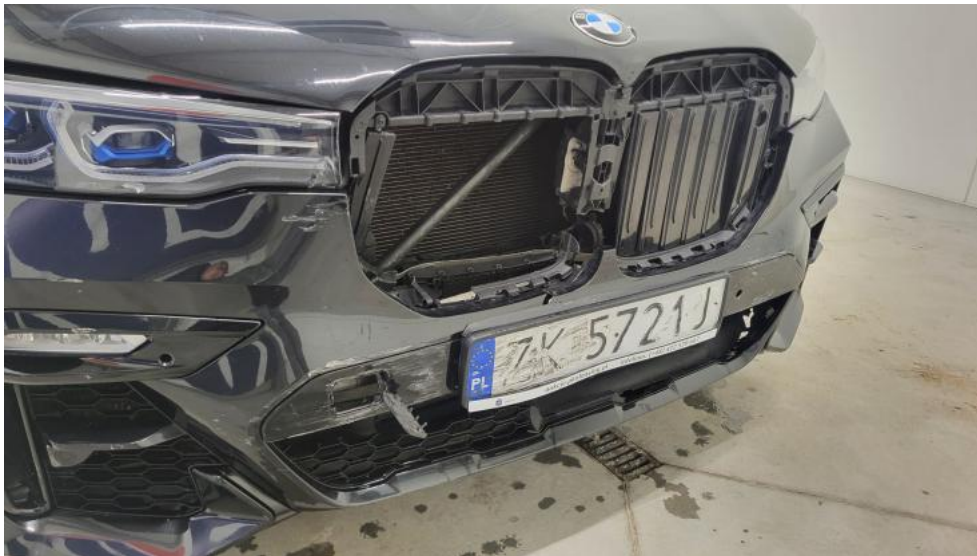
**Photo 49.**

Atrapa przednia - zdjęcie pogładowe 1

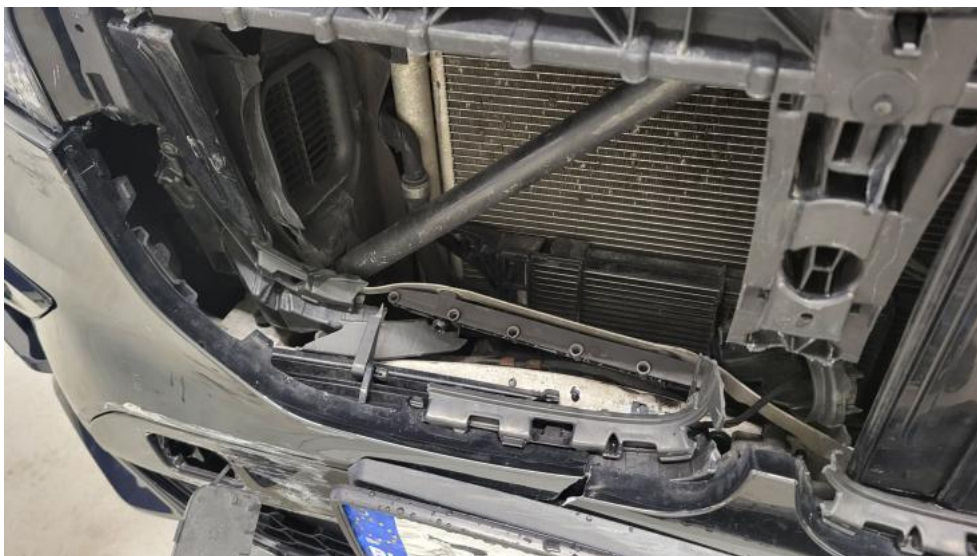
**Photo 50.**

Atrapa przednia - zdjęcie pogładowe 2

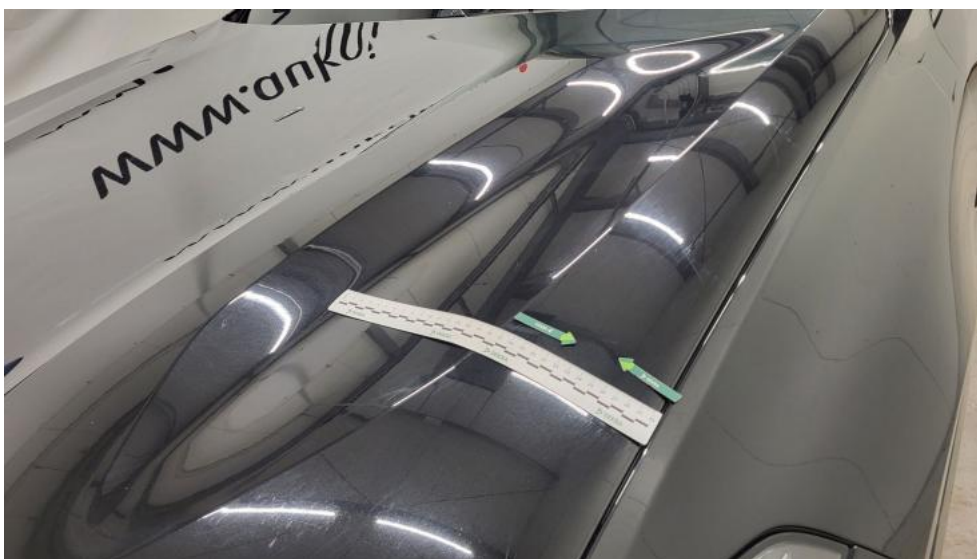
**Photo 57.**

Pokrywa komory silnika - zdjęcie poglądowe 1

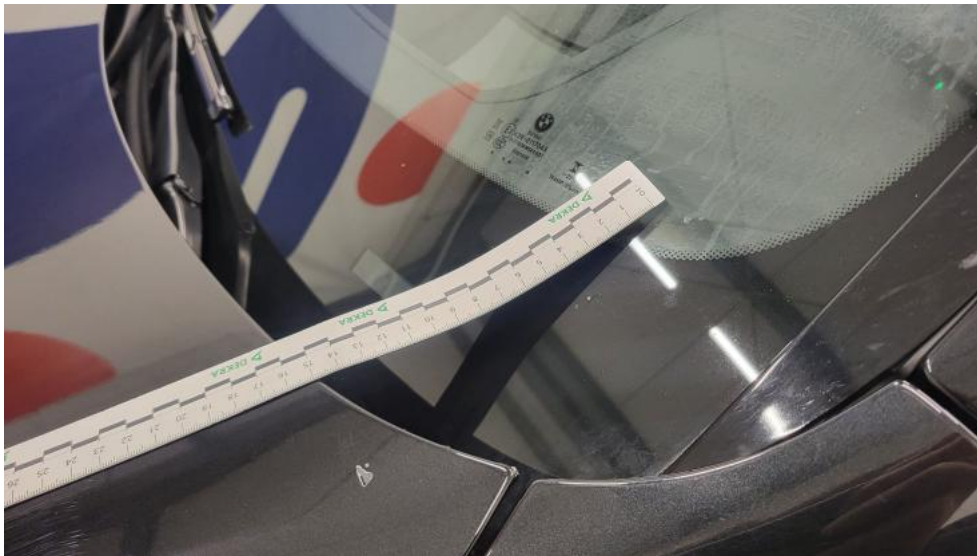
**Photo 59.**

Szyba czołowa - zdjęcie poglądowe 1

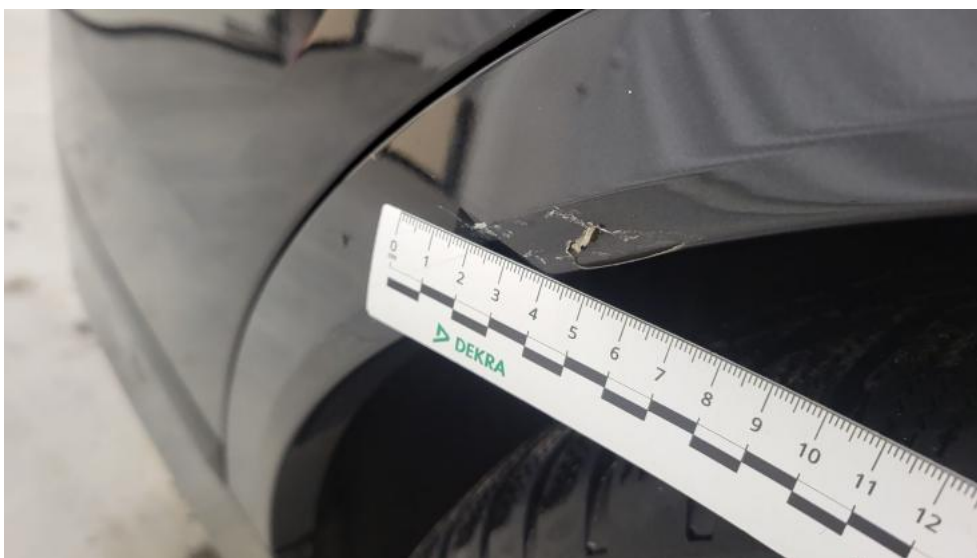
**Photo 78.**

Listwa krawędzi błotnika tyl P - Rysa/odprysk 1

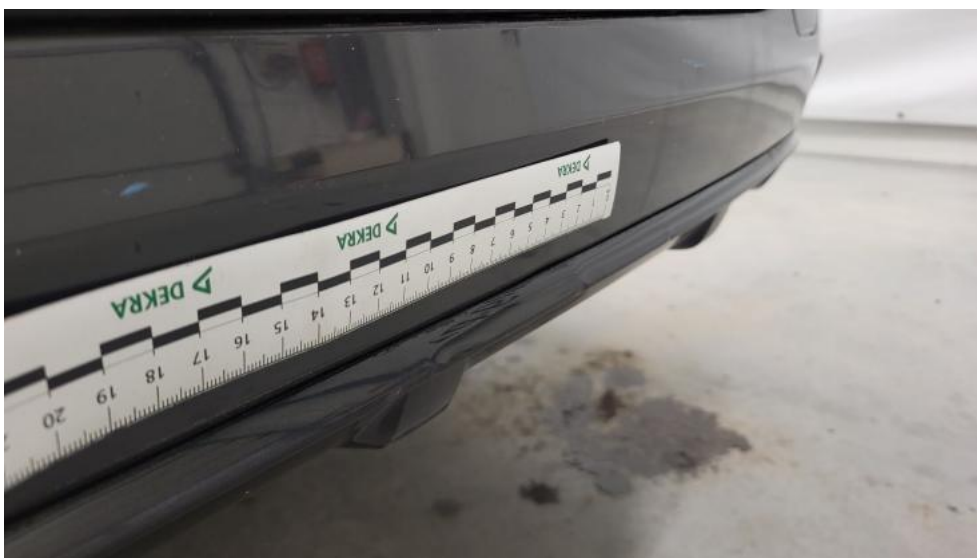
**Photo 80.**

Spojler zderzaka tylnego - Wgniecenie/odkształcenie 1

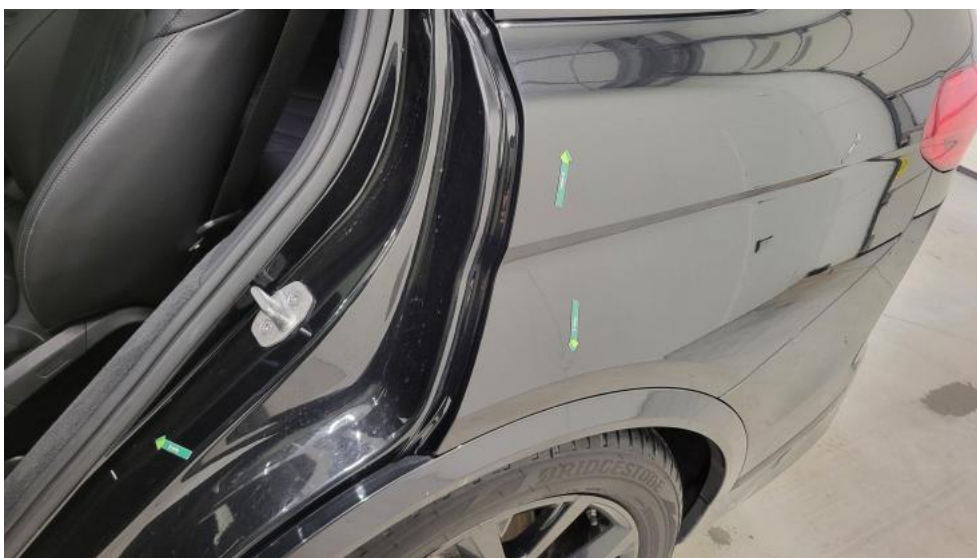
**Photo 82.**

Ścianka tylna L / Ścianka boczna L - Wgniecenie/odkształcenie 1

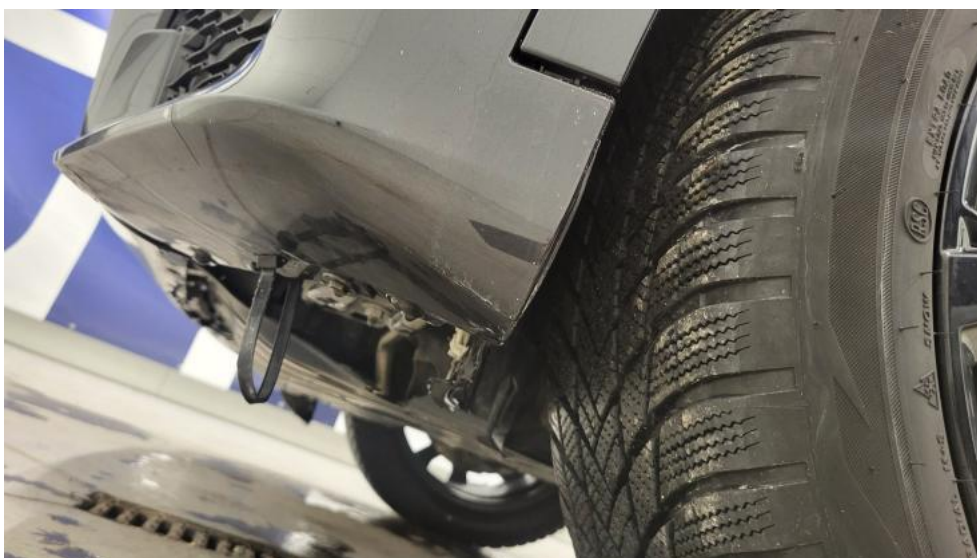
**Photo 84.**

Nadkole przednie L - zdjęcie pogłądowe 1
