DEKRA's commission No. : PKOL(W)/LODZ/77042/26/08/18  
commission/ damage No. : 21/044114  
Date of commission: 18-08-2026

| Manufacturer | OPEL |
| Model | Corsa F Hatchback 19-23 |
| Registration /record No. | WZ114EG |

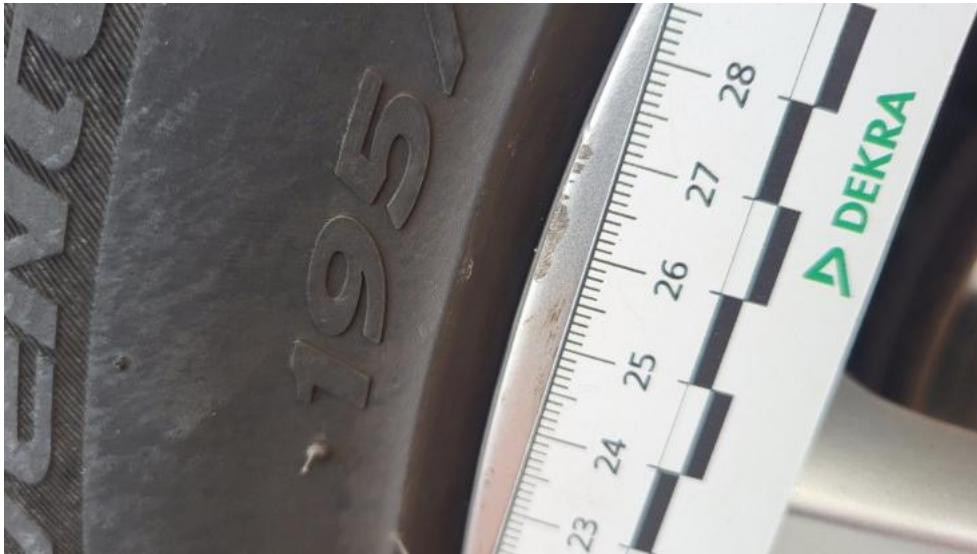
**Photo 43.**

Felga aluminiowa przednia P - Rysa/odprysk 1

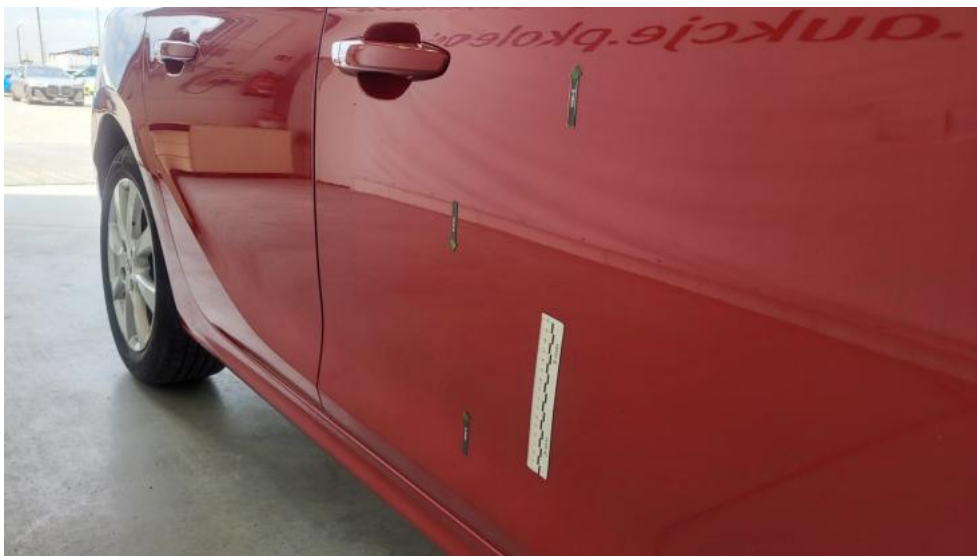
**Photo 44.**

Drzwi przednie P - zdjęcie poglądowe 1

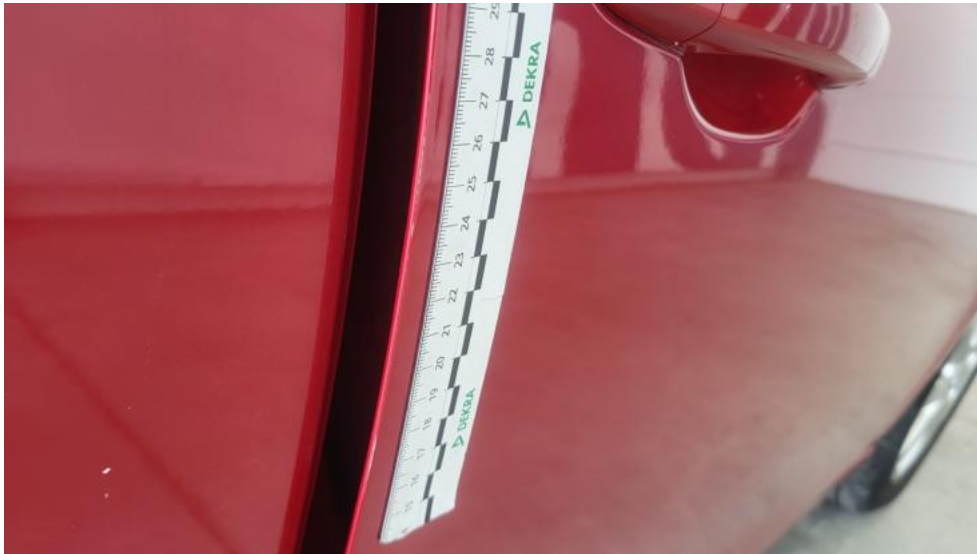
**Photo 45.**

Drzwi przednie P - Rysa/odprysk 1

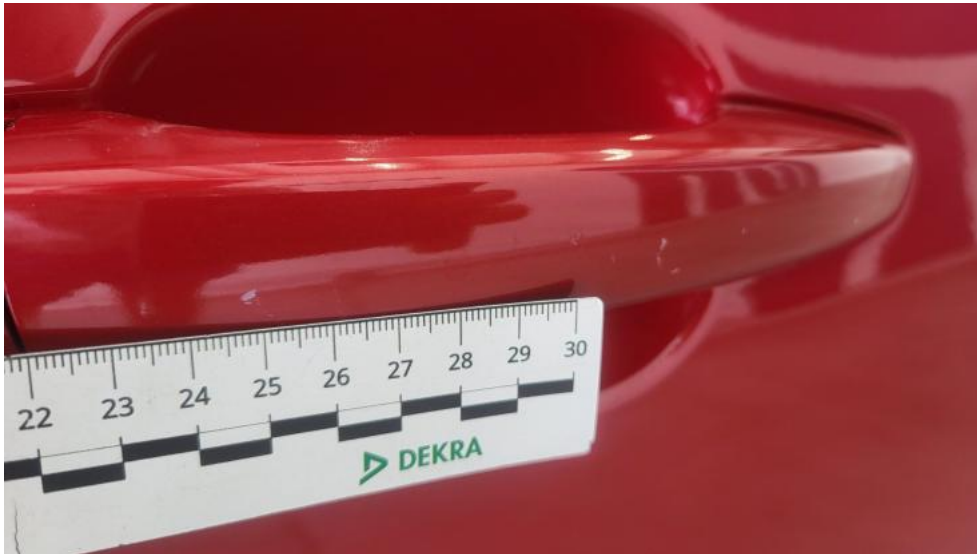
**Photo 49.**

Klamka drzwi prz P - Rysa/odprysk 1

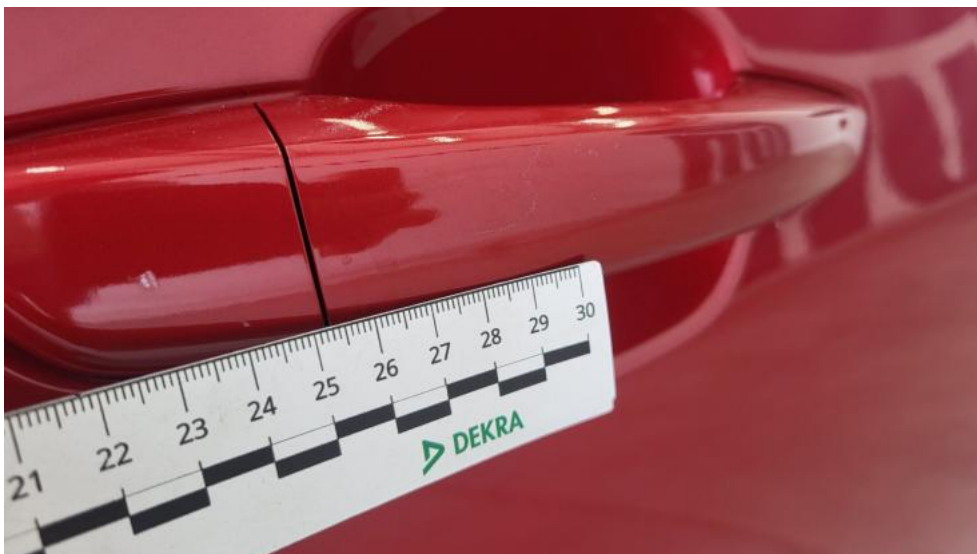
**Photo 50.**

Klamka drzwi tyl P - Rysa/odprysk 1

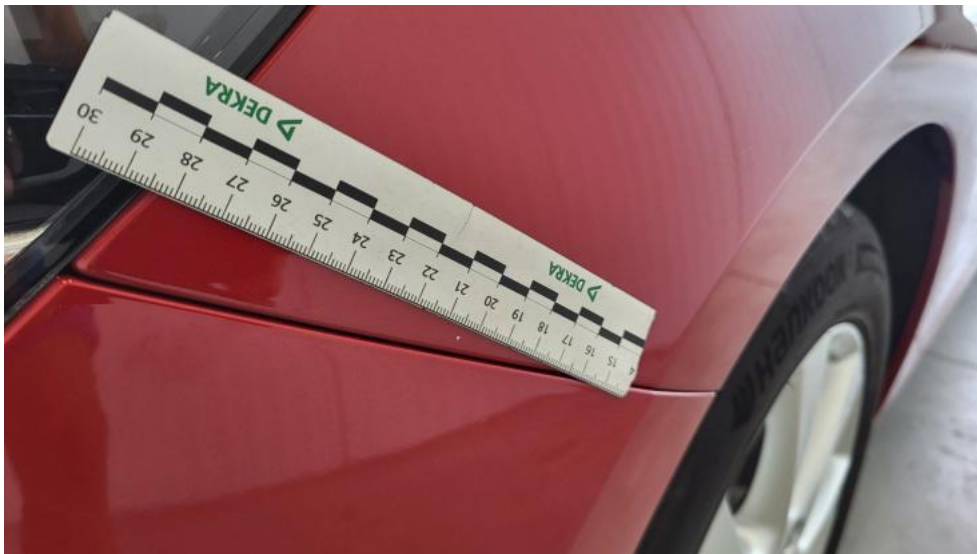
**Photo 75.**

Błotnik przedni L - Rysa/odprysk 2
