DEKRA's commission No. : PKOL(W)/LODZ/80667/26/08/28  
commission/ damage No. : 20/043739  
Date of commission: 28-08-2026

**DEKRA Poland - Headquarters**  
02-673 Warszawa, ul. Konstruktorska 12A

PKO Leasing SA  
Świętokrzyska 36  
00-116 Warszawa

| Type / version | Edge 2.0 EcoBlue Twin-Turbo 4WD Vignale aut |

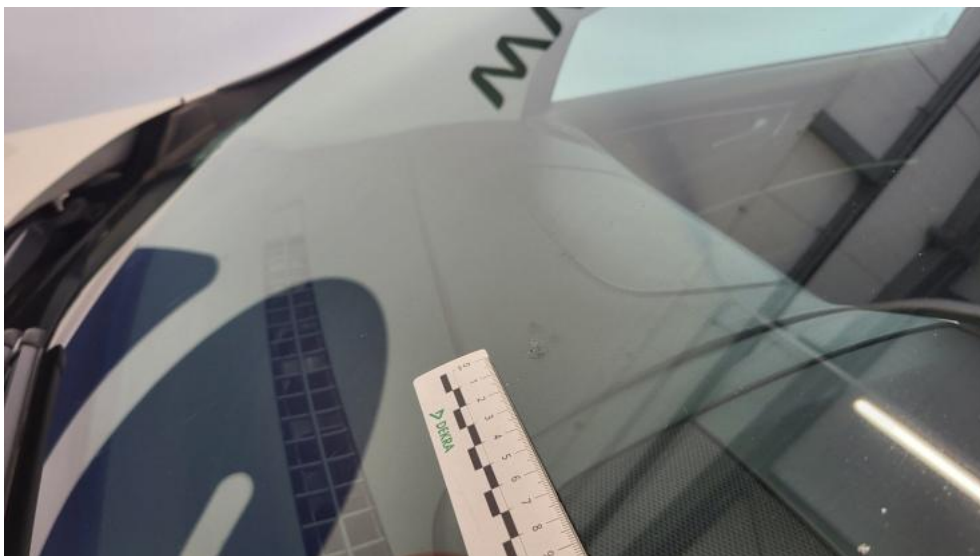
**Photo 42.**

Szyba czołowa - zdjęcie poglądowe 1

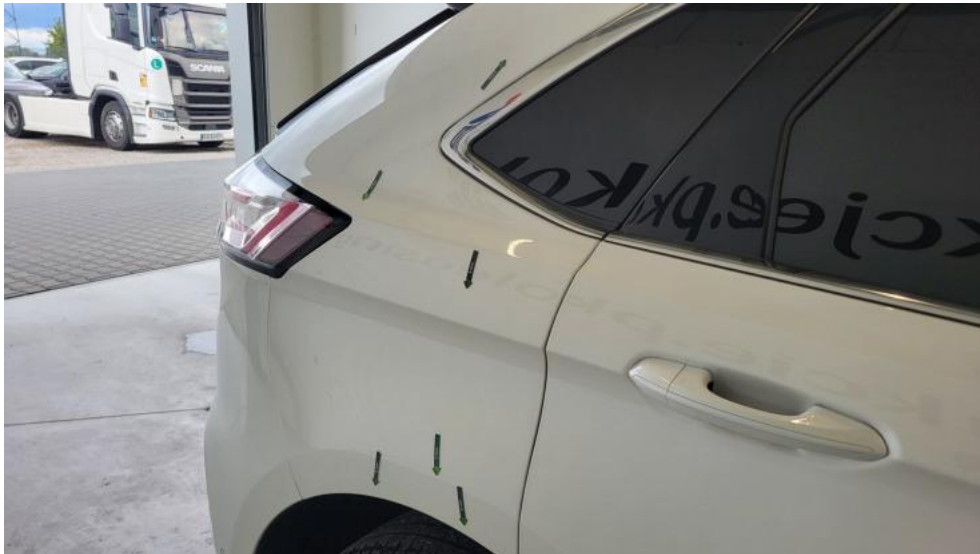
**Photo 49.**

Błotnik tylny P / Ściana boczna P - zdjęcie pogładowe 1

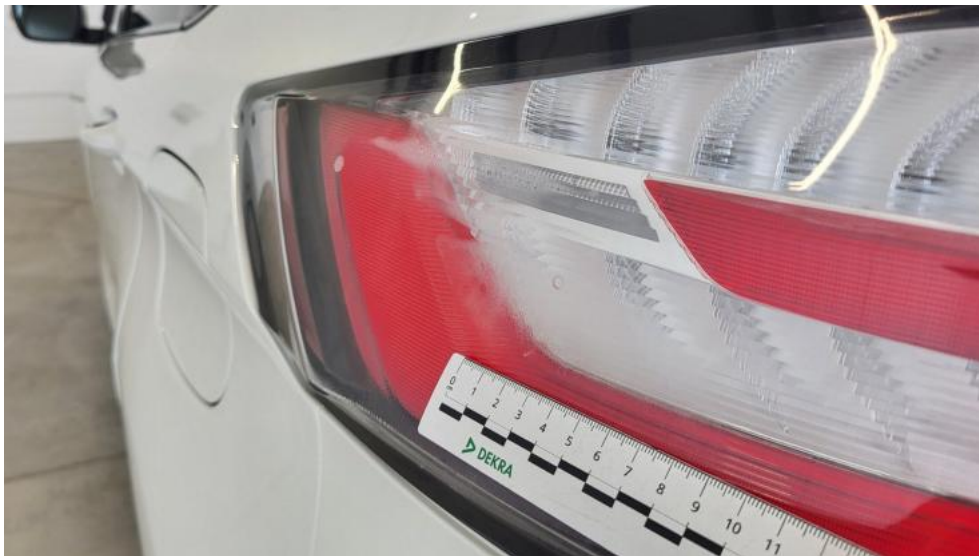
**Photo 55.**

Lampa tylna zew L - Inne 1

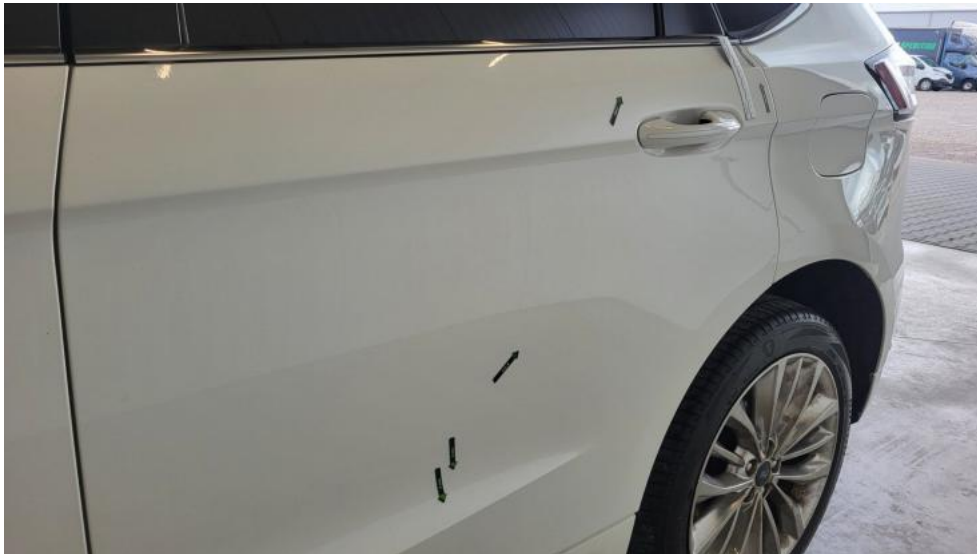
**Photo 57.**

Drzwi tylne L - zdjęcie poglądowe 1

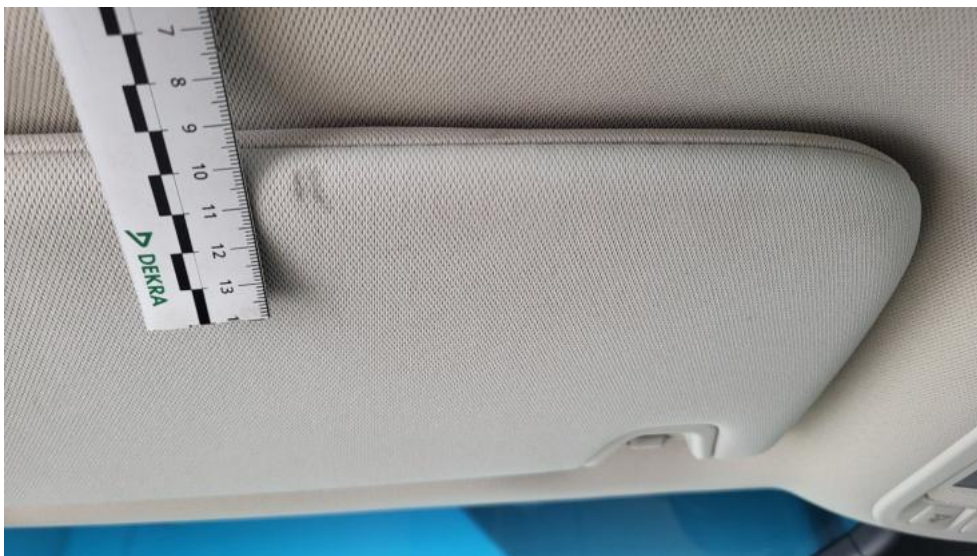
**Photo 65.**

Osłona p/słoneczna lewa - Inne 1

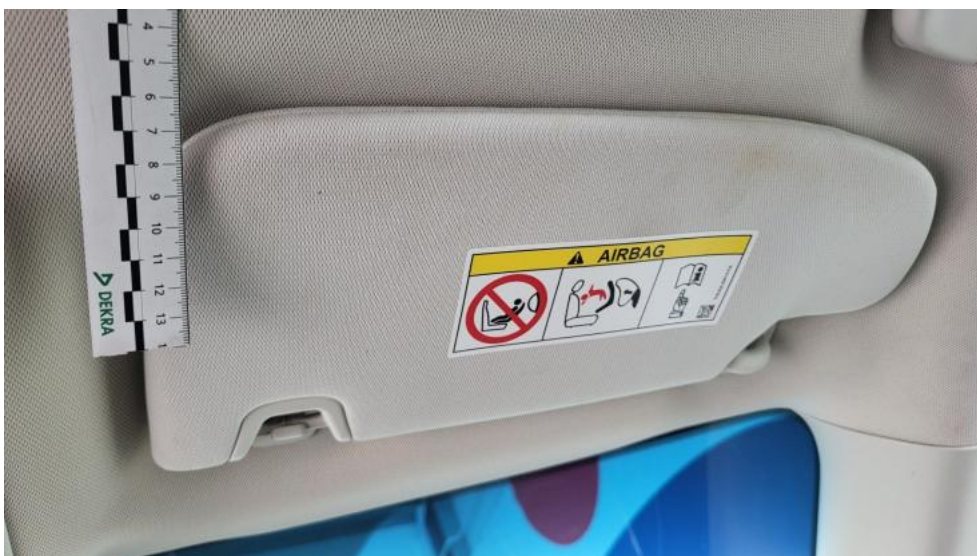
**Photo 66.**

Osłona p/słoneczna prawa - Inne 1
