DEKRA's commission No. : PKOL(W)/LODZ/41786/26/05/14
commission/ damage No. : PS22/00731
Date of commission: 14-05-2026

Group of objects (Eurotax)	cars
EC code (Eurotax)	0128688
Manufacturer	AUDI
Model	A8 [4N] 17-21
Type / version	A8 L 50 TDI mHEV Quattro Tiptr.
Body type	sedan
Number of doors / seats	4/5
Curb weight [kg]	2000
Gross vehicle weight [kg]	2700
Wheelbase 1/2	3128
Engine type	Automatic ignition
Pollution reduction system	KSC
Engine capacity [ccm]	2967
Engine Power [hp/kW]	286/210
Gearbox	automatic 8- gear
Registration /record No.	KR2KE77
VIN / serial number	WAUZZZF83KN011558
Date of first registration	31-01-2019
Date of next. tech. test	31-01-2027
Year of manufacture	2019 (year has been verified with the manufacturer's base)
Readout [km]	151 675 (read)
Body color / type of coating	grafitowy/METALIK

PHOTOGRAPHIC DOCUMENTATION

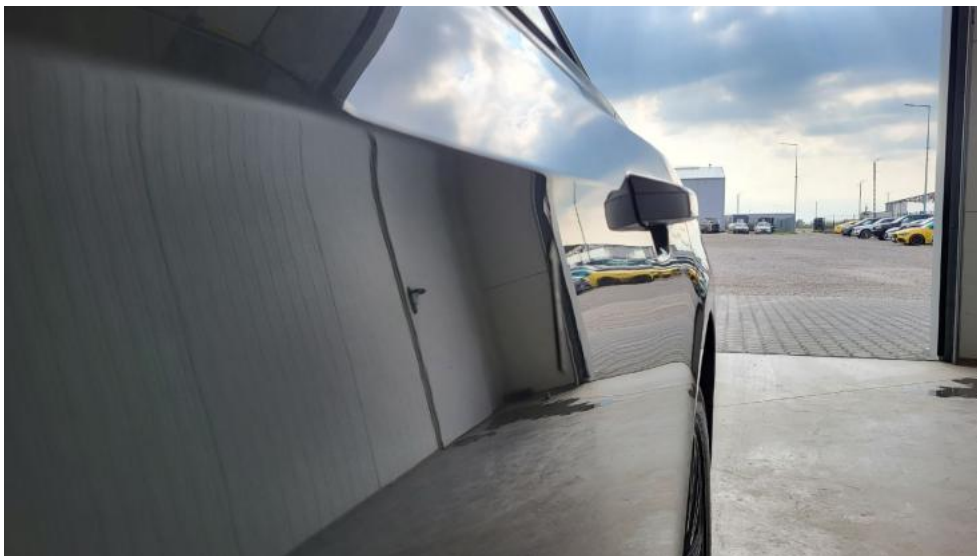
Photo 67.
Drzwi tylne L - Wgniecenie/odkształcenie 1
