DEKRA's commission No. : PKOL(W)/LODZ/56391/25/07/31  
commission/ damage No. : 20/002083  
Date of commission: 31-07-2025

| Model | Grand Cherokee 16-20 |
| Type / version | Gr. Cherokee 6.4 V8 SRT8 |
| Registration /record No. | WZ6228Y |

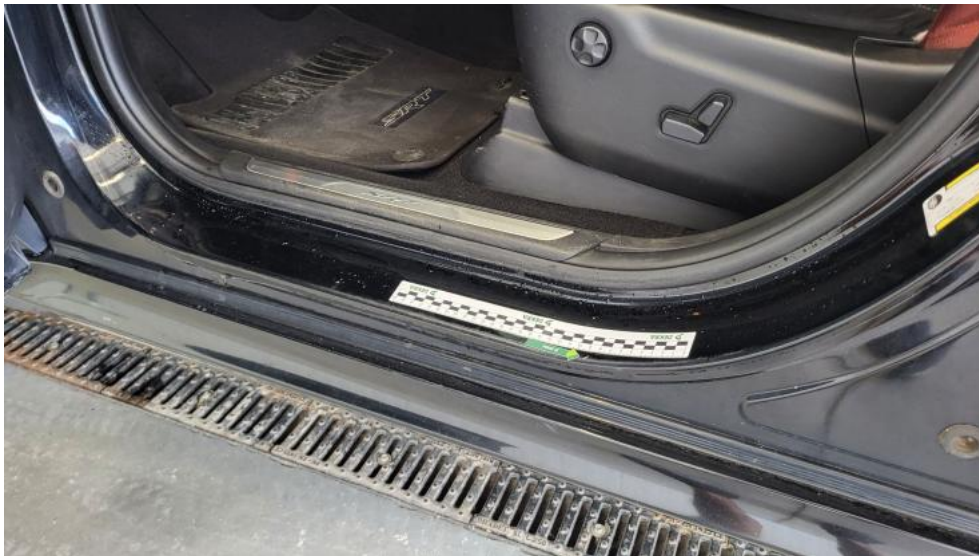
**Photo 69.**

Próg L - zdjęcie poglądowe 1

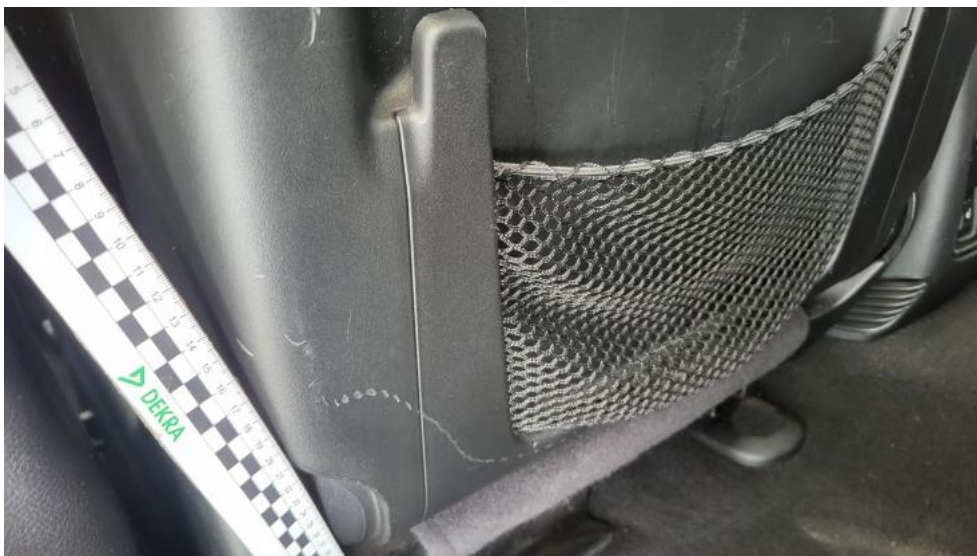
**Photo 72.**

Fotel prz. lew. - Rysa/odprysk 1

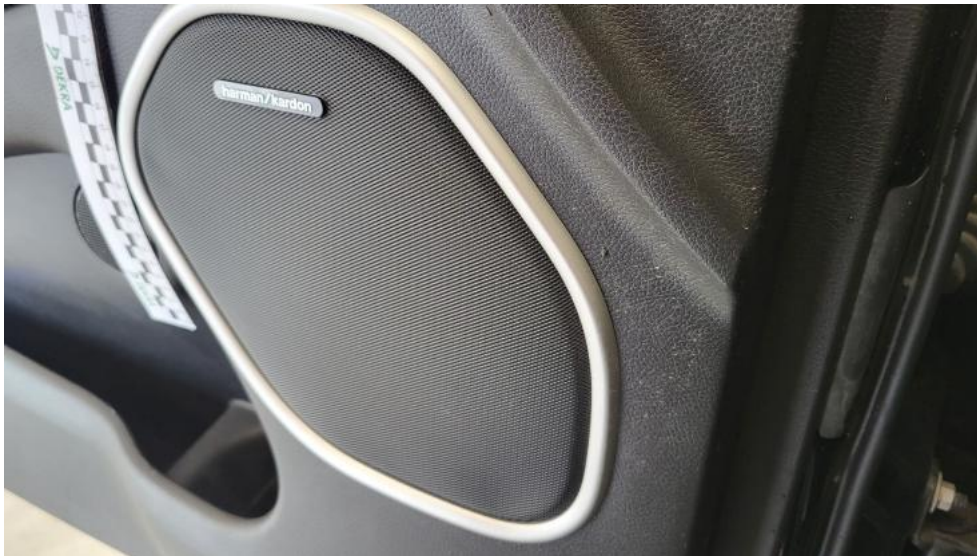
**Photo 75.**

Tapicerka drzwi przednich L - Wgniecenie/odkształcenie 1

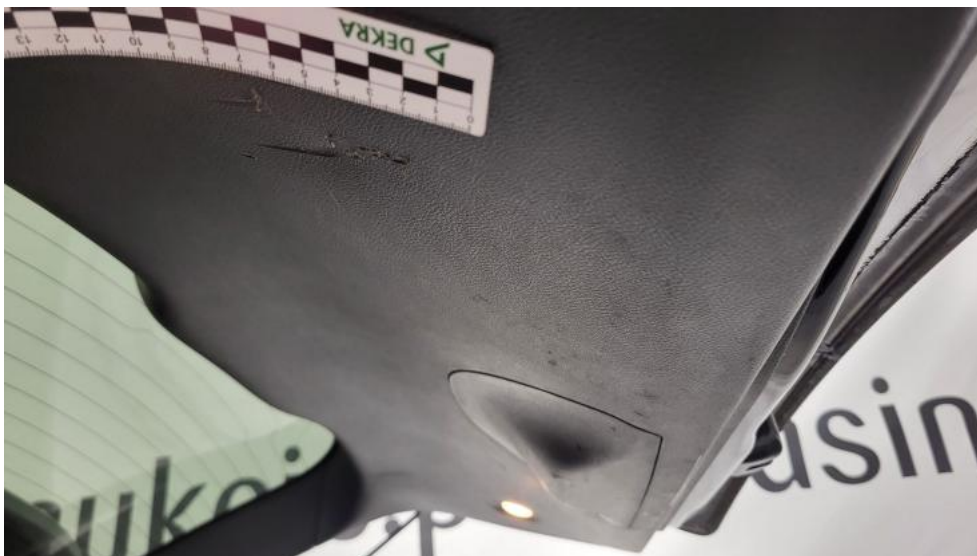
**Photo 76.**

Wykładzina pokrywy tylnej - Rysa/odprysk 1
