DEKRA's commission No. : PKOL(W)/LODZ/79923/24/10/15  
 commission/ damage No. : 22/010866  
 Date of commission: 15-10-2024

Group of objects (Eurotax)	cars
EC code (Eurotax)	0126753
Manufacturer	MERCEDES-BENZ
Model	S Klasa [W 222] 17-20
Type / version	AMG S 63 4-Matic+ L
Body type	sedan
Number of doors / seats	4/5
Curb weight [kg]	2185
Gross vehicle weight [kg]	2745
Wheelbase 1/2	3165
Engine type	spark ignition
Supercompression	turbocompressor with intercooler
Pollution reduction system	three-way catalytic converter
Emission standard	EURO 6
Engine capacity [ccm]	3982
Engine Power [hp/kW]	612/450
Gearbox	automatic 9- gear
Registration /record No.	E1TRAKO
VIN / serial number	WDD2221881A401225
Date of first registration	13-03-2018
Date of next. tech. test	28-06-2025
Year of manufacture	2018 (year has been verified with the manufacturer's base)
Readout [km]	102 778 (read)
Body color / type of coating	white/INNY

Description of the technical condition

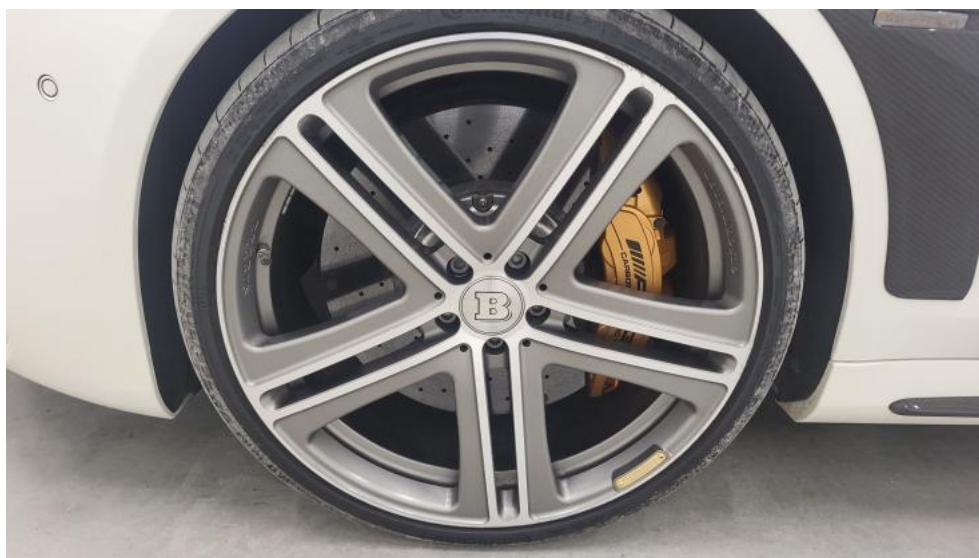
**Photo 69.**

Felga aluminiowa tylna P - Rysa/odprysk 1
