DEKRA's commission No. : PKOL(W)/LODZ/82058/24/10/23
 commission/ damage No. : 01285/EO/21
 Date of commission: 23-10-2024

PKO Leasing SA
 Świętokrzyska 36
 00-116 Warszawa

Group of objects (Eurotax)	jeeps
EC code (Eurotax)	0157973
Manufacturer	MASERATI
Model	Levante 16-21
Type / version	Levante Trofeo
Body type	hatchback
Number of doors / seats	5/5
Curb weight [kg]	2245
Gross vehicle weight [kg]	2825
Wheelbase 1/2	3004
Engine type	spark ignition
Supercompression	turbocompressor with intercooler
Pollution reduction system	GPF
Emission standard	EURO 6
Engine capacity [ccm]	3798
Engine Power [hp/kW]	580/427
Gearbox	automatic 8- gear
Registration /record No.	ZS373NJ
VIN / serial number	ZN6ZU61B00X371660
Date of first registration	29-03-2021
Date of next. tech. test	29-03-2026
Year of manufacture	2021 (year has been verified with the manufacturer's base)
Readout [km]	72 952 (read)
Body color / type of coating	white/INNY

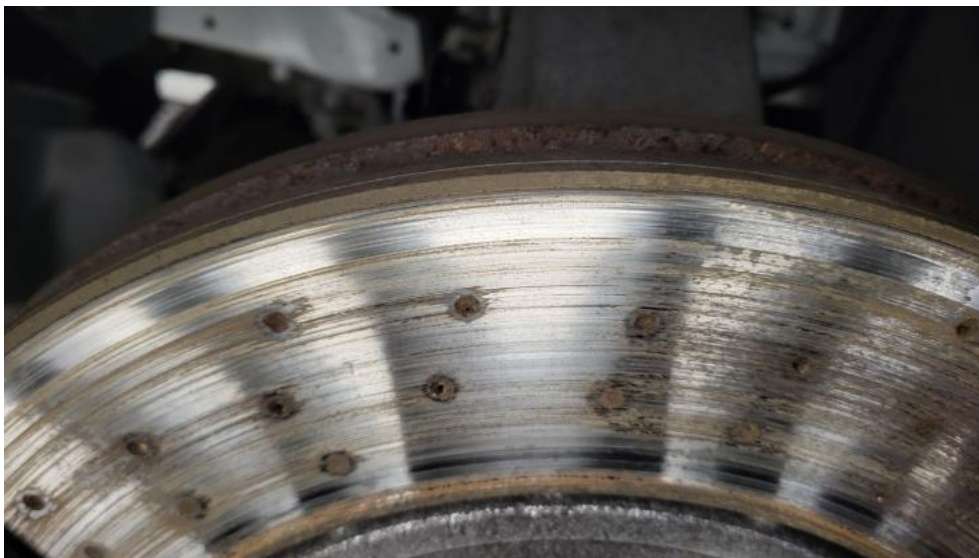
Photo 15.

Tarcza hamulcowa przednia prawa

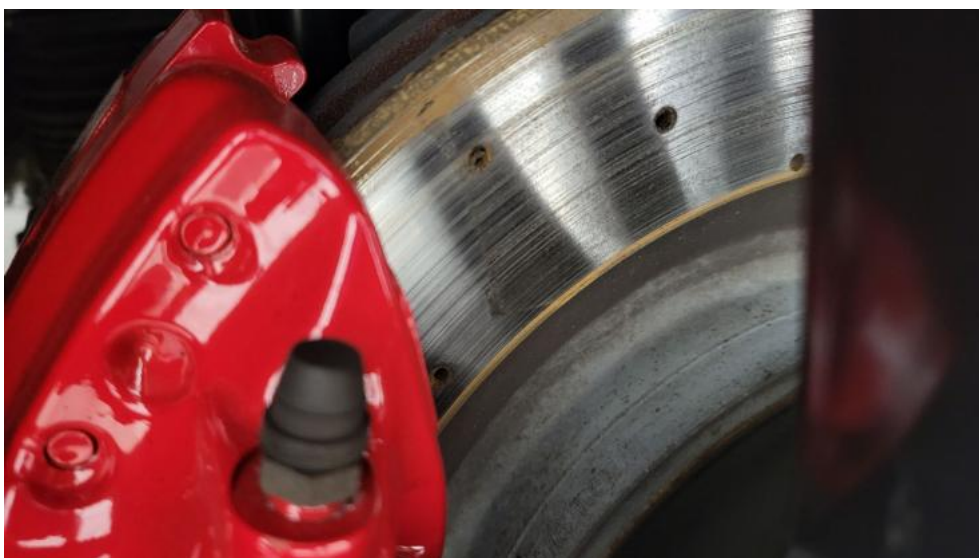
Photo 16.

Tarcza hamulcowa tylna prawa
