DEKRA's commission No. : PKOL(W)/LODZ/84479/25/11/03  
commission/ damage No. : 21/046227  
Date of commission: 03-11-2025

| Manufacturer | AUDI |
| Model | A6 [C8] 18-23 |
| Registration /record No. | CT0461Y |

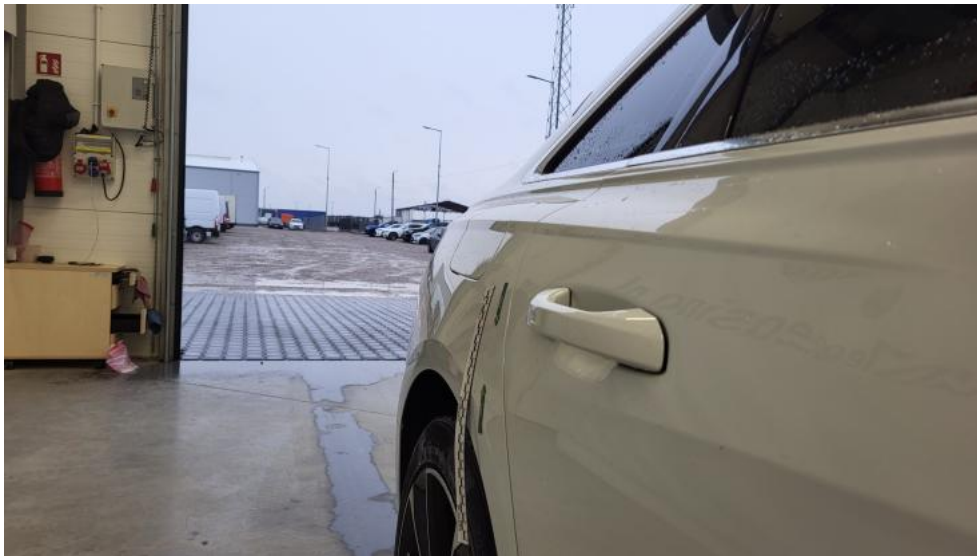
**Photo 53.**

Błotnik tylny P / Ściana boczna P - Wgniecenie/odkształcenie 1

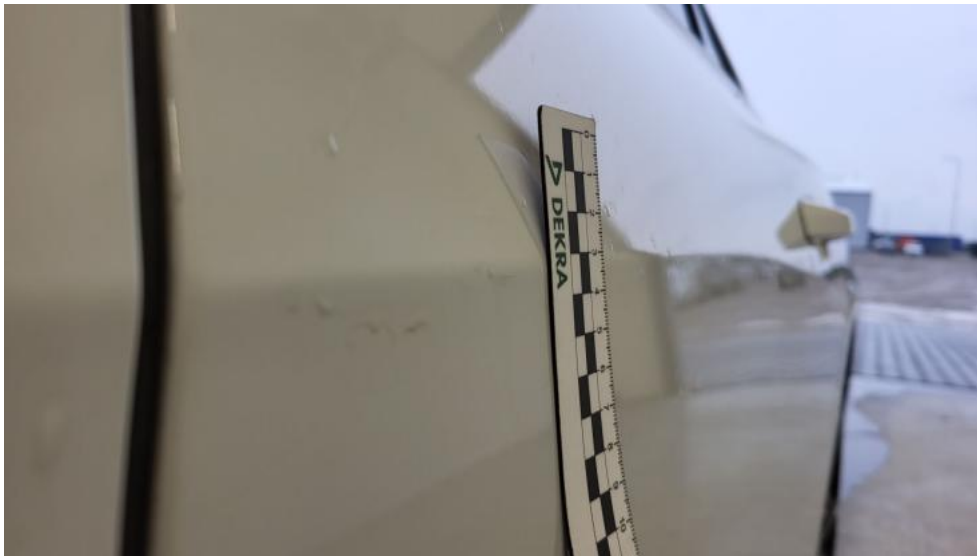
**Photo 63.**

Drzwi tylne L - Wgniecenie/odkształcenie 1

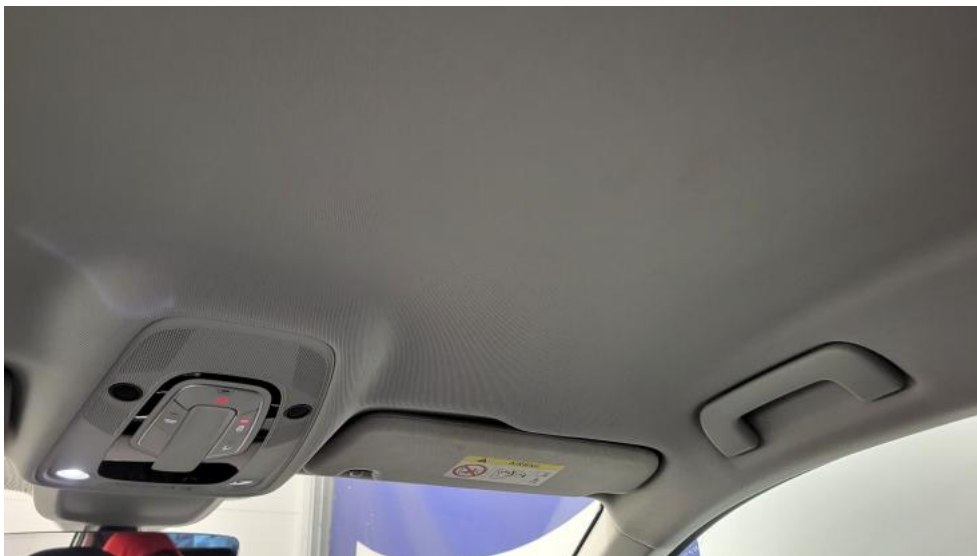
**Photo 73.**  
Podsufitka - Inne 1
