DEKRA's commission No. : PKOL(W)/LODZ/13677/25/02/24  
commission/ damage No. : 22/008782  
Date of commission: 24-02-2025

**Vehicle data**

Group of objects (Eurotax)	cars
EC code (Eurotax)	0126688
Manufacturer	SKODA
Model	Rapid Spaceback 17-19
Type / version	Rapid Spb. 1.0 TSI Active
Body type	hatchback
Number of doors / seats	5/5
Curb weight [kg]	1090
Gross vehicle weight [kg]	1625
Wheelbase 1/2	2602
Engine type	spark ignition
Pollution reduction system	three-way catalytic converter
Engine capacity [ccm]	999
Engine Power [hp/kW]	95/70
Gearbox	manual 5- gear
Registration /record No.	PO3XE81
VIN / serial number	TMBEP6NH1J4524013
Date of first registration	10-11-2017
Date of next. tech. test	07-11-2025
Year of manufacture	2017 (year has been verified with the manufacturer's base)
Readout [km]	138 935 (read)
Body color / type of coating	white/UNI

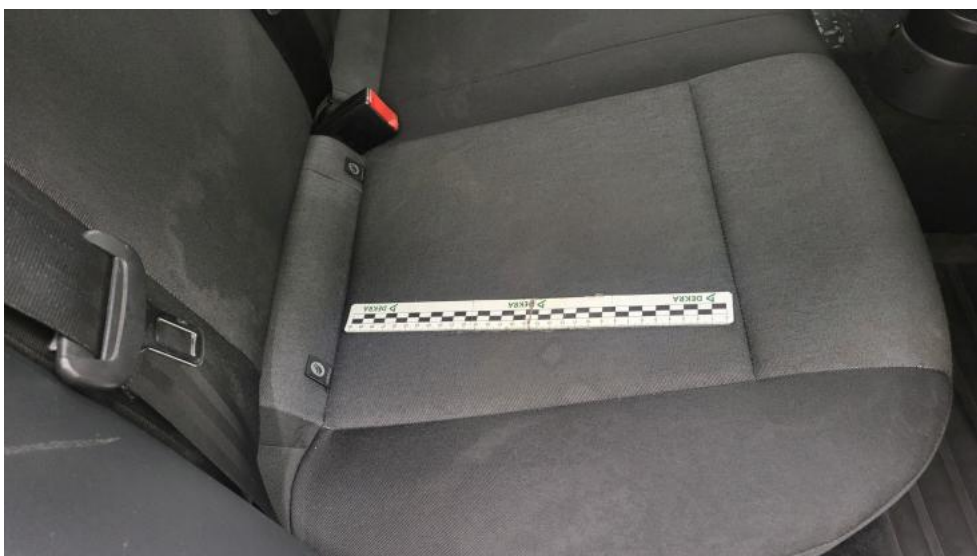
**Photo 68.**  
Kanapa tyl. - Inne 2
