DEKRA's commission No. : PKOL(W)/LODZ/98690/26/10/21  
commission/ damage No. : 21/040822  
Date of commission: 21-10-2026

| Manufacturer | KIA |
| Model | ProCeed 21-25 |
| Registration /record No. | KR5WU33 |

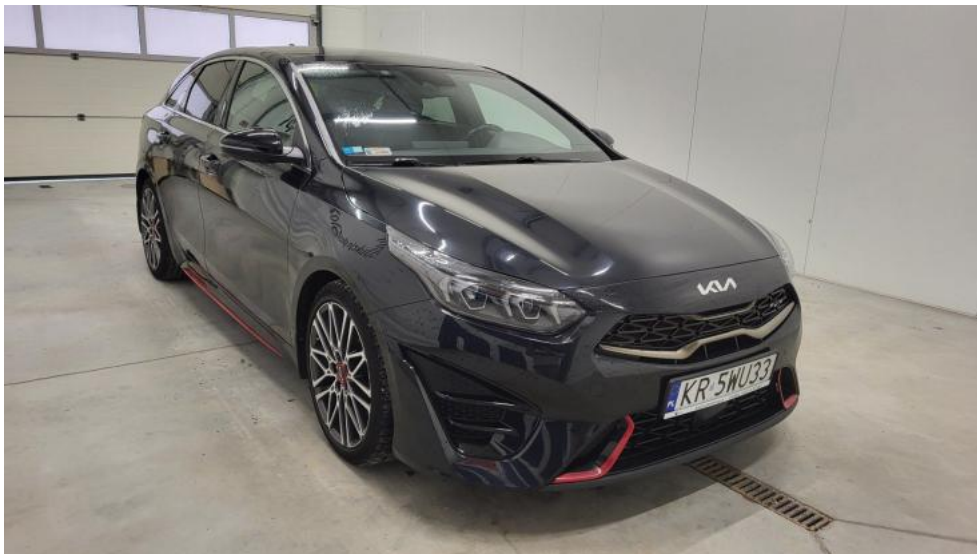
**Photo 3.**

Przekątna przednia prawa

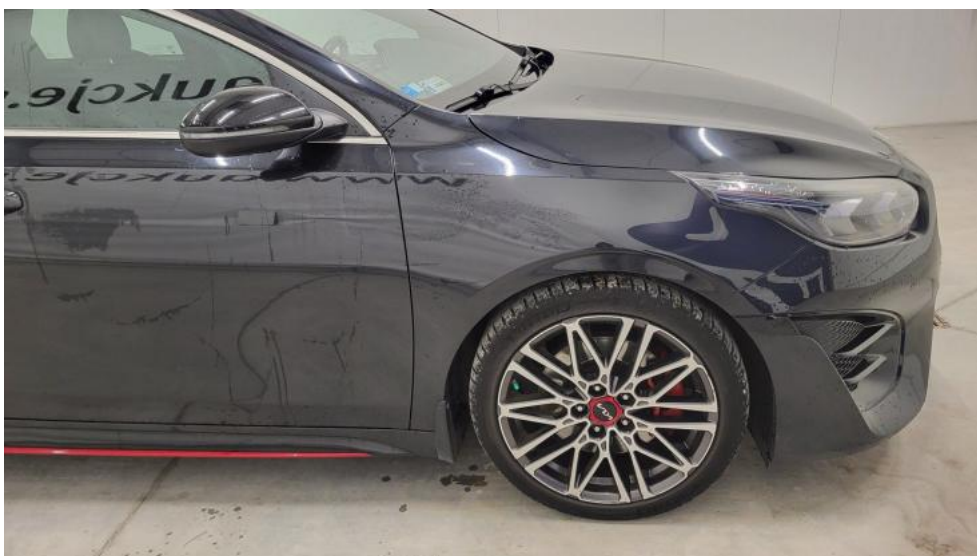
**Photo 4.**

Bok prawy z przodu

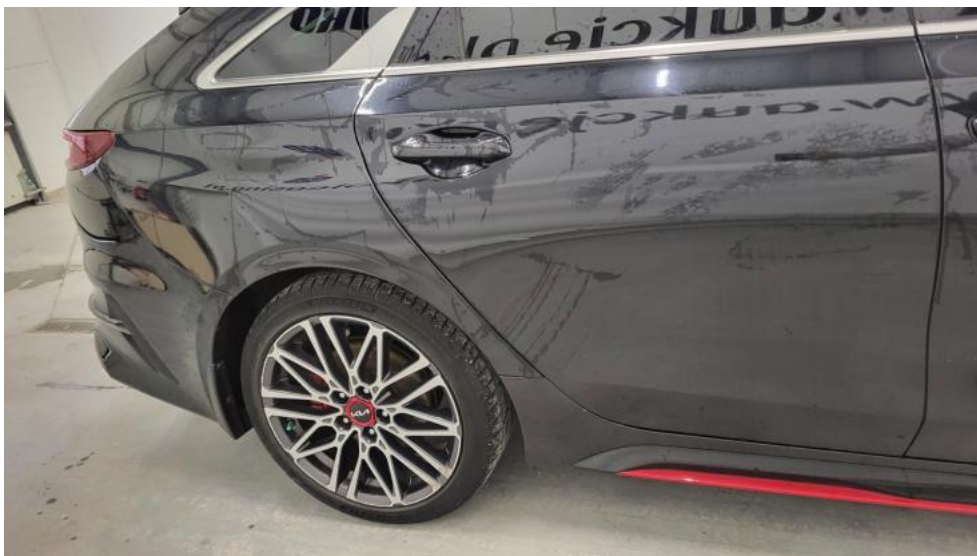
**Photo 5.**

Bok prawy z tyłu

Drzwi tylne P - Rysa/odprysk 2

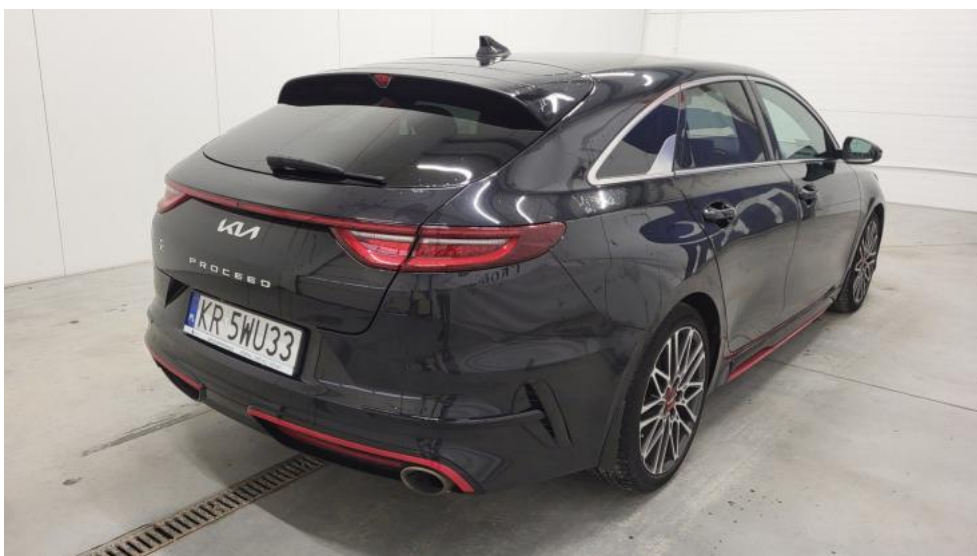
**Photo 6.**

Przekątna tylna prawa

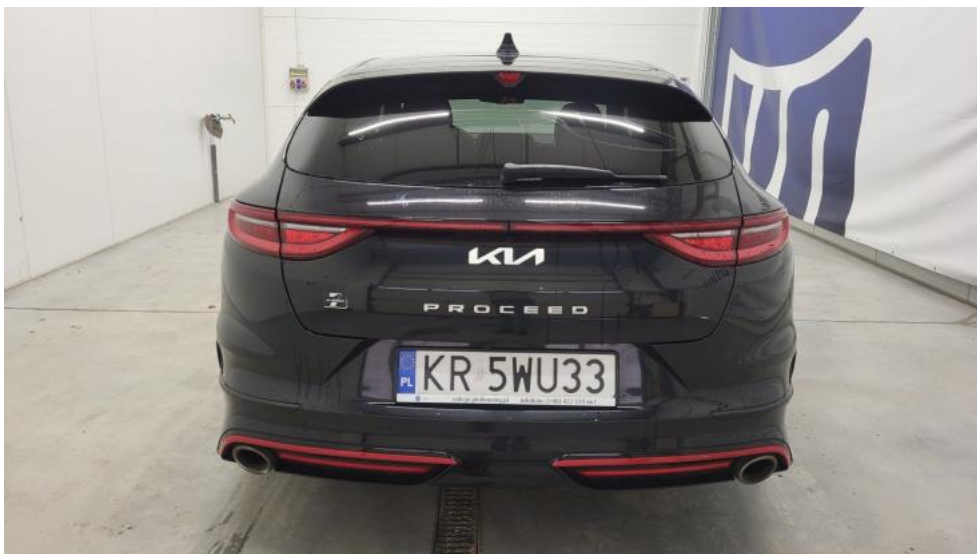
**Photo 7.**

Tył

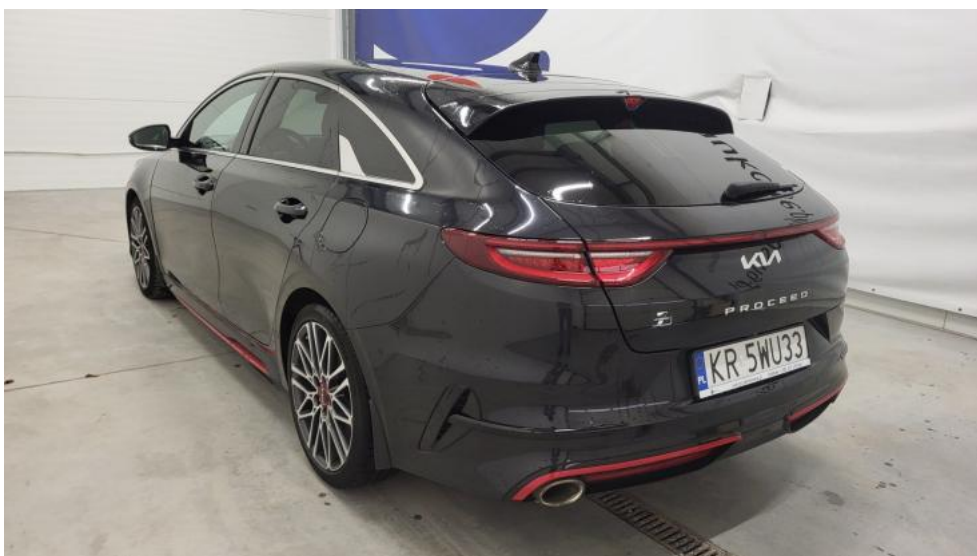
**Photo 8.**

Przekątna tylna lewa

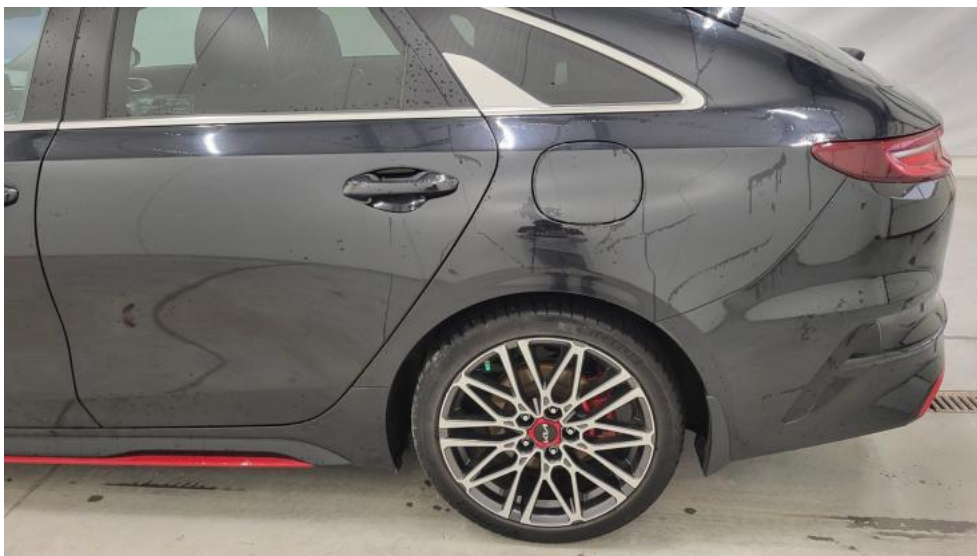
**Photo 9.**

Bok lewy z tyłu

Drzwi tylne L - Rysa/odprysk 2

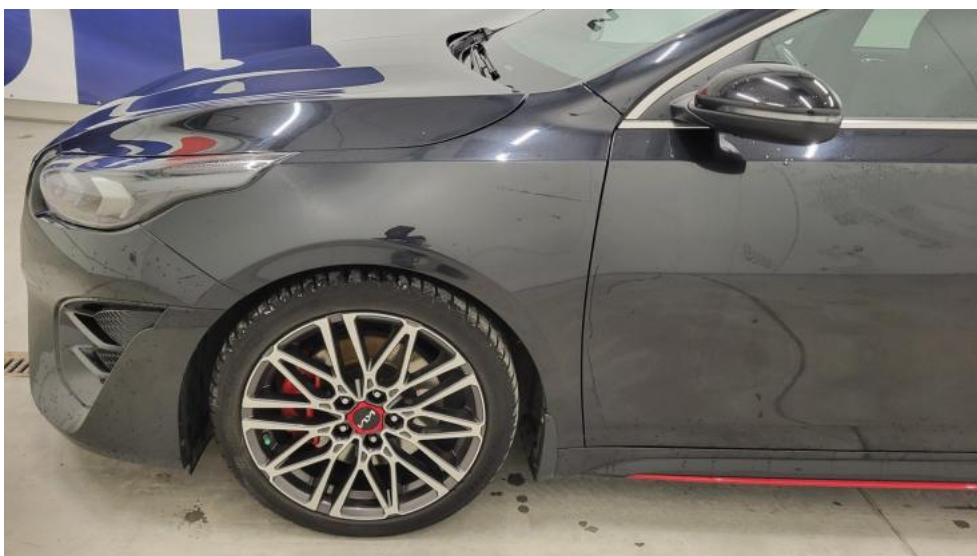
**Photo 10.**

Bok lewy z przodu

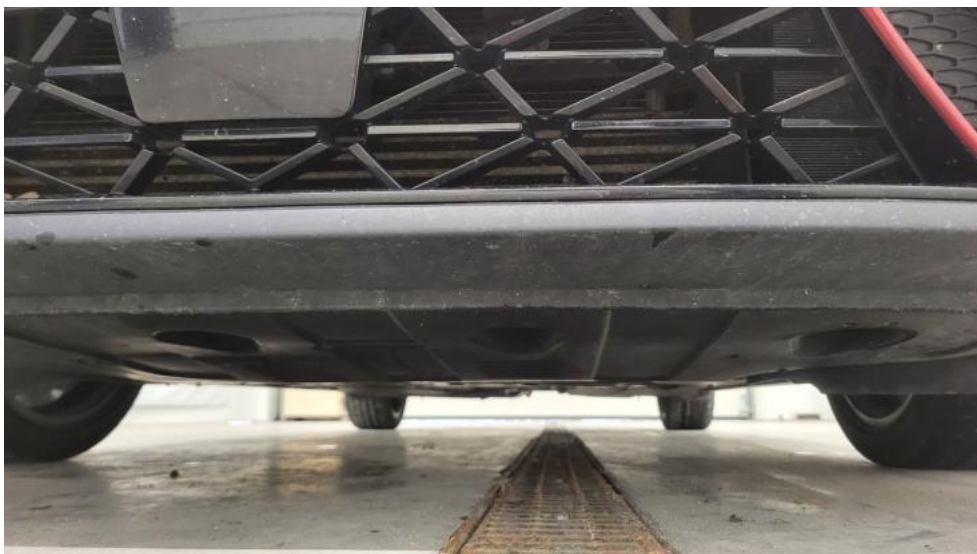
**Photo 13.**  
Spód pojazdu przód

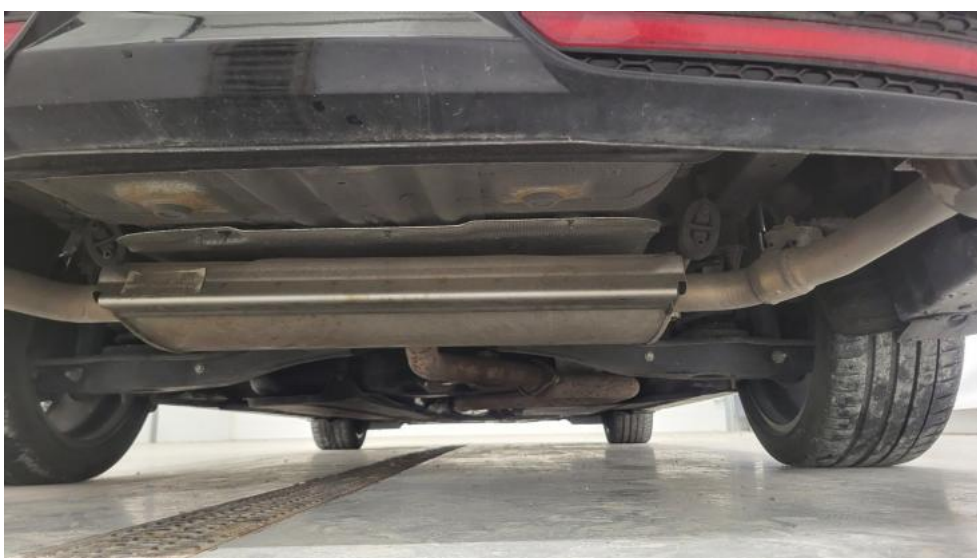
**Photo 14.**  
Spód pojazdu tył

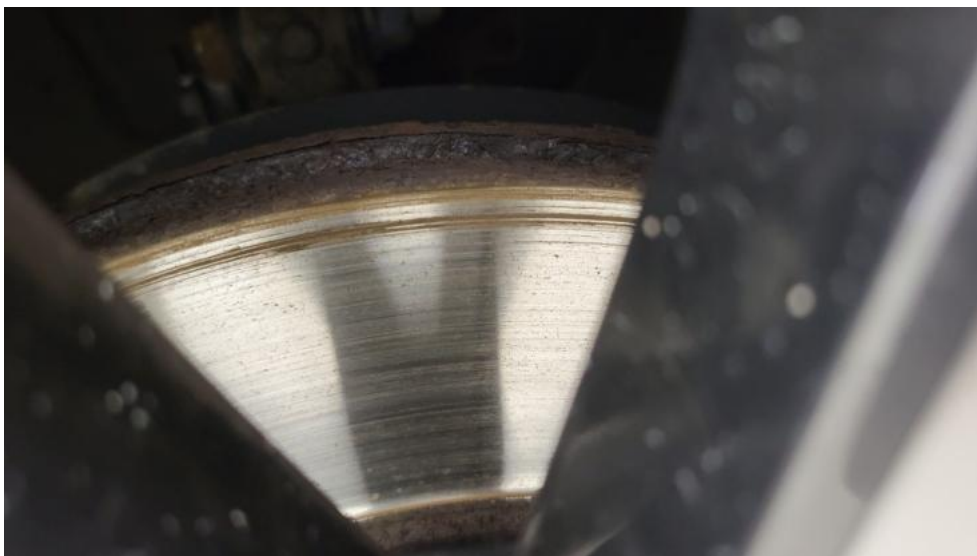
**Photo 15.**

Tarcza hamulcowa przednia prawa

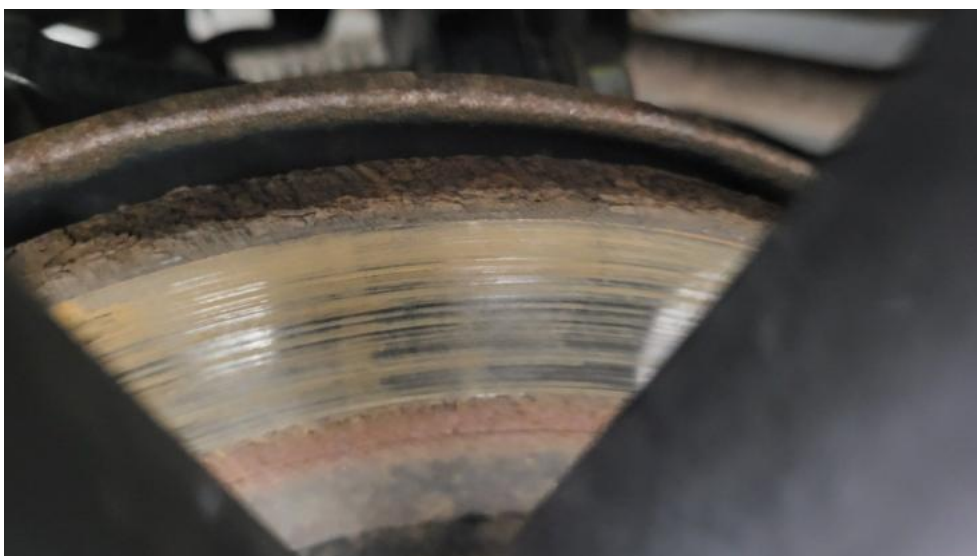
**Photo 16.**

Tarcza hamulcowa tylna prawa

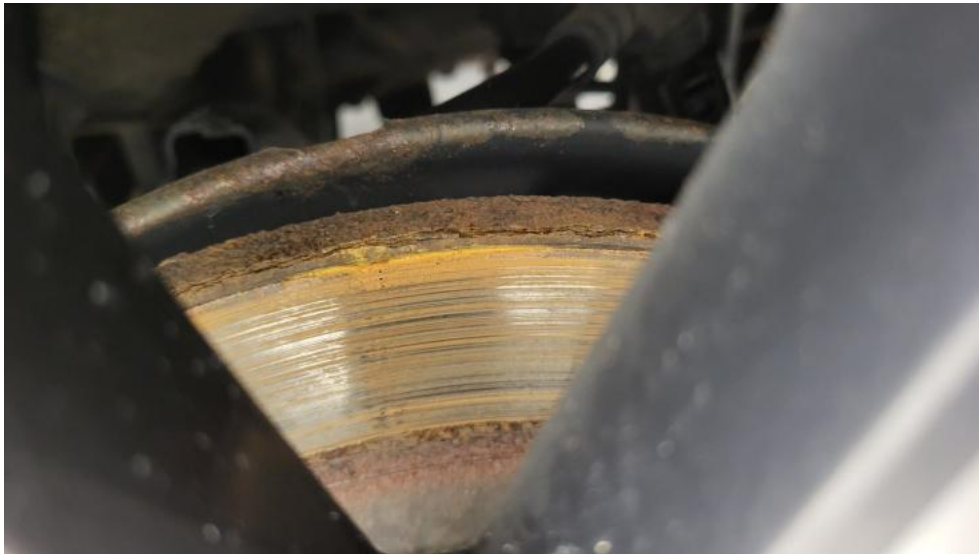
**Photo 17.**

Tarcza hamulcowa tylna lewa

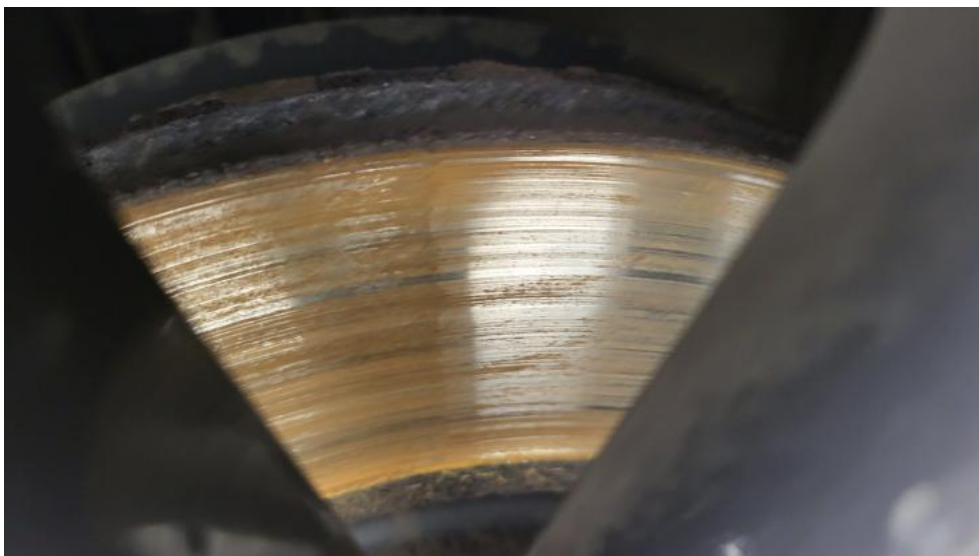
**Photo 18.**

Tarcza hamulcowa przednia lewa

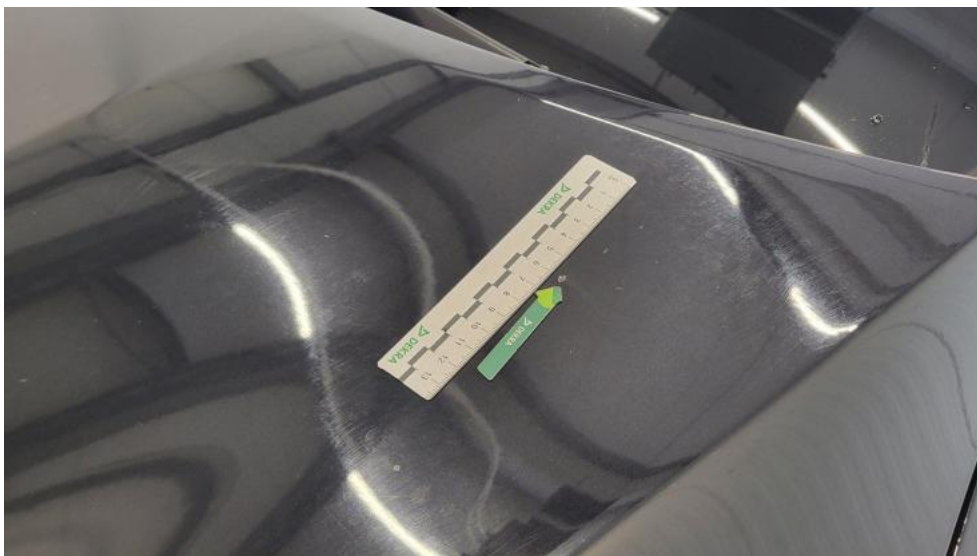
**Photo 41.**

Pokrywa komory silnika - zdjęcie poglądowe 1

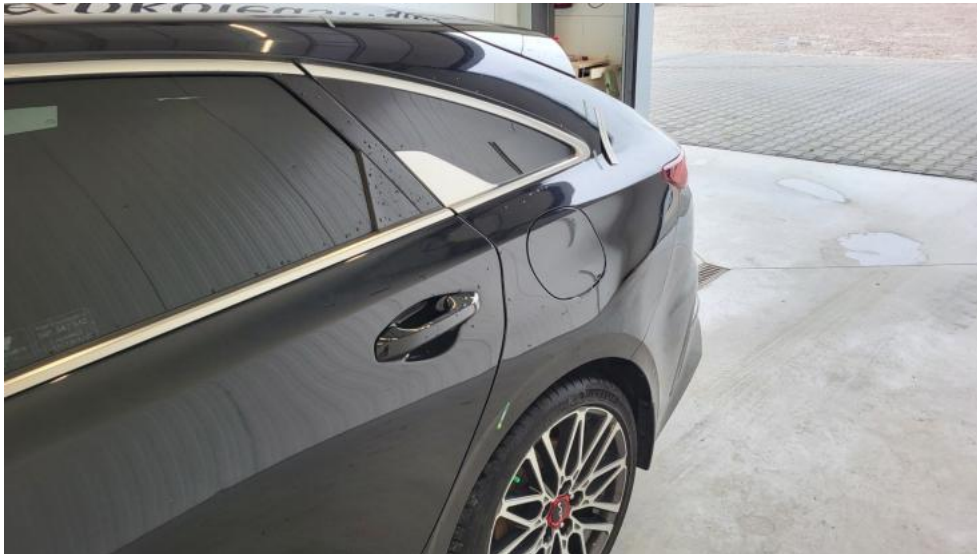
**Photo 59.**

Błotnik tylny L / Ściana boczna L - zdjęcie poglądowe 1
