DEKRA's commission No. : PKOL(W)/LODZ/36409/26/04/27  
 commission/ damage No. : 22/026782  
 Date of commission: 27-04-2026

**DEKRA Poland - Headquarters**  
 02-673 Warszawa, ul. Konstruktorska 12A

PKO Leasing SA  
 Świętokrzyska 36  
 00-116 Warszawa

Group of objects (Eurotax)	jeeps
EC code (Eurotax)	146108
Manufacturer	TOYOTA
Model	Highlander 20-25
Type / version	Highlander 2.5 Hybrid Executive
Body type	KOM
Number of doors / seats	5/7
Curb weight [kg]	2105
Gross vehicle weight [kg]	2720
Wheelbase 1/2	2850
Engine type	spark ignition
Engine capacity [ccm]	2487
Engine Power [hp/kW]	190/140
Gearbox	automatic
Registration /record No.	NO319AC
VIN / serial number	5TDLB3CH10S092937
Date of first registration	30-08-2022
Date of next. tech. test	30-08-2027
Year of manufacture	2022 (year has been verified with the manufacturer's base)
Readout [km]	160 412 (read)
Body color / type of coating	black/double-layered, metallized

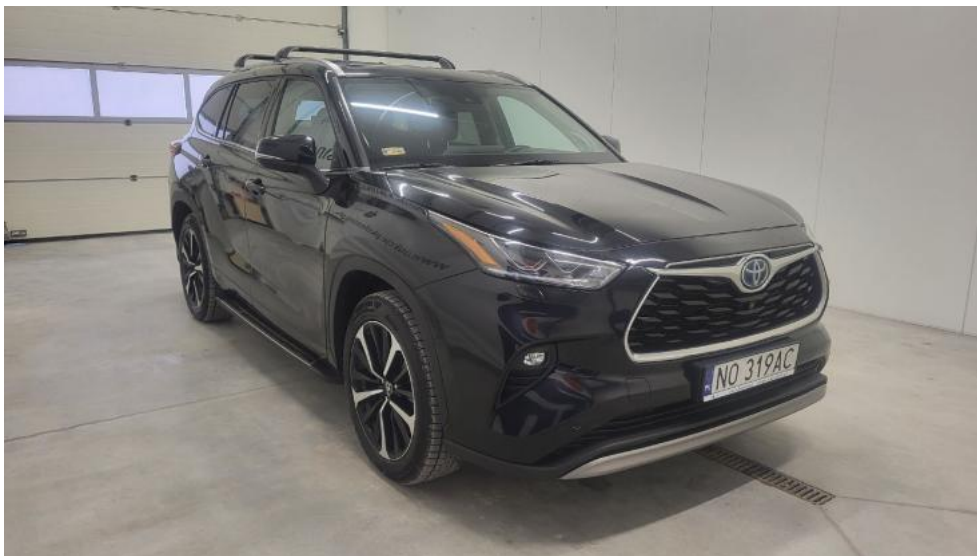
**Photo 3.**

Przekątna przednia prawa

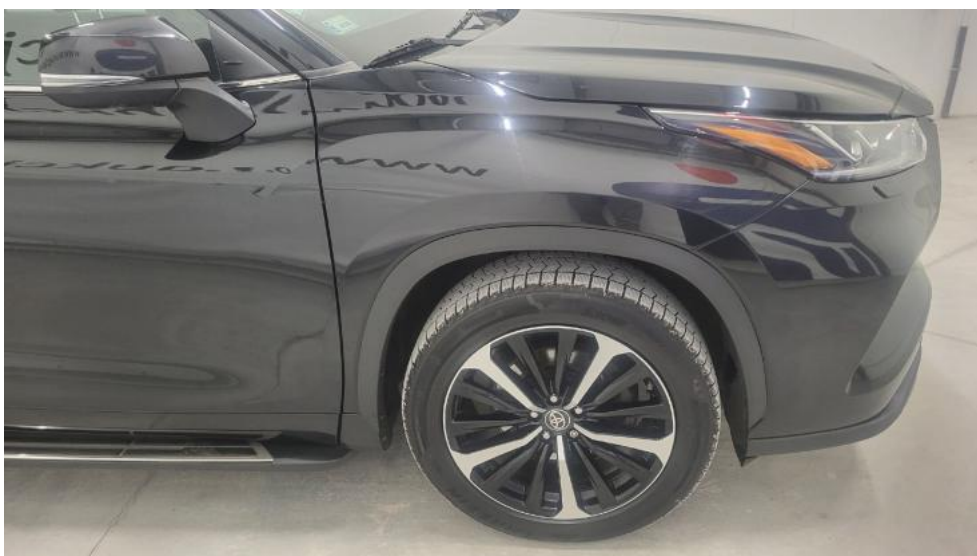
**Photo 4.**

Bok prawy z przodu

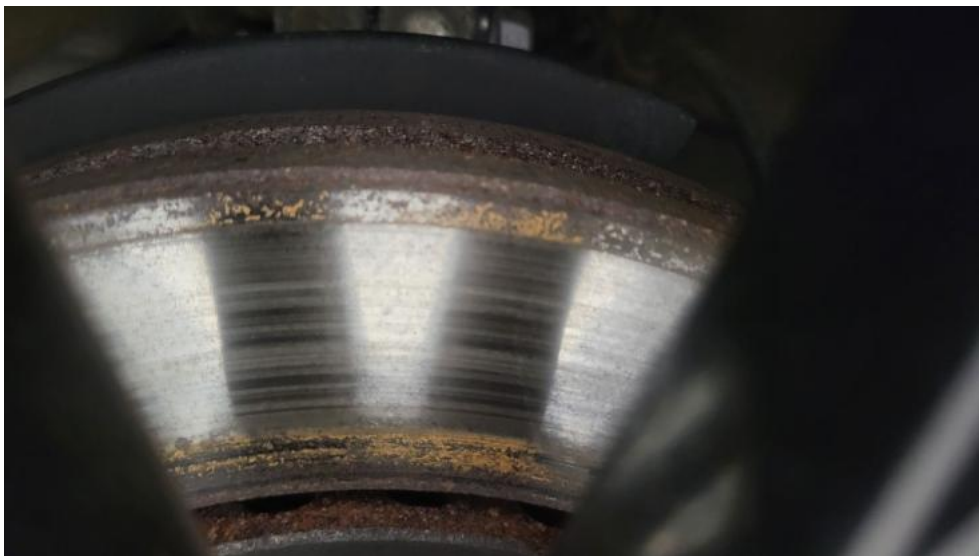
**Photo 15.**

Tarcza hamulcowa przednia prawa

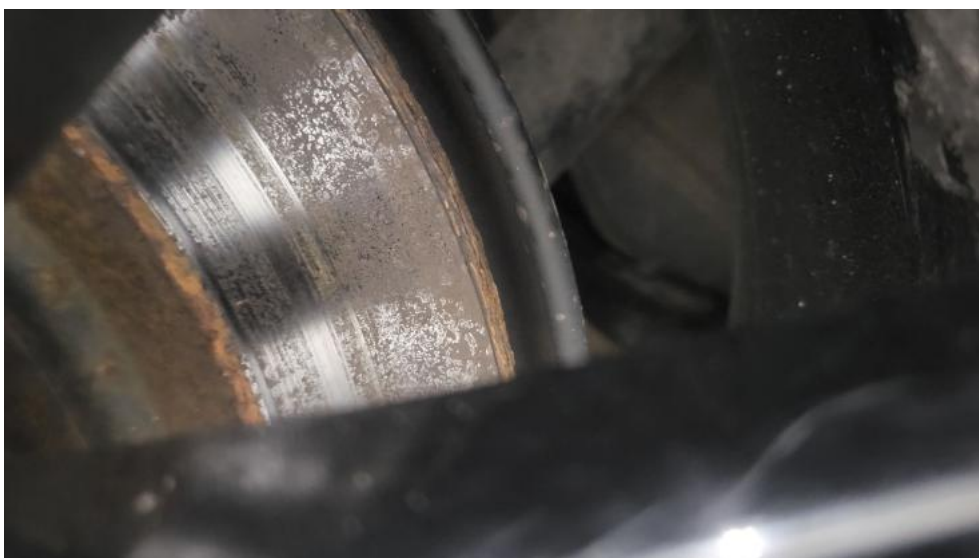
**Photo 16.**

Tarcza hamulcowa tylna prawa

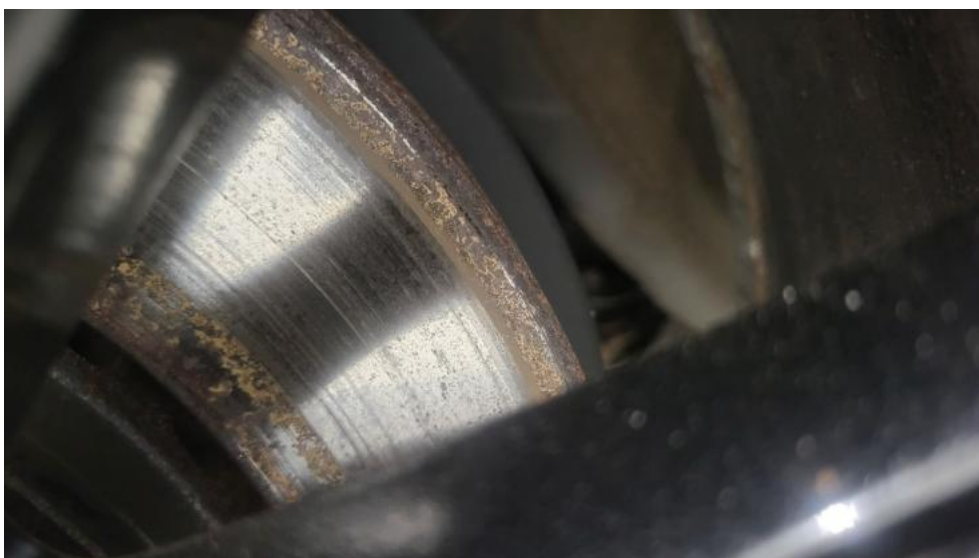
**Photo 18.**

Tarcza hamulcowa przednia lewa

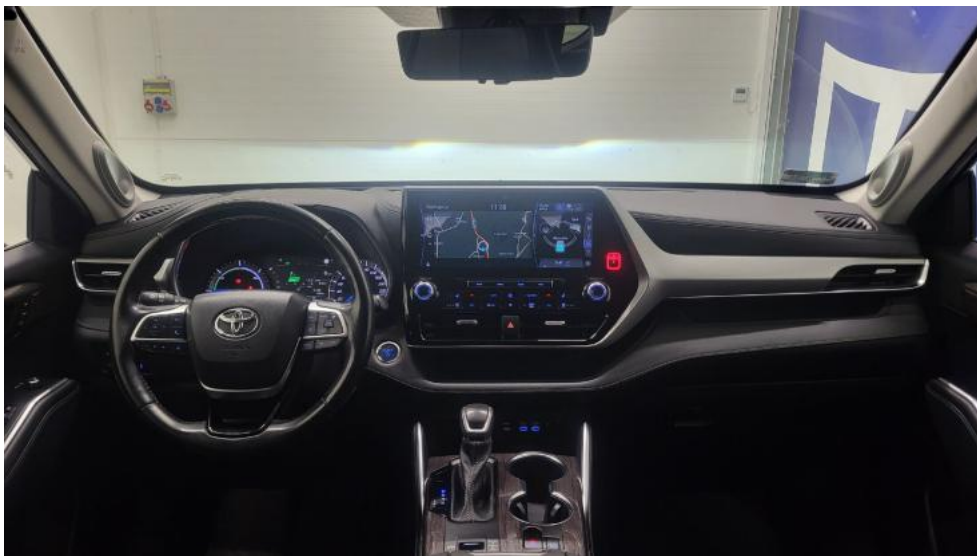
**Photo 29.**

Widok z tylnej kanapy na deskę rozd.

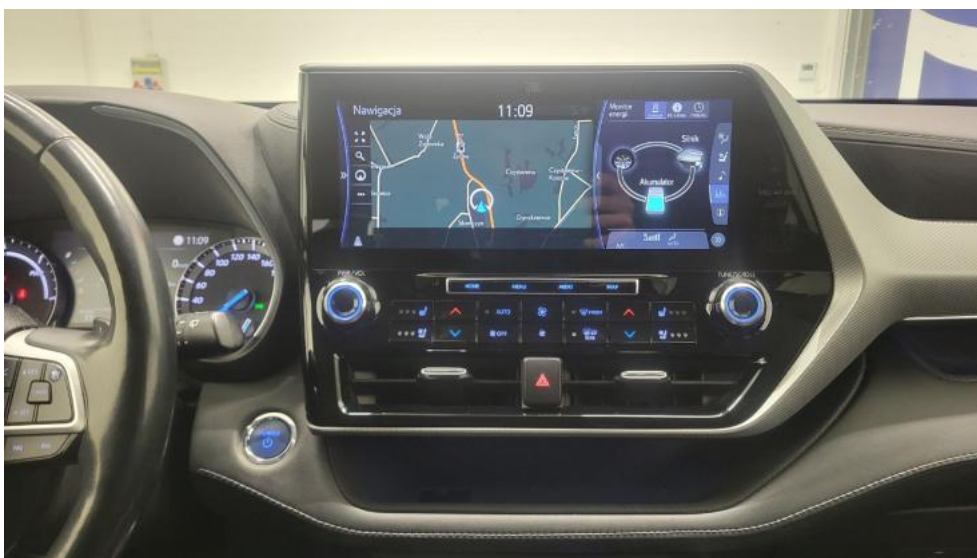
**Photo 30.**

Konsola środkowa

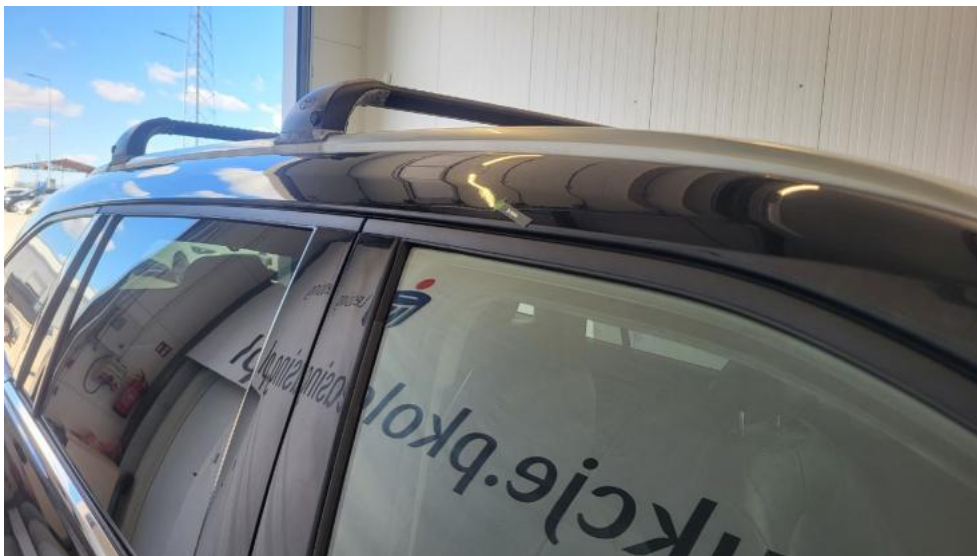
**Photo 59.**

Stupek przedni P - Wgniecenie/odkształcenie 1
