DEKRA's commission No. : PKOL(W)/LODZ/15782/26/02/19
 commission/ damage No. : PS24/01207
 Date of commission: 19-02-2026

Vehicle data

Group of objects (Eurotax)	cars
EC code (Eurotax)	0130729
Manufacturer	FORD
Model	Focus Hatchback 18-21
Type / version	Focus 1.5 EcoBlue ST-Line Business
Body type	hatchback
Number of doors / seats	5/5
Curb weight [kg]	1288
Gross vehicle weight [kg]	1895
Wheelbase 1/2	2650
Engine type	Automatic ignition
Pollution reduction system	DPF
Engine capacity [ccm]	1498
Engine Power [hp/kW]	120/88
Gearbox	manual
Registration /record No.	WU9765R
VIN / serial number	WF0NXXGCHNLB27053
Date of first registration	16-10-2020
Date of next. tech. test	16-10-2026
Year of manufacture	2020 (year has been verified with the manufacturer's base)
Readout [km]	105 494 (read)
Body color / type of coating	silver/double-layered, metallized

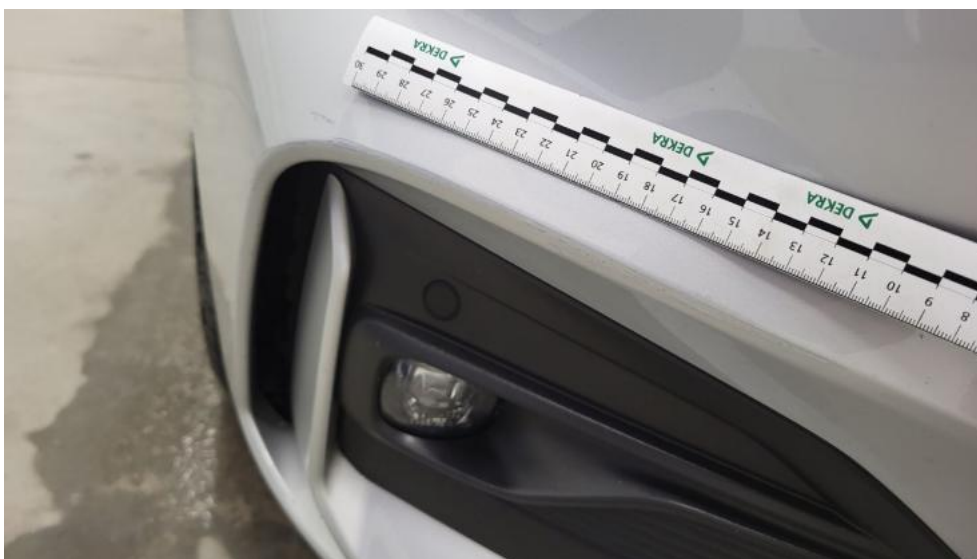
Photo 43.

Zderzak - zdjęcie poglądowe 1
