DEKRA's commission No. : PKOL(W)/LODZ/24045/26/03/18  
commission/ damage No. : 24/044131  
Date of commission: 18-03-2026

**DEKRA Poland - Headquarters**  
02-673 Warszawa, ul. Konstruktorska 12A

| Model | Corolla Sedan 18-22 |
| Type / version | Corolla 1.8 Hybrid GPF Comfort |

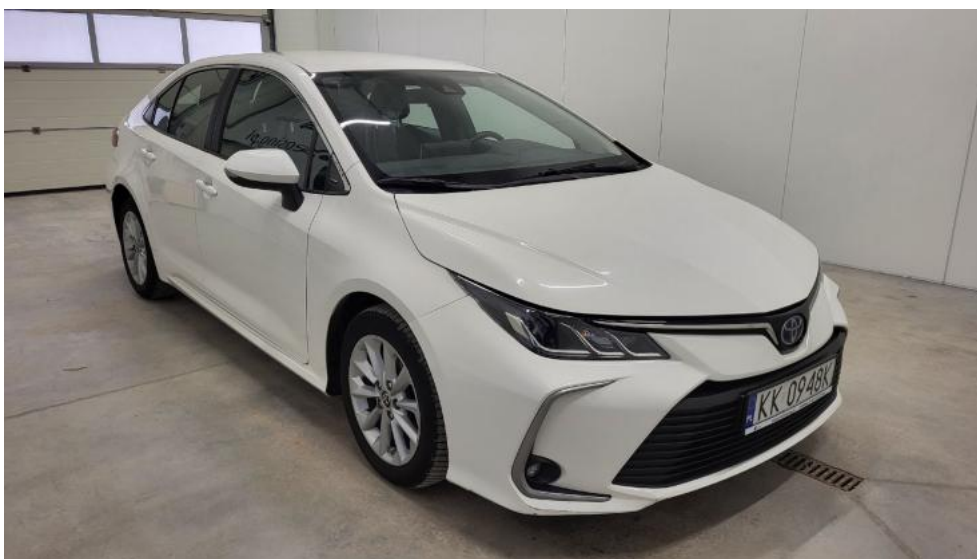
**Photo 3.**

Przekątna przednia prawa

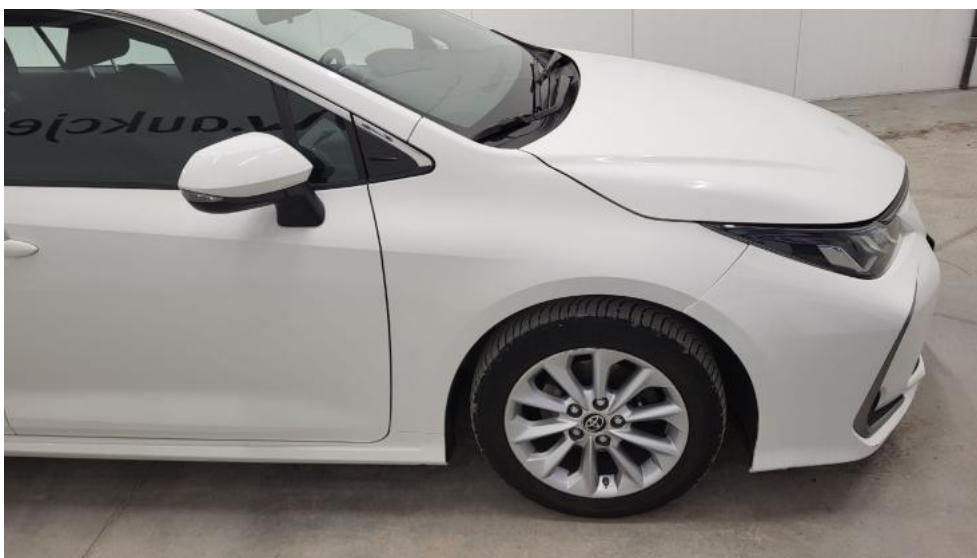
**Photo 4.**

Bok prawy z przodu

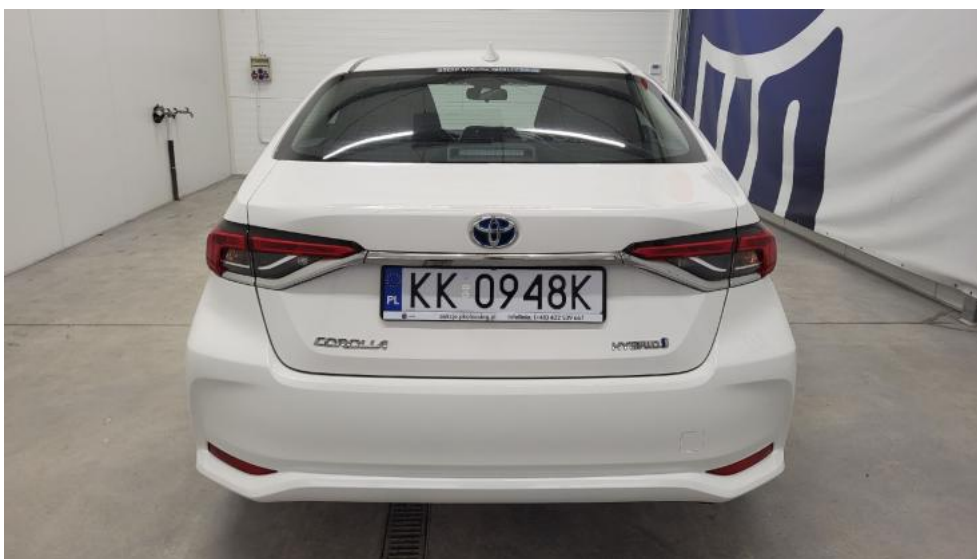
**Photo 7.**

Tył

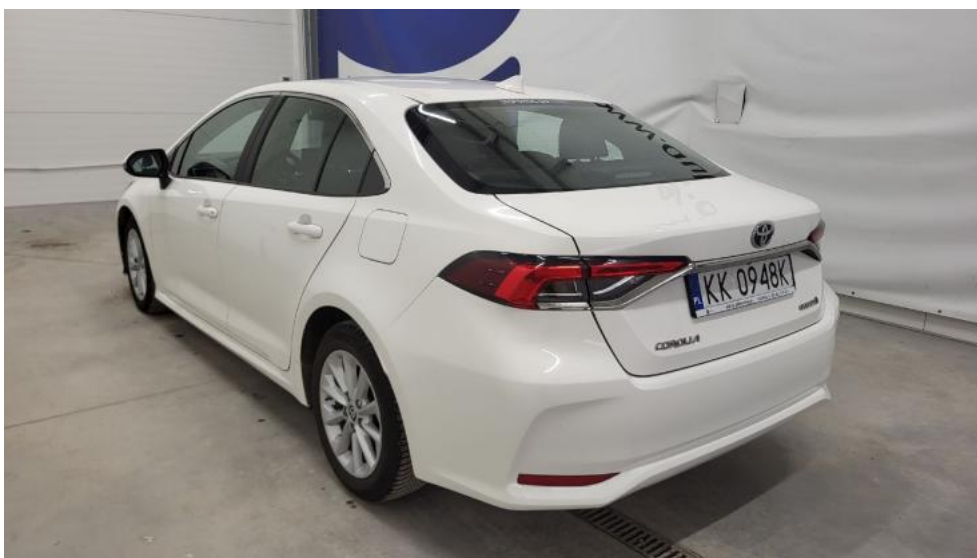
**Photo 8.**

Przekątna tylna lewa

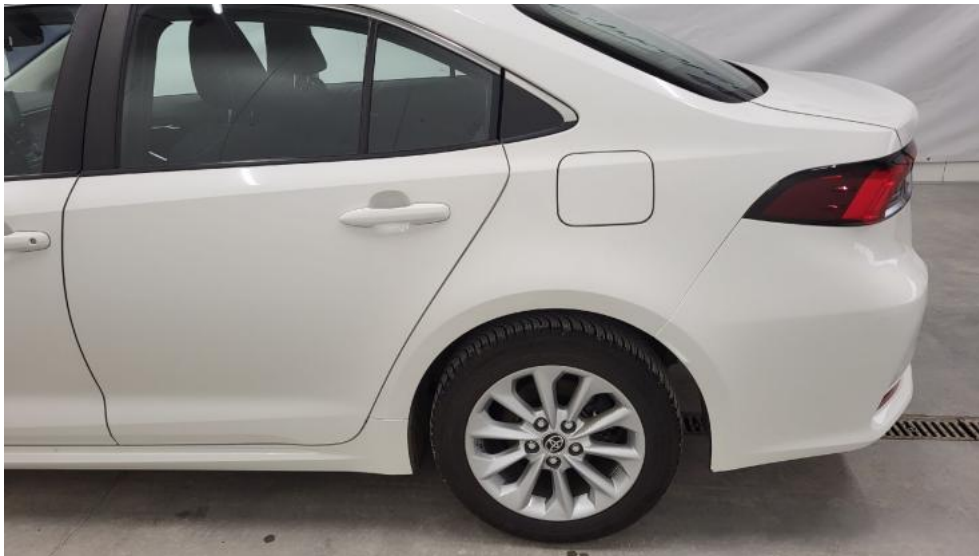
**Photo 9.**

Bok lewy z tyłu

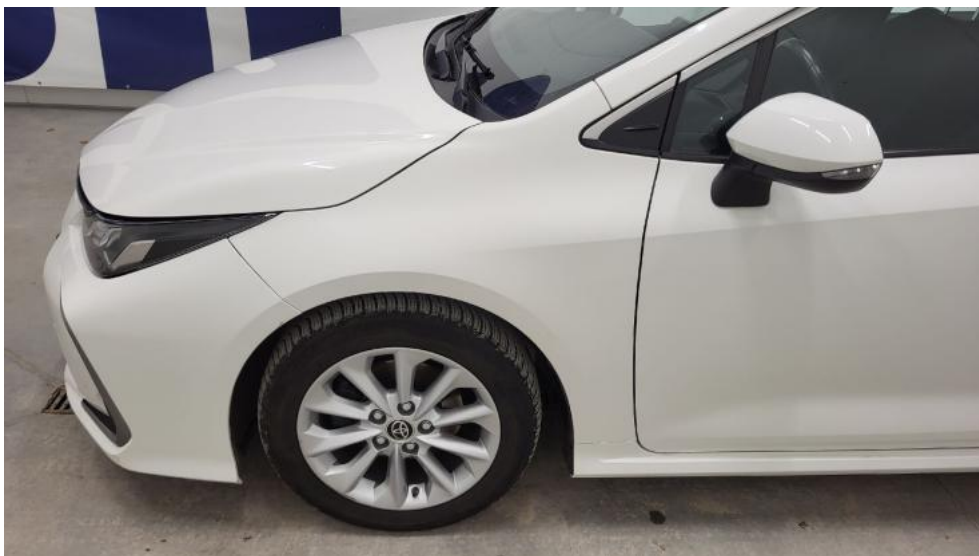
**Photo 10.**

Bok lewy z przodu

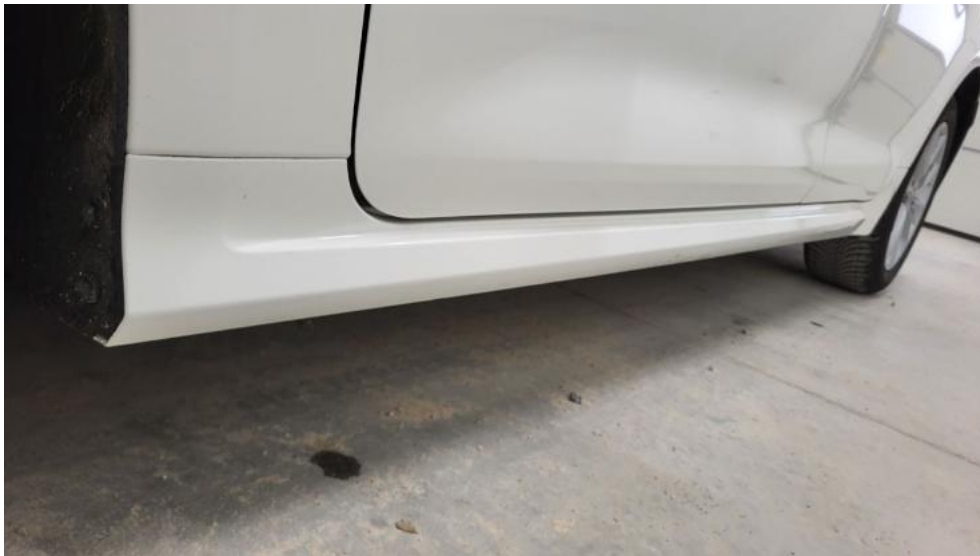
**Photo 11.**

Próg lewy (widok od przodu)

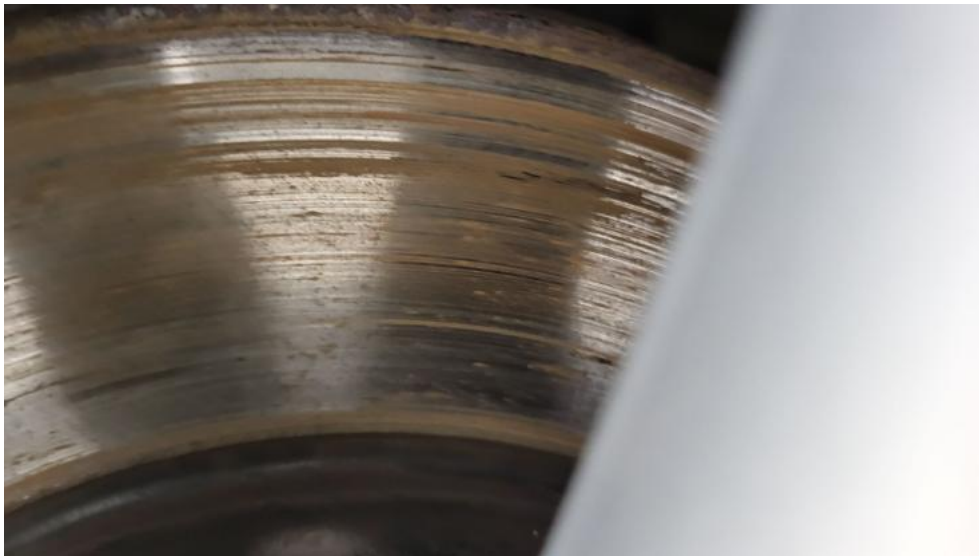
**Photo 15.**

Tarcza hamulcowa przednia prawa

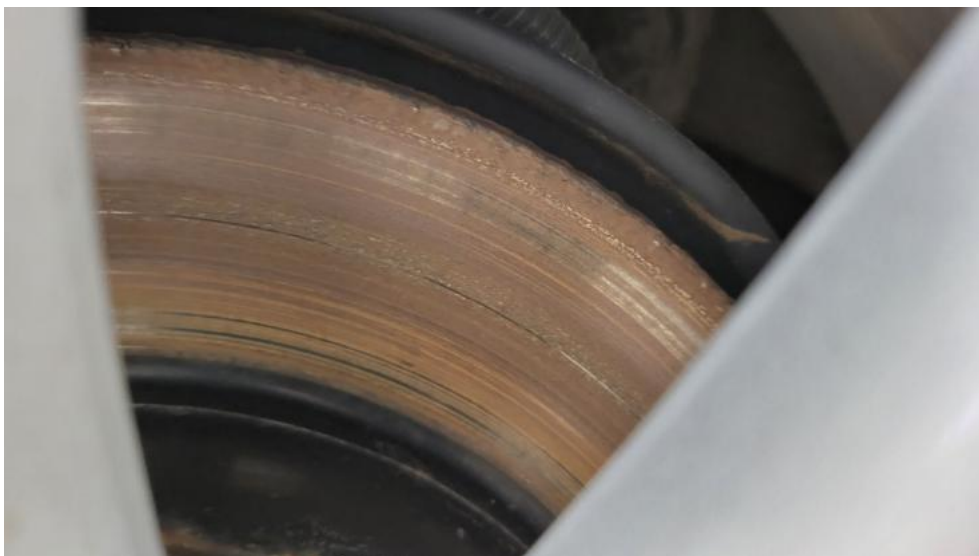
**Photo 16.**

Tarcza hamulcowa tylna prawa

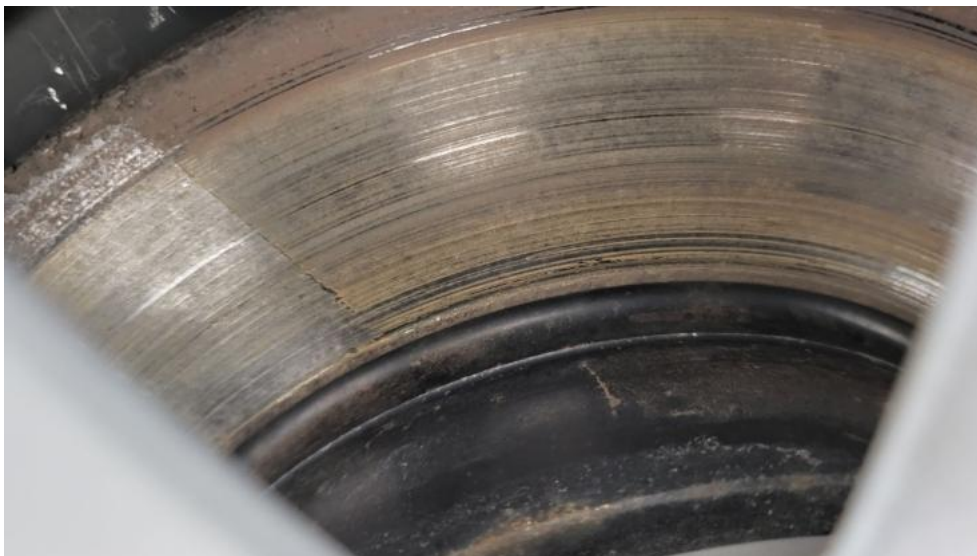
**Photo 17.**

Tarcza hamulcowa tylna lewa

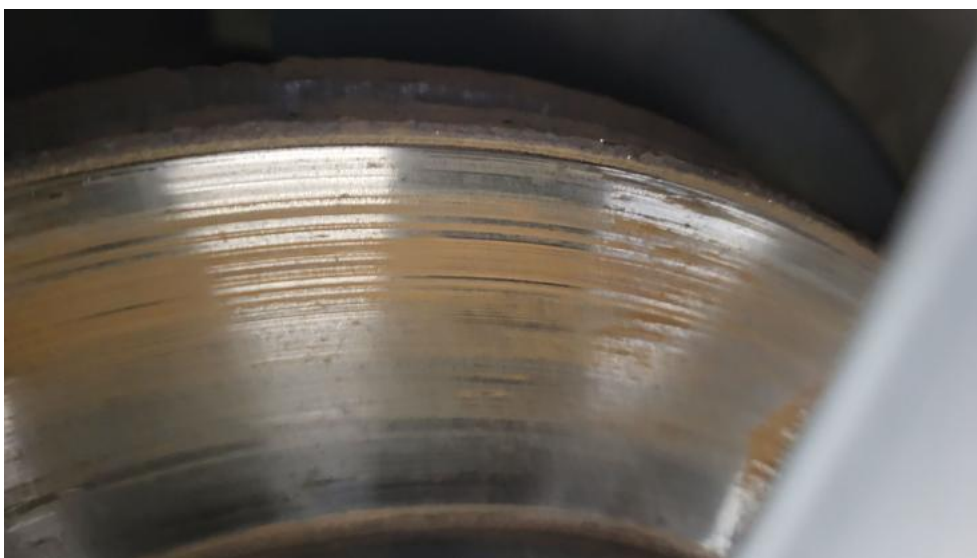
**Photo 18.**

Tarcza hamulcowa przednia lewa

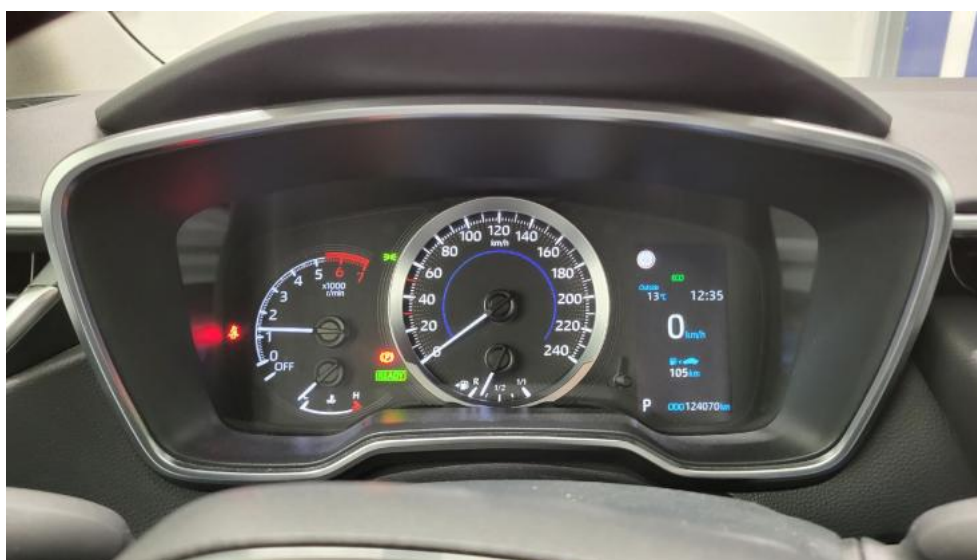
**Photo 24.**

Zestaw wskaźników - przebieg

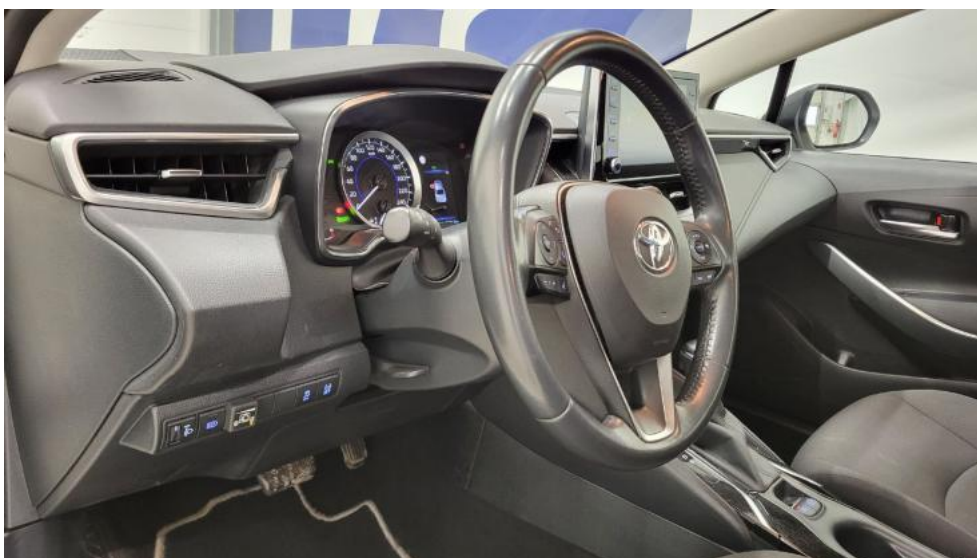
**Photo 26.**

Kierownica z lewej strony

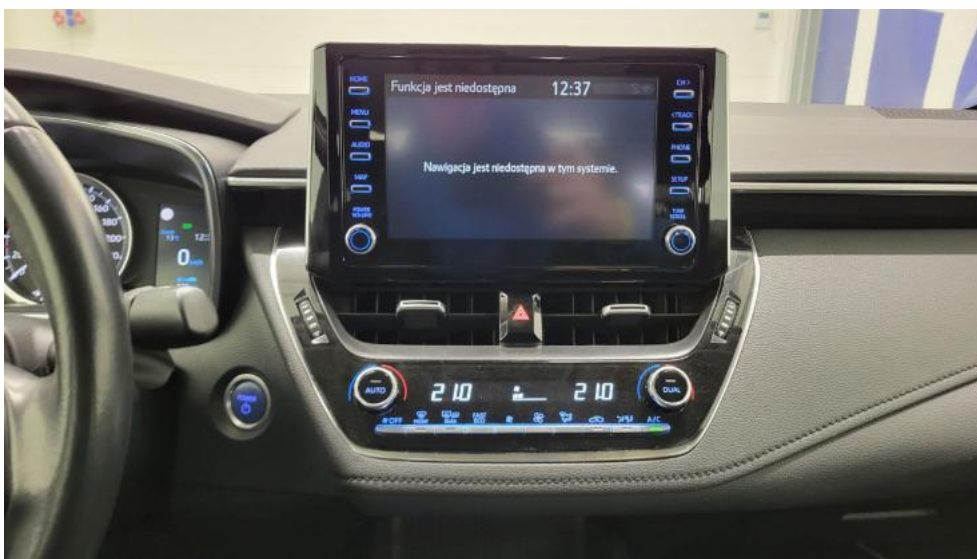
**Photo 29.**

Konsola środkowa

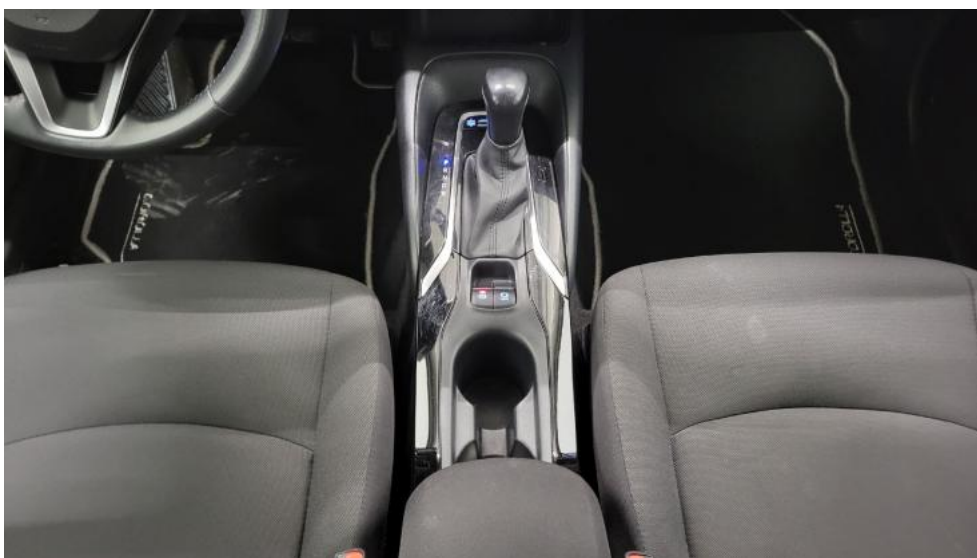
**Photo 30.**

Tunel środkowy

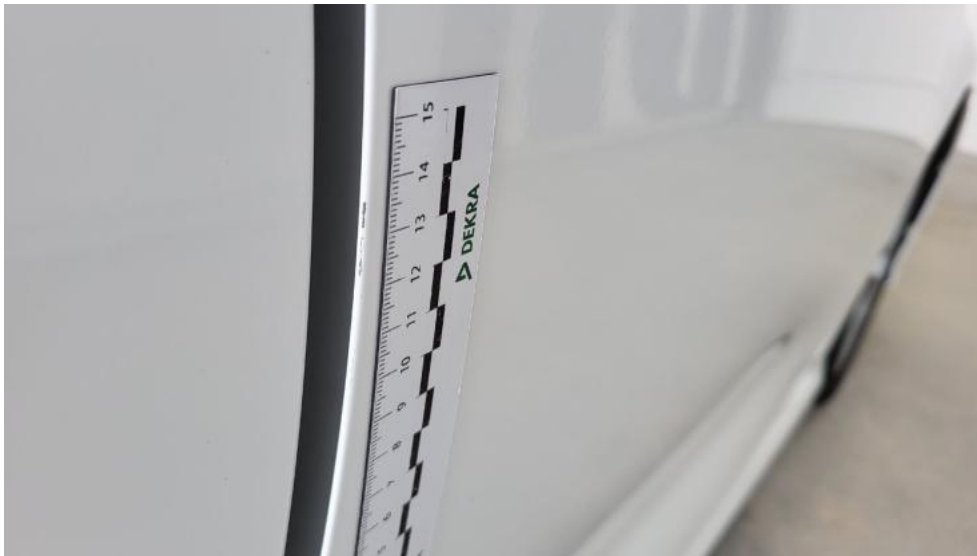
**Photo 51.**

Drzwi przednie P - Rysa/odprysk 1

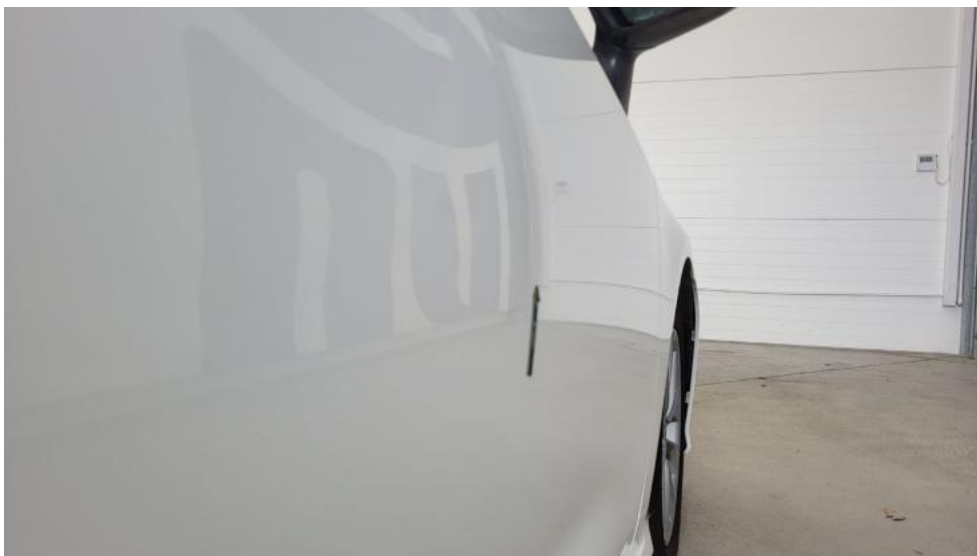
**Photo 52.**

Drzwi przednie P - Wgniecenie/odkształcenie 1
