DEKRA's commission No. : PKOL(W)/LODZ/07663/25/01/31
 commission/ damage No. : PS18/03279
 Date of commission: 31-01-2025

Group of objects (Eurotax)	jeeps
EC code (Eurotax)	0132888
Manufacturer	KIA
Model	Sportage 18-21
Type / version	Sportage 2.0 CRDI GT Line 4WD aut
Body type	KOM
Number of doors / seats	5/5
Curb weight [kg]	1672
Gross vehicle weight [kg]	2250
Wheelbase 1/2	2670
Engine type	Automatic ignition
Pollution reduction system	KSC
Engine capacity [ccm]	1995
Engine Power [hp/kW]	185/136
Gearbox	automatic
Registration /record No.	GD874TH
VIN / serial number	U5YPK813DKL717348
Date of first registration	16-04-2019
Date of next. tech. test	16-04-2024
Year of manufacture	2019
Readout [km]	106 155 (read)
Body color / type of coating	blue/double-layered, metallized

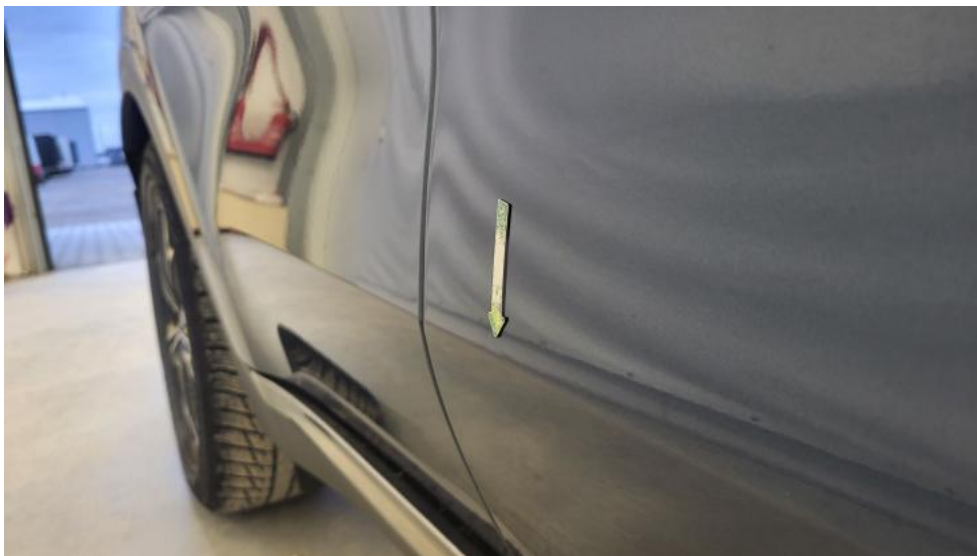
Photo 51.
Drzwi przednie P - Wgniecenie/odkształcenie 1

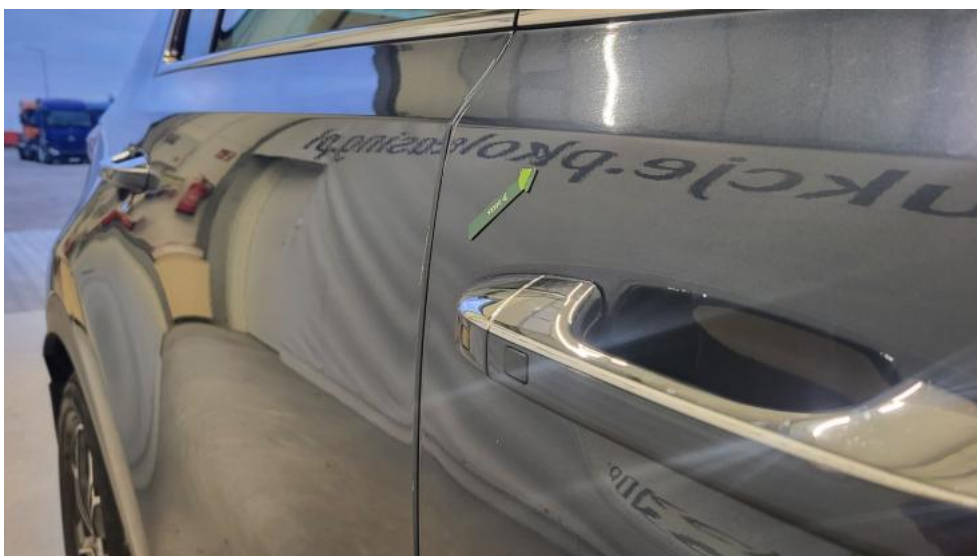
Photo 52.
Drzwi przednie P - Wgniecenie/odkształcenie 2

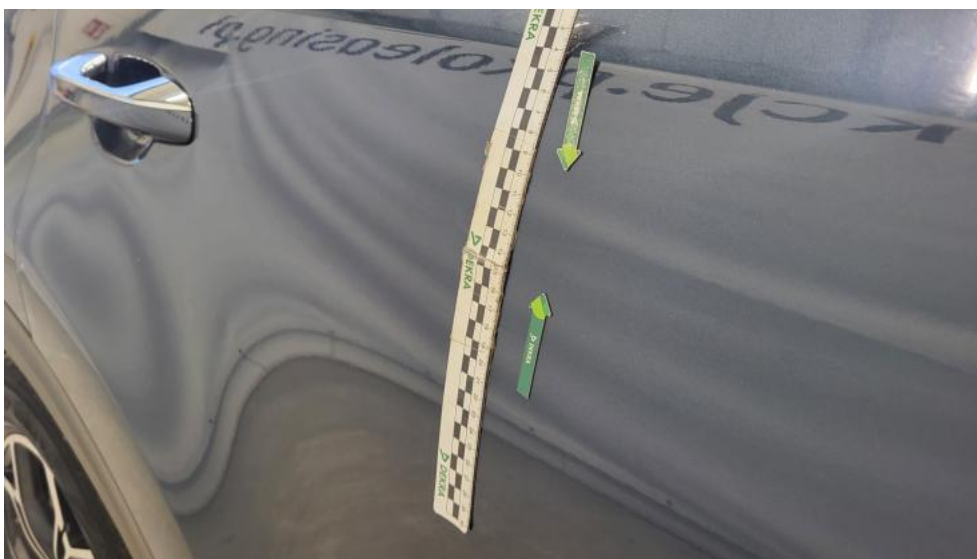
Photo 55.

Drzwi tylne P - zdjęcie pogładowe 1

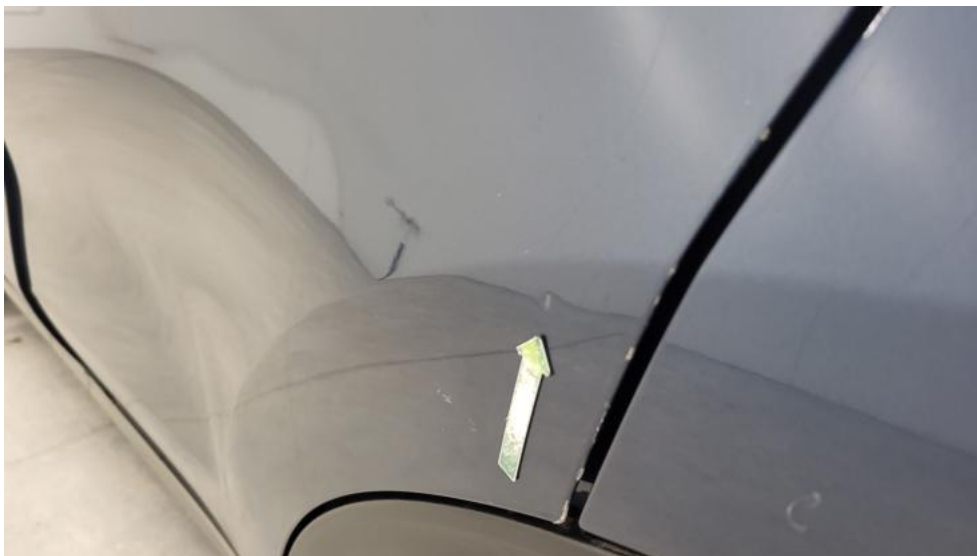
Photo 67.
Drzwi tylne L - Wgniecenie/odkształcenie 1
