DEKRA's commission No. : PKOL(W)/LODZ/15587/26/02/19
 commission/ damage No. : 24/019994
 Date of commission: 19-02-2026

Group of objects (Eurotax)	cars
EC code (Eurotax)	0134587
Manufacturer	VOLVO
Model	S90 16-20
Type / version	S90 D5 SCR AWD Inscription aut
Body type	sedan
Number of doors / seats	4/5
Curb weight [kg]	1847
Gross vehicle weight [kg]	2360
Wheelbase 1/2	2941
Engine type	Automatic ignition
Pollution reduction system	KSC
Emission standard	EURO 6
Engine capacity [ccm]	1969
Engine Power [hp/kW]	235/173
Gearbox	automatic 8- gear
Registration /record No.	WP7005S
VIN / serial number	LVYPS68UCKP058434
Date of first registration	26-09-2018
Date of next. tech. test	22-10-2025
Year of manufacture	2018 (year has been verified with the manufacturer's base)
Readout [km]	224 797 (read)
Body color / type of coating	blue/2-warstwowy metalik

Date: 13-03-2026

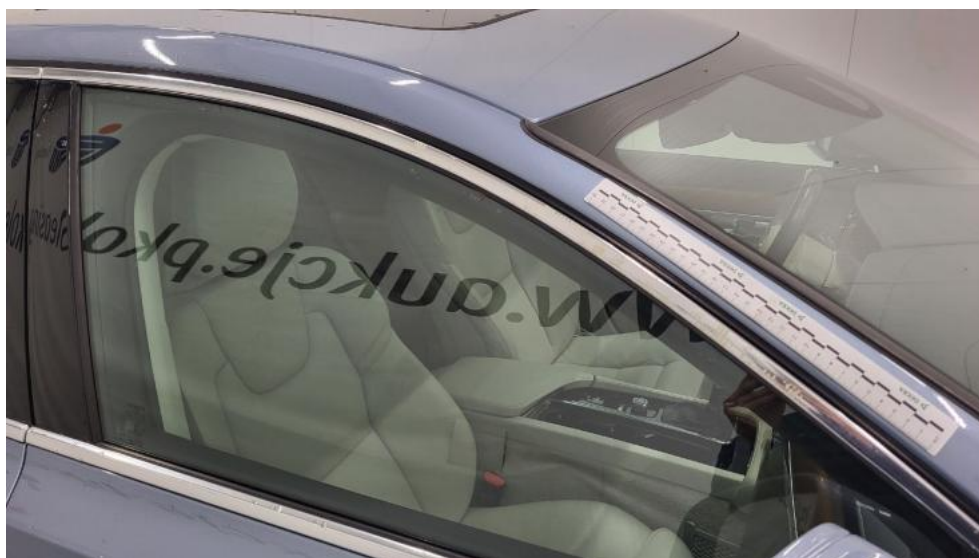
Photo 56.

Listwa drzwi przednich P - zdjęcie poglądowe 1

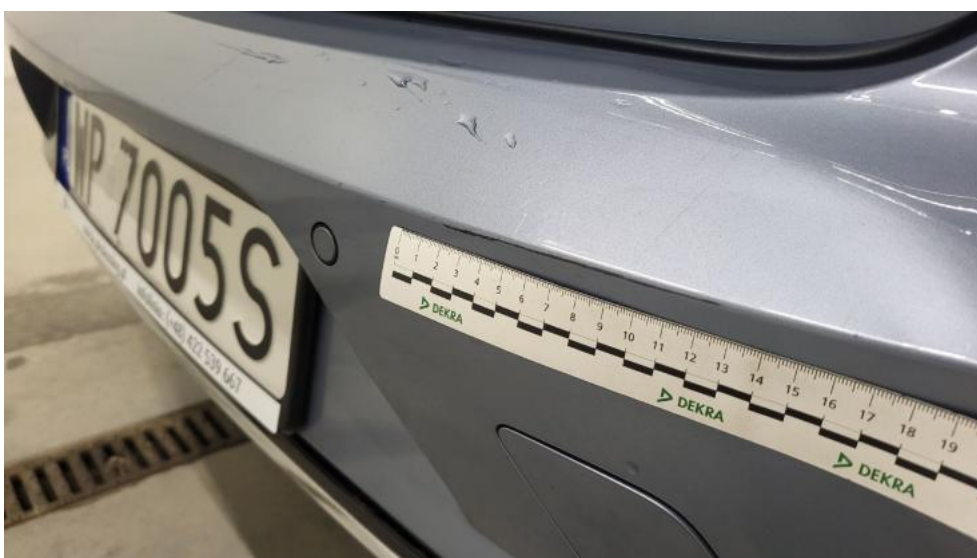
Photo 64.
Zderzak tylny - Rysa/odprysk 1

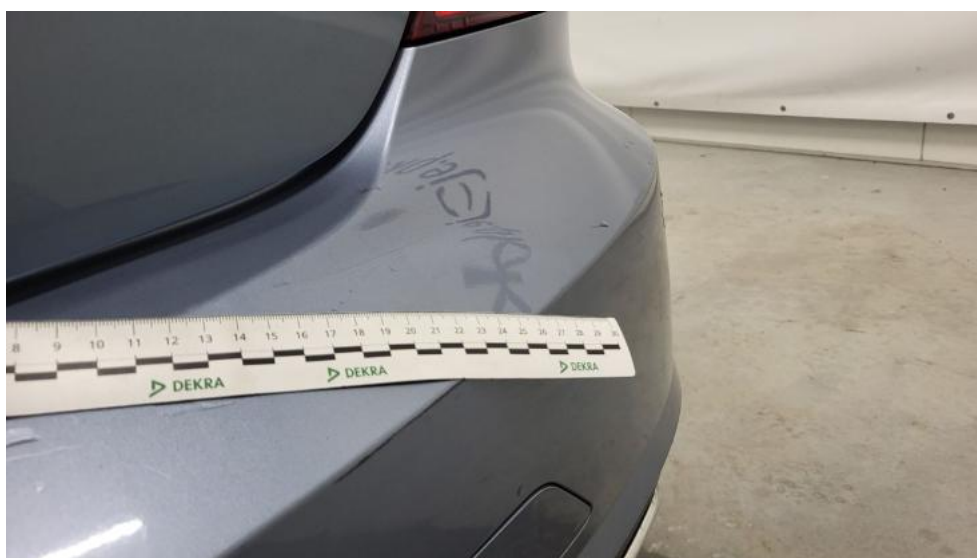
Photo 68.
Zderzak tylny() - Wgniecenie/odkształcenie 3

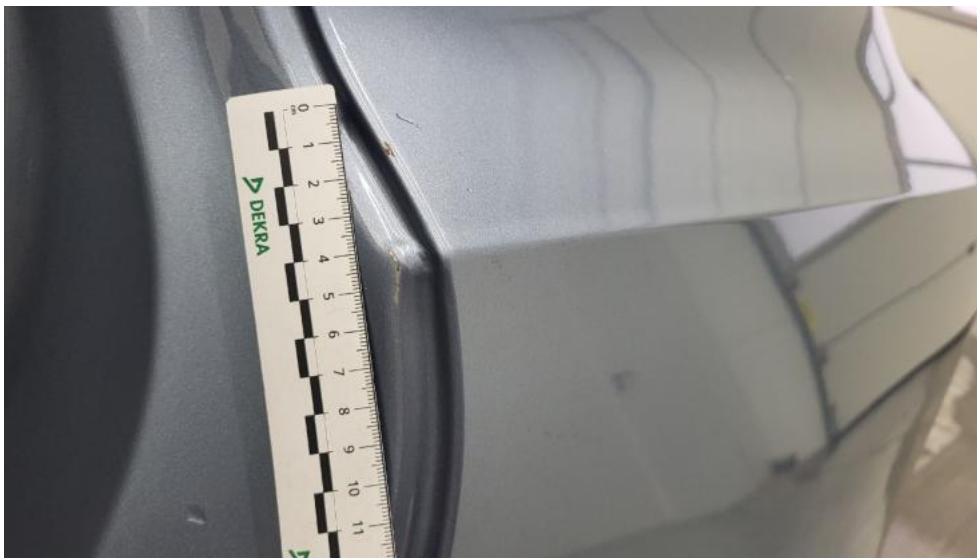
Photo 71.

Błotnik tylny L / Ściana boczna L - Rysa/odprysk 2

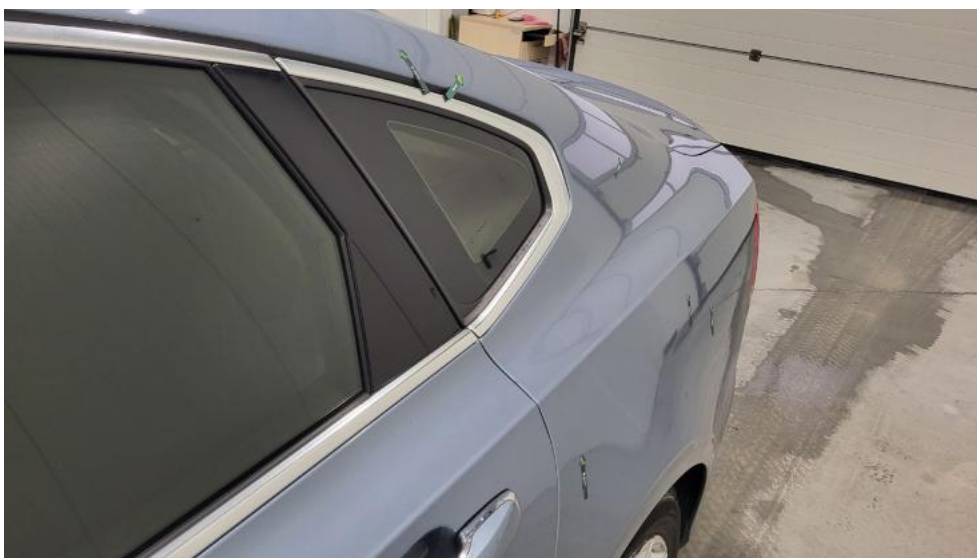
Photo 72.

Błotnik tylny L / Ściana boczna L - Wgniecenie/odkształcenie 1

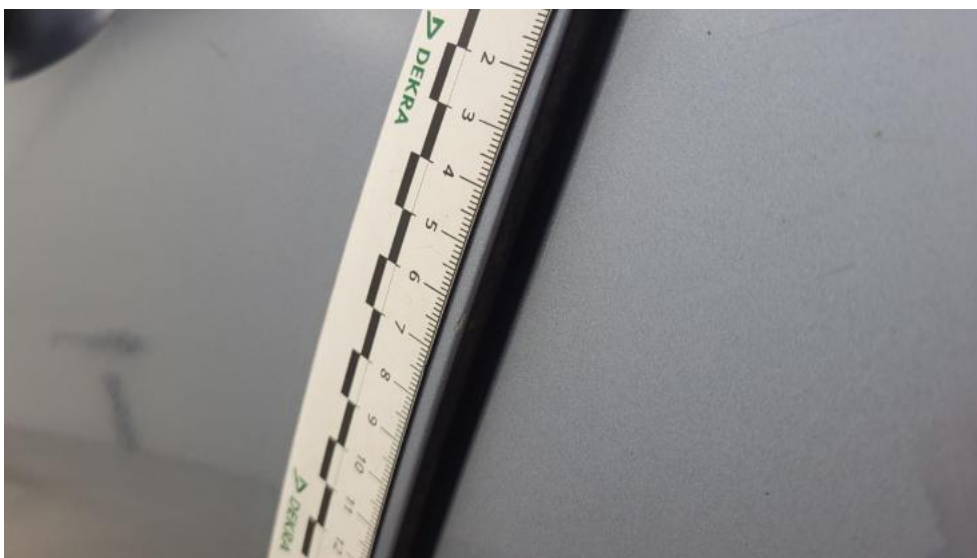
Photo 76.
Drzwi tylne L - Rysa/odprysk 1

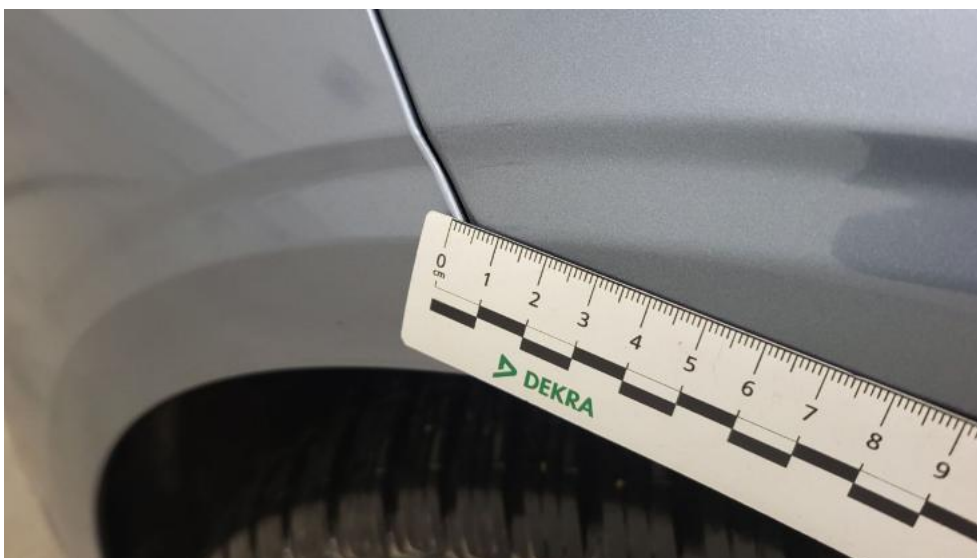
Photo 80.
Błotnik przedni L - Rysa/odprysk 1

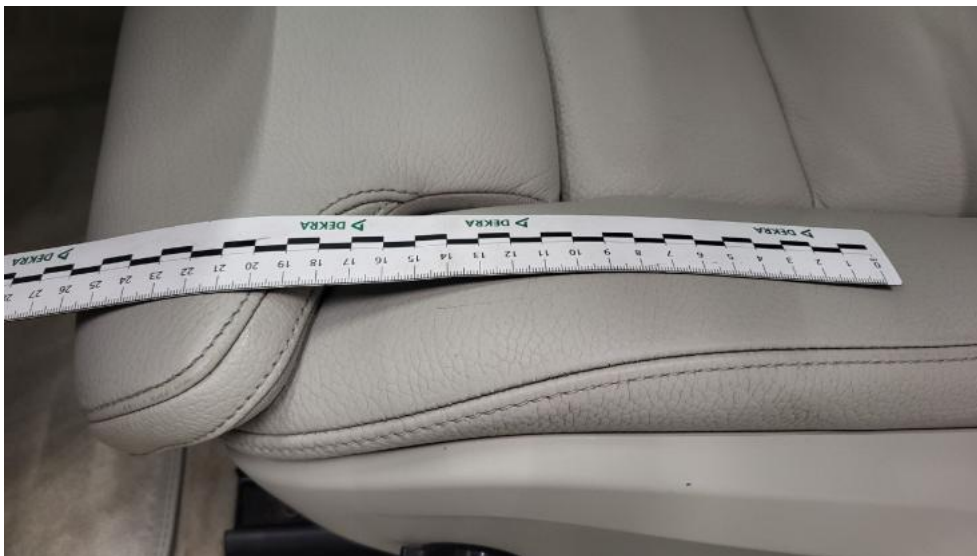
Photo 85.

Fotel prz. lew. - Rysa/odprysk 1

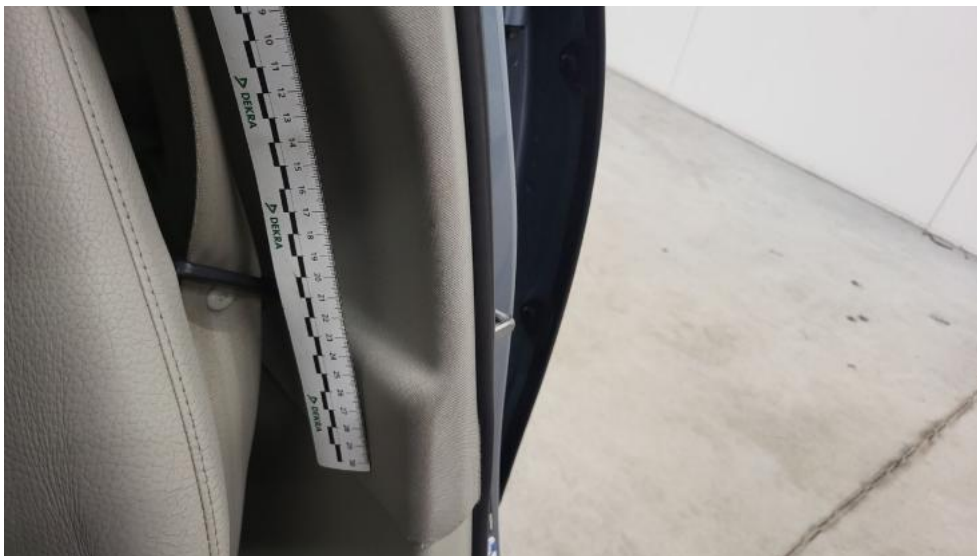
Photo 91.
Wykładzina(y) słupka środkowego L - Inne 1
