DEKRA's commission No. : PKOL(W)/LODZ/07751/26/01/29
 commission/ damage No. : 20/049005
 Date of commission: 29-01-2026

PKO Leasing SA
 Świętokrzyska 36
 00-116 Warszawa

Group of objects (Eurotax)	jeeps
EC code (Eurotax)	0128373
Manufacturer	PORSCHE
Model	Cayenne III 17-23
Type / version	Cayenne Turbo
Body type	KOM
Number of doors / seats	5/5
Curb weight [kg]	2355
Gross vehicle weight [kg]	2935
Wheelbase 1/2	2895
Engine type	spark ignition
Pollution reduction system	three-way catalytic converter
Engine capacity [ccm]	3996
Engine Power [hp/kW]	550/404
Gearbox	automatic 8- gear
Registration /record No.	WU7629L
VIN / serial number	WP1ZZZ9YZMDA37059
Date of first registration	25-01-2021
Date of next. tech. test	19-01-2027
Year of manufacture	2020 (year has been verified with the manufacturer's base)
Readout [km]	65 449 (read)
Body color / type of coating	red/METALIK

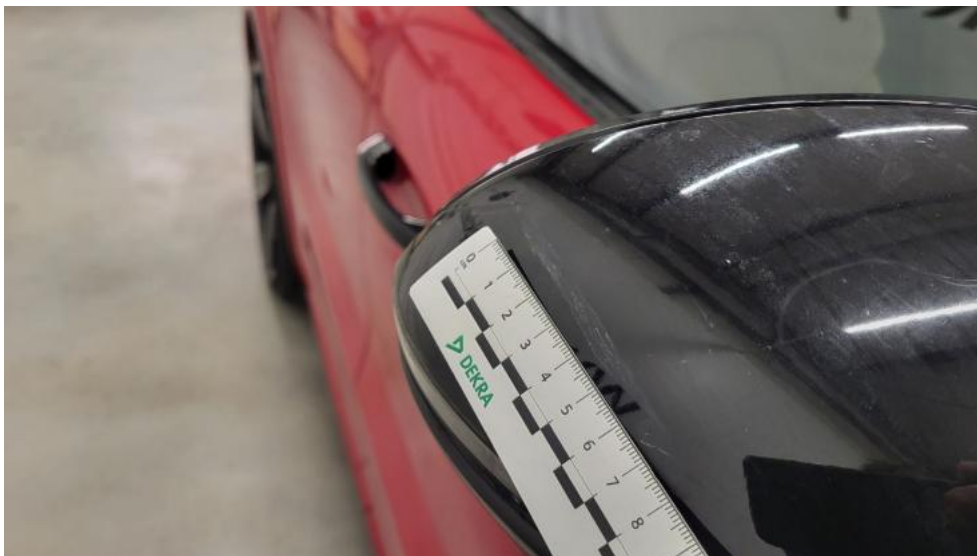
Photo 55.

Lusterko zew P - Rysa/odprysk 1
