DEKRA's commission No. : PKOL(W)/LODZ/81909/26/09/01  
commission/ damage No. : 24/028962  
Date of commission: 01-09-2026

| Manufacturer | MERCEDES-BENZ |
| Model | V Klasa 14-19 |
| VIN / serial number | WDF44781313295887 |

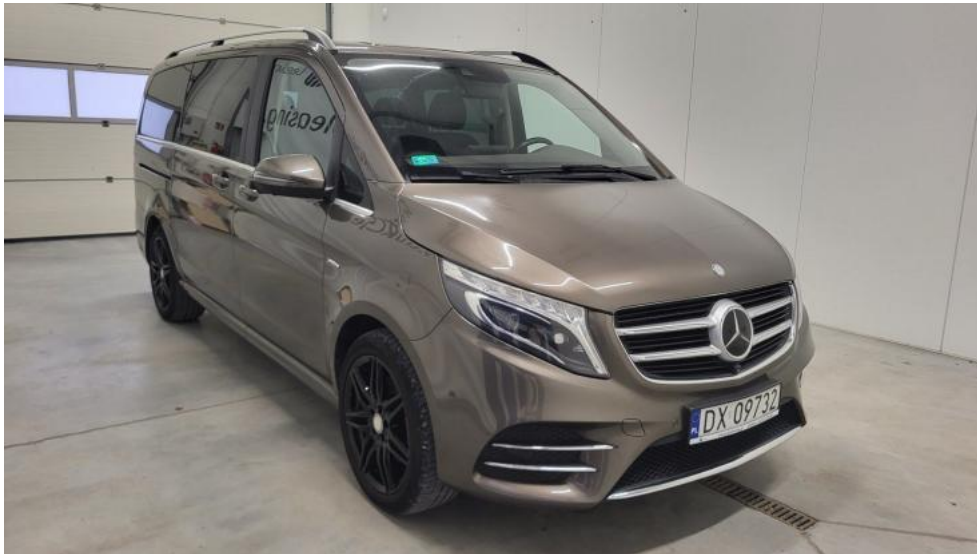
**Photo 3.**

Przekątna przednia prawa

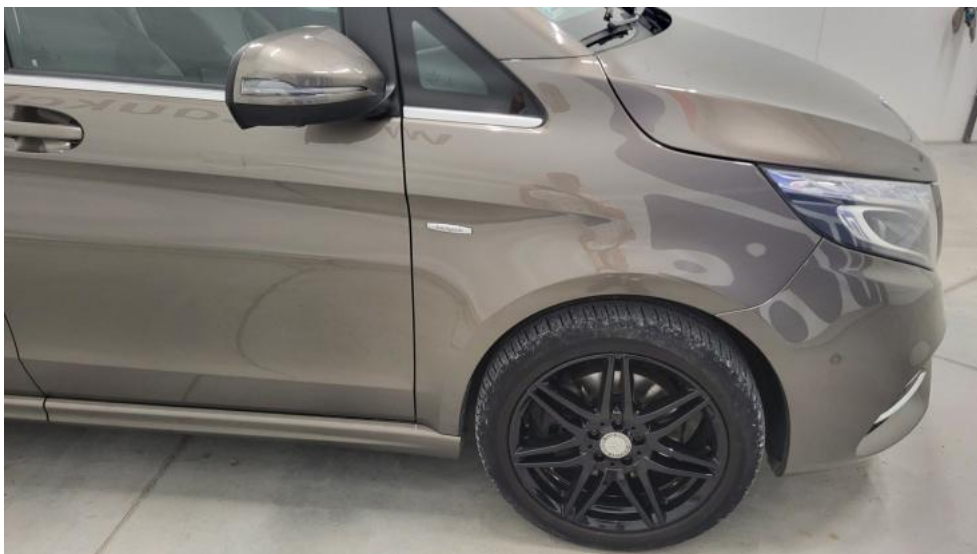
**Photo 4.**

Bok prawy z przodu

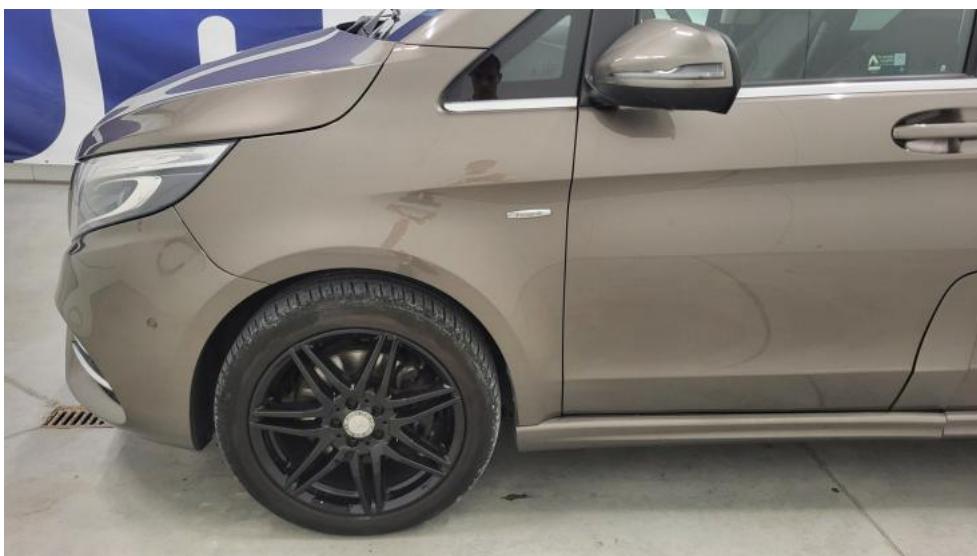
**Photo 10.**

Bok lewy z przodu

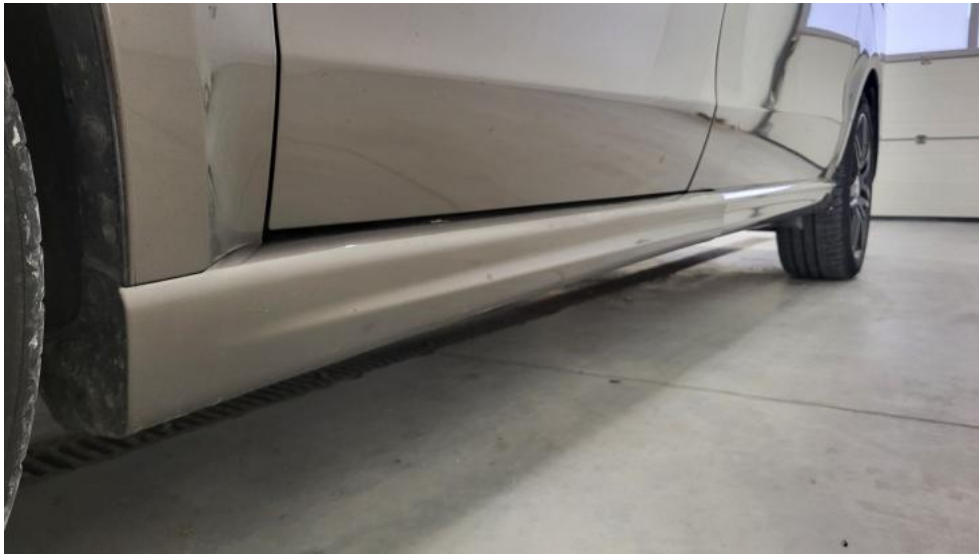
**Photo 11.**

Próg lewy (widok od przodu)

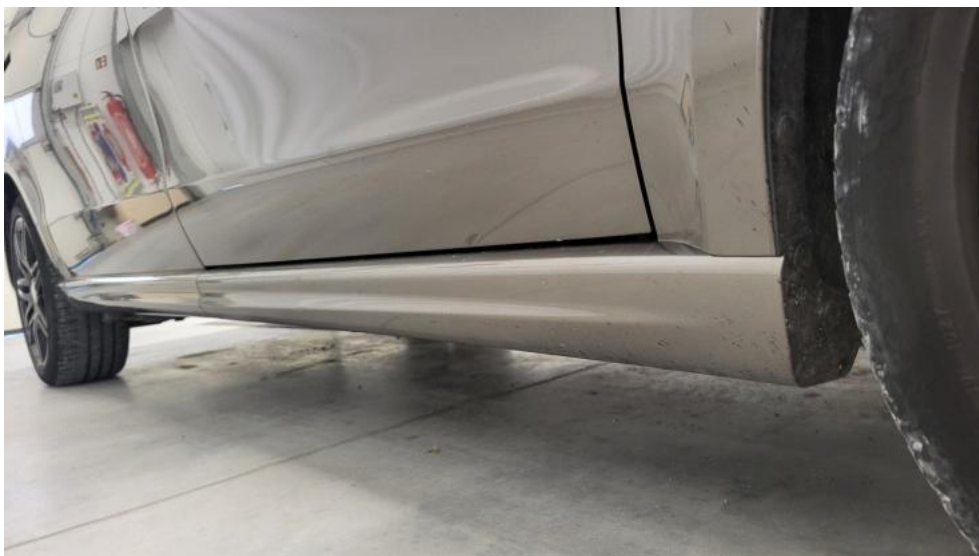
**Photo 12.**

Próg prawy (widok od przodu)

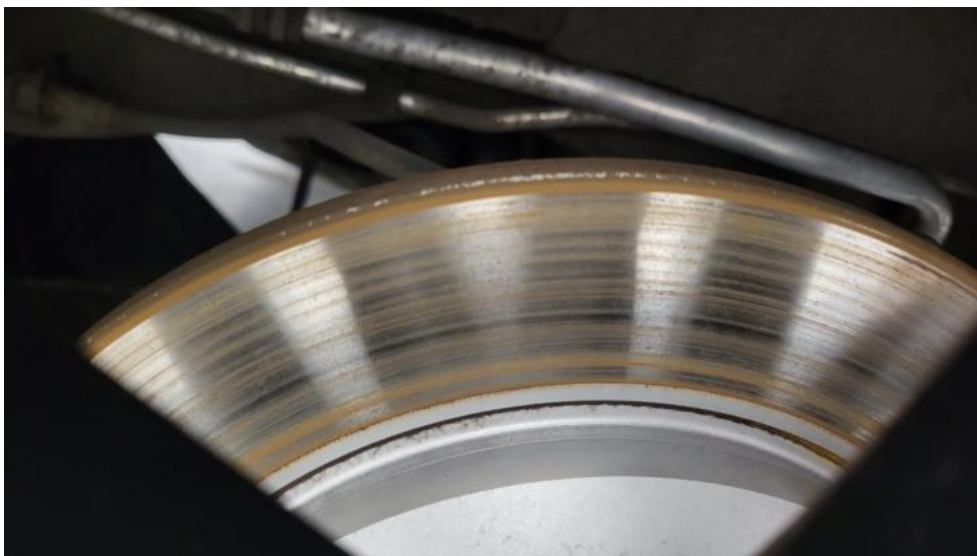
**Photo 17.**

Tarcza hamulcowa tylna lewa

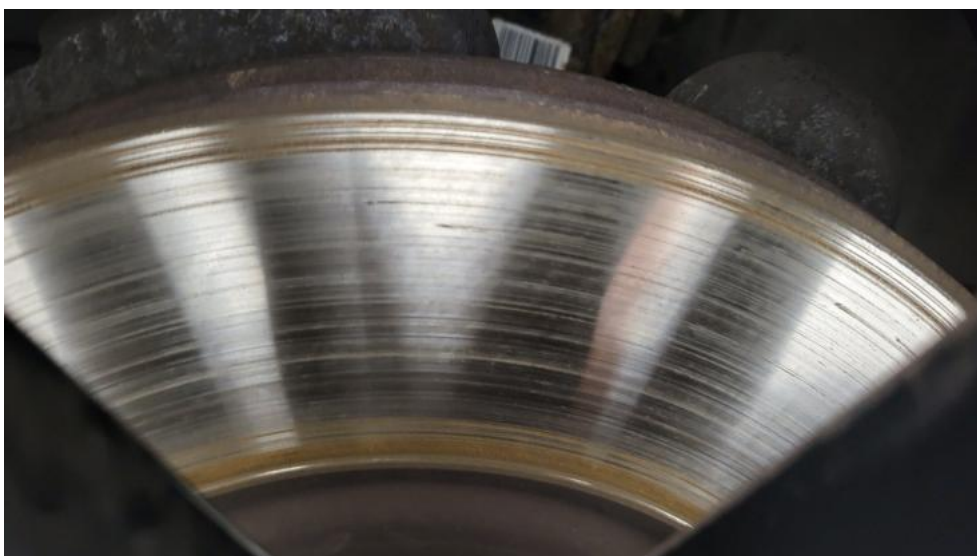
**Photo 18.**

Tarcza hamulcowa przednia lewa

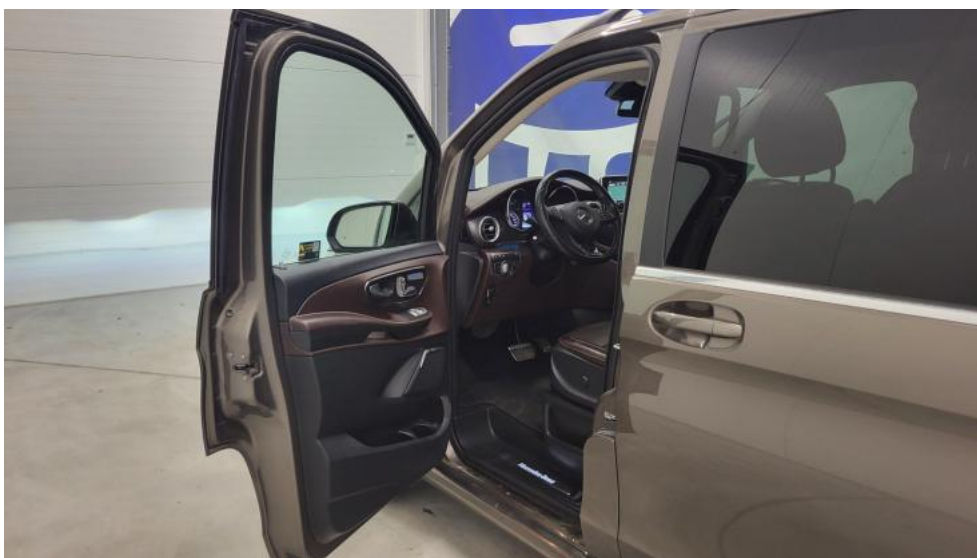
**Photo 26.**

Widok przez otwarte drzwi przednie lewe

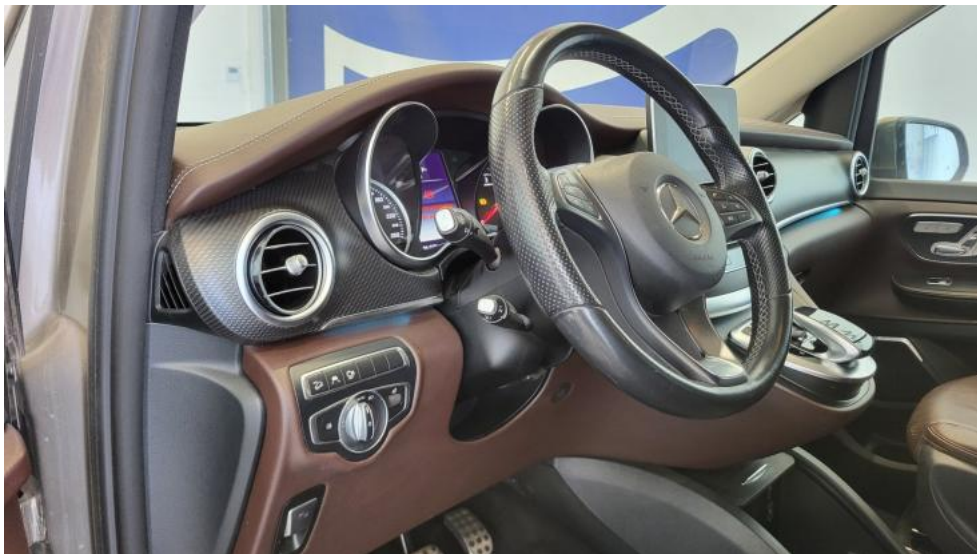
**Photo 27.**

Kierownica z lewej strony

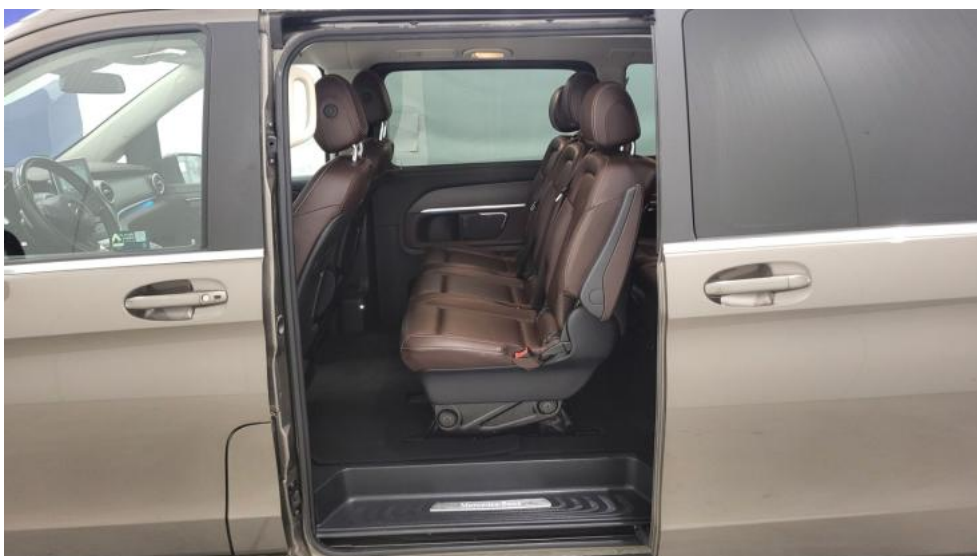
**Photo 28.**

Widok przez otwarte drzwi tylne lewe

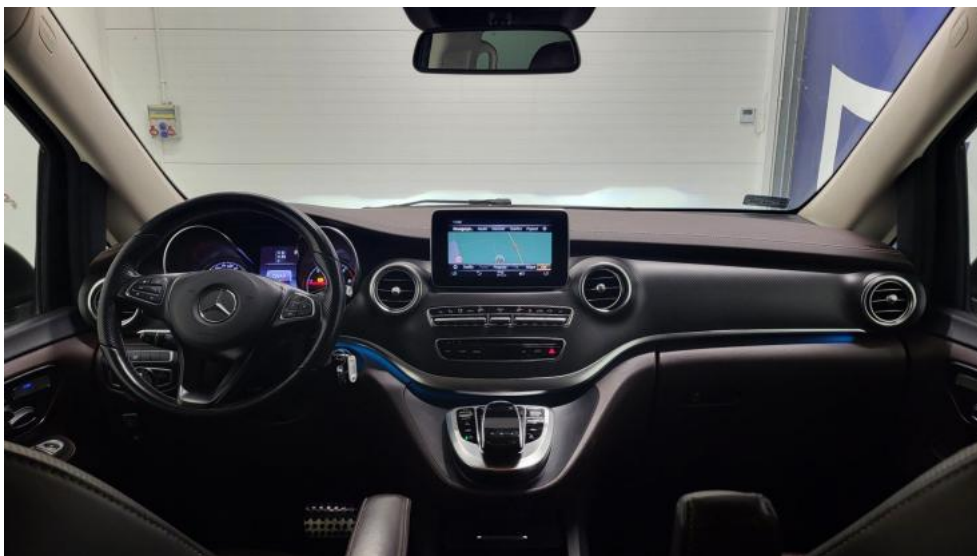
**Photo 29.**

Widok z tylnej kanapy na deskę rozd.

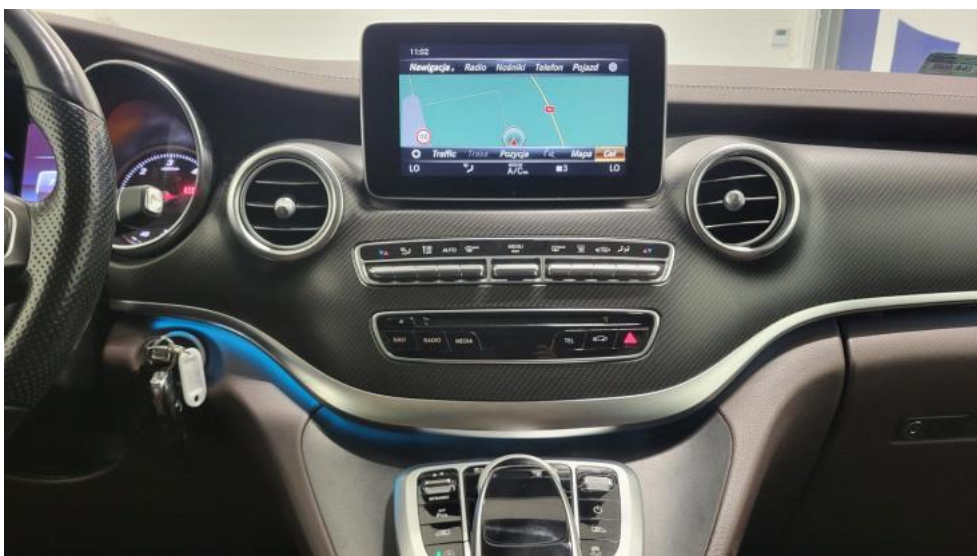
**Photo 30.**

Konsola środkowa

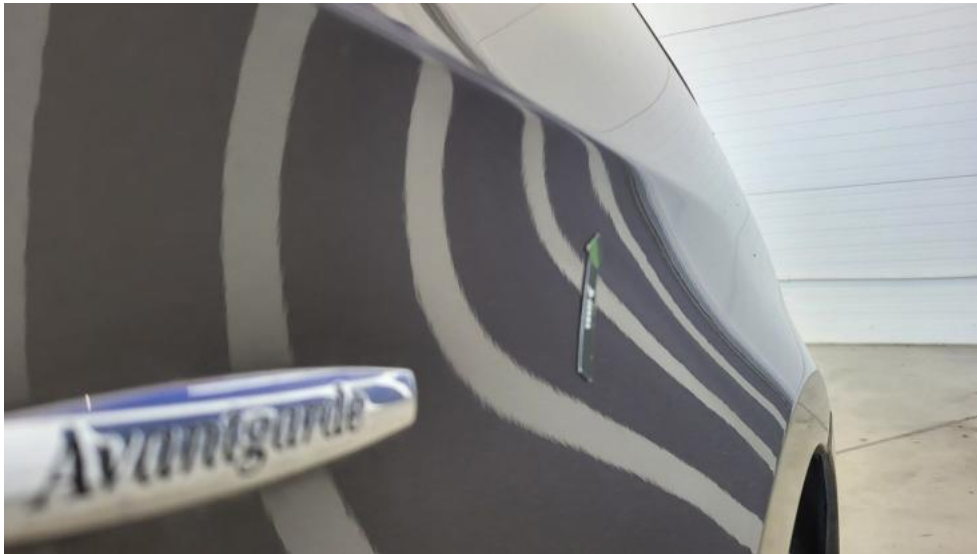
**Photo 49.**

Błotnik przedni P - Wgniecenie/odkształcenie 1

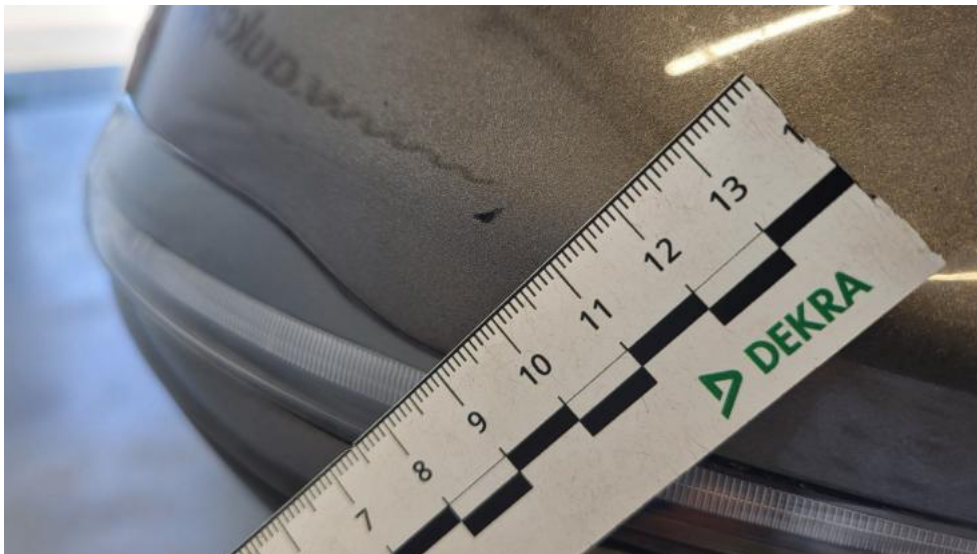
**Photo 59.**

Lusterko zew P - Rysa/odprysk 1

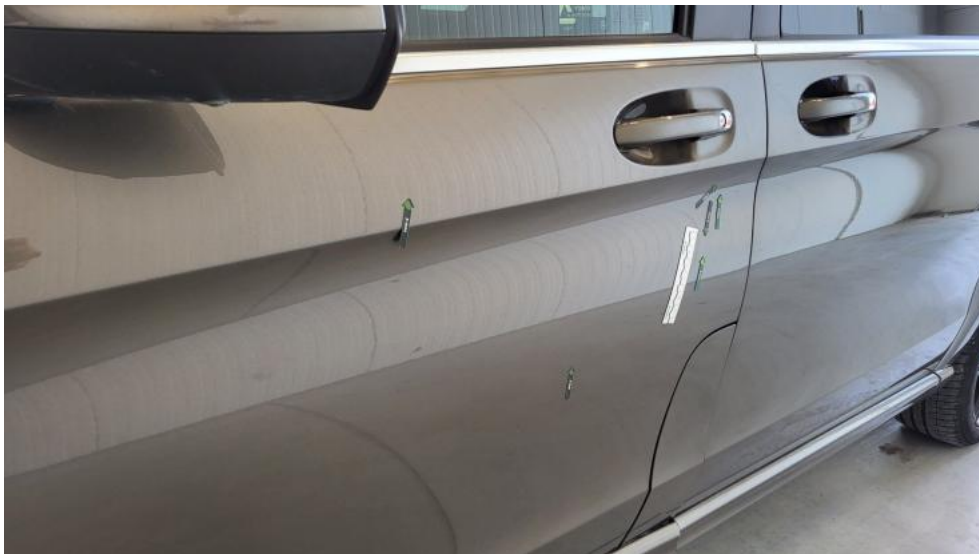
**Photo 63.**

Drzwi przed L - zdjęcie poglądowe 1
