DEKRA's commission No. : PKOL(W)/LODZ/70073/26/07/28  
commission/ damage No. : PS24/00708  
Date of commission: 28-07-2026

| Manufacturer | VOLKSWAGEN |
| Type / version | Multivan 6.1 2.0 TDI L1 Highline 4Motion DSG |
| Registration /record No. | CB081RG |

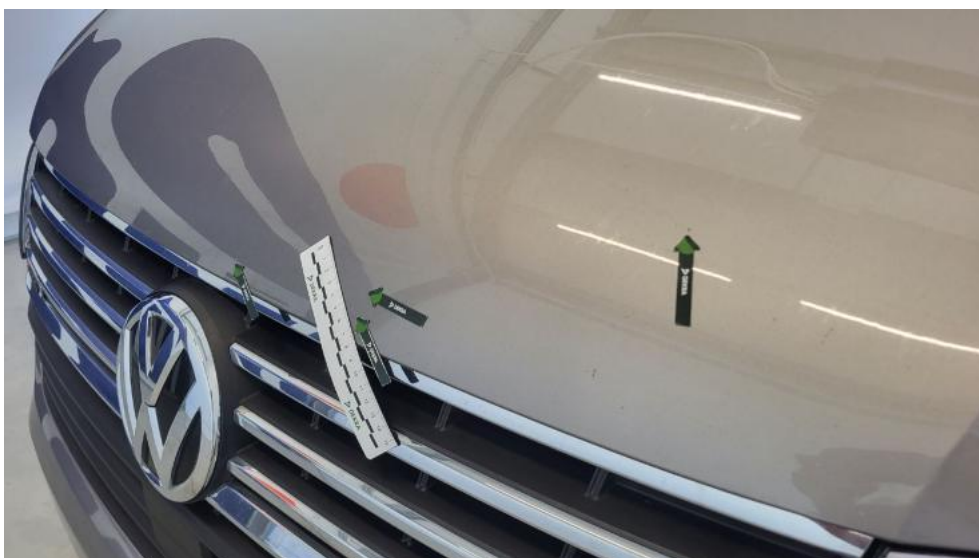
**Photo 45.**

Listwa śr zderzaka przedniego - Inne 1

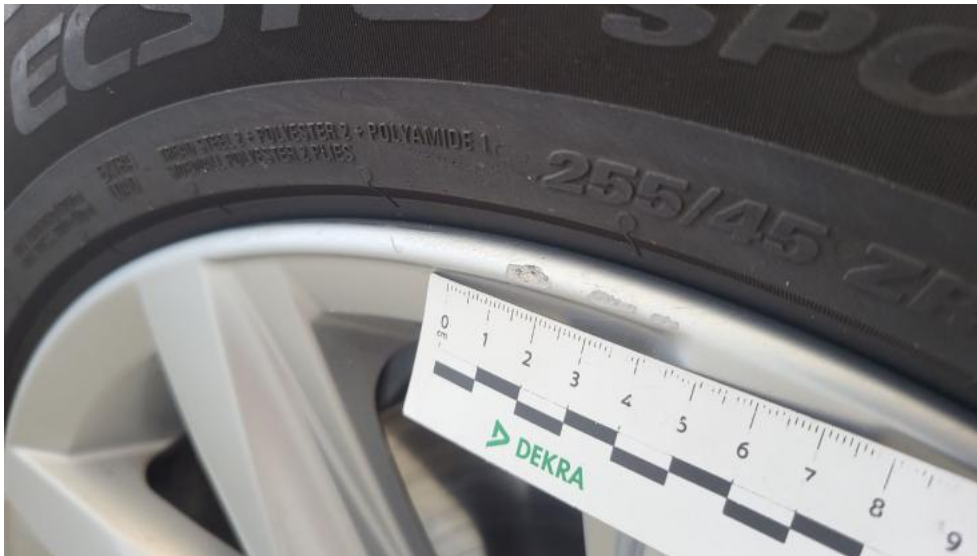
**Photo 50.**

Błotnik przedni P - Inne 1

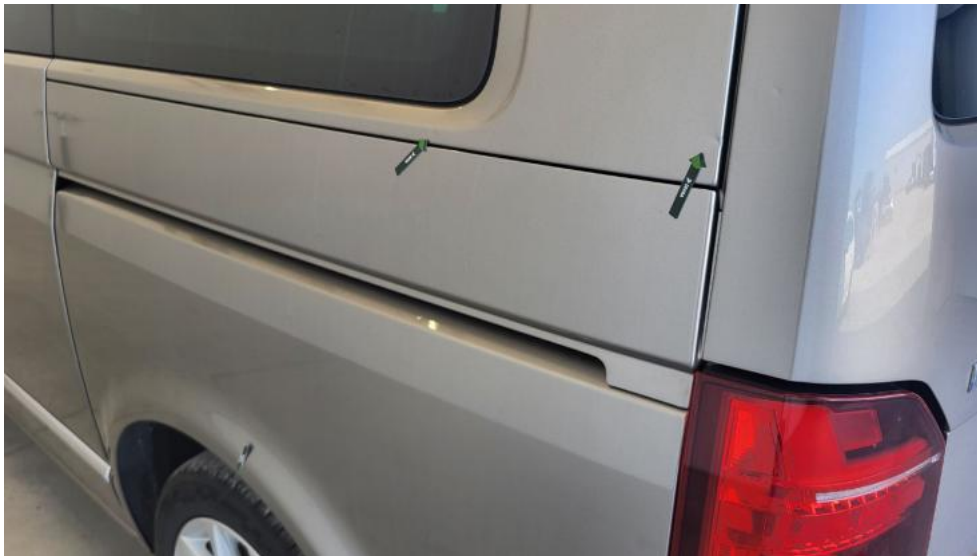
**Photo 66.**

Błotnik tylny L / Ściana boczna L - zdjęcie pogładowe 1
