DEKRA's commission No. : PKOL(W)/LODZ/89088/26/09/22  
commission/ damage No. : 21/050722  
Date of commission: 22-09-2026

**DEKRA Poland - Headquarters**  
02-673 Warszawa, ul. Konstruktorska 12A

| Model | Insignia B Grand Sport 20-22 |
| Type / version | Insignia 2.0 CDTI GS Line S&S aut |

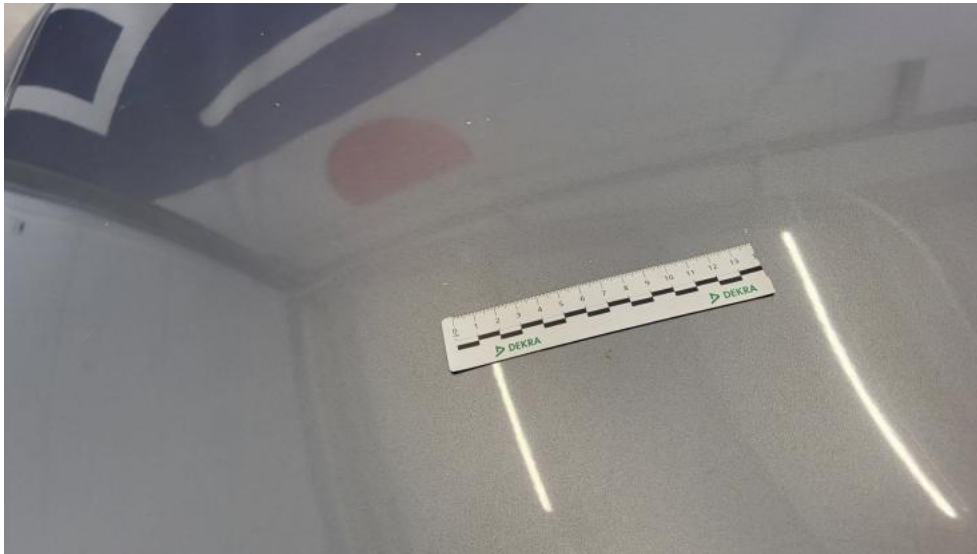
**Photo 39.**

Pokrywa komory silnika - Rysa/odprysk 1

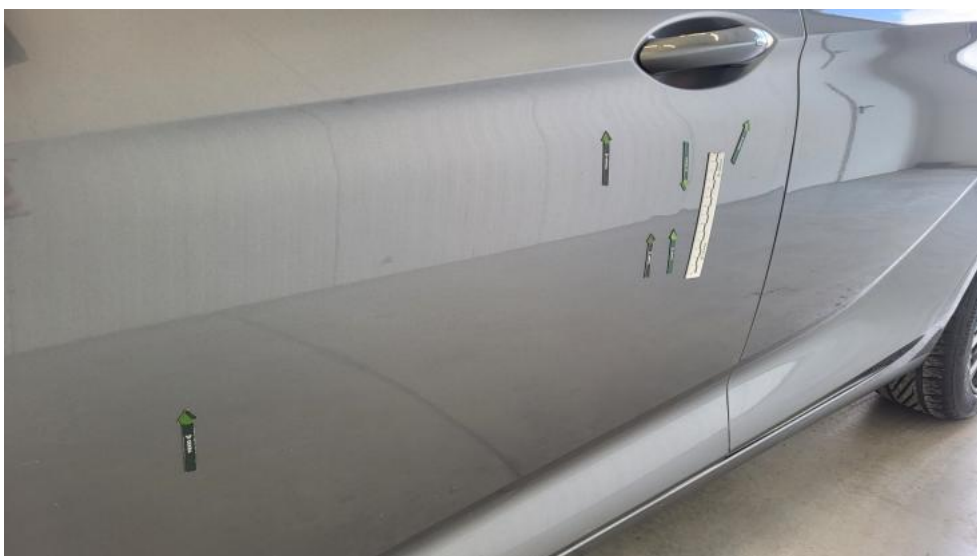
**Photo 62.**

Drzwi przed L - zdjęcie poglądowe 1

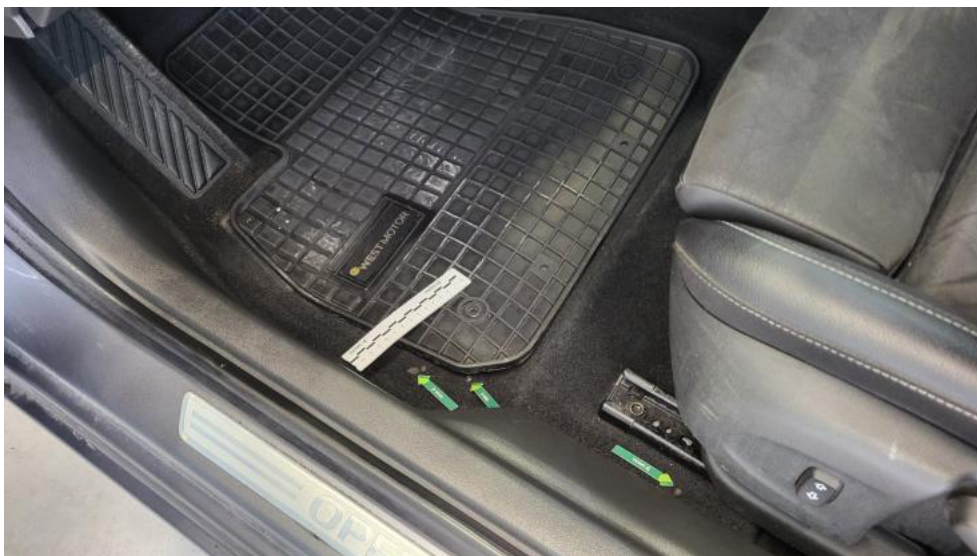
**Photo 73.**

Wykładzina podłogi - zdjęcie poglądowe 1
