DEKRA's commission No. : PKOL(W)/LODZ/71043/26/07/30  
commission/ damage No. : 22/036206  
Date of commission: 30-07-2026

| Manufacturer | MAZDA |
| Model | MX-30 EV 20- |
| Registration /record No. | KR7XY36 |

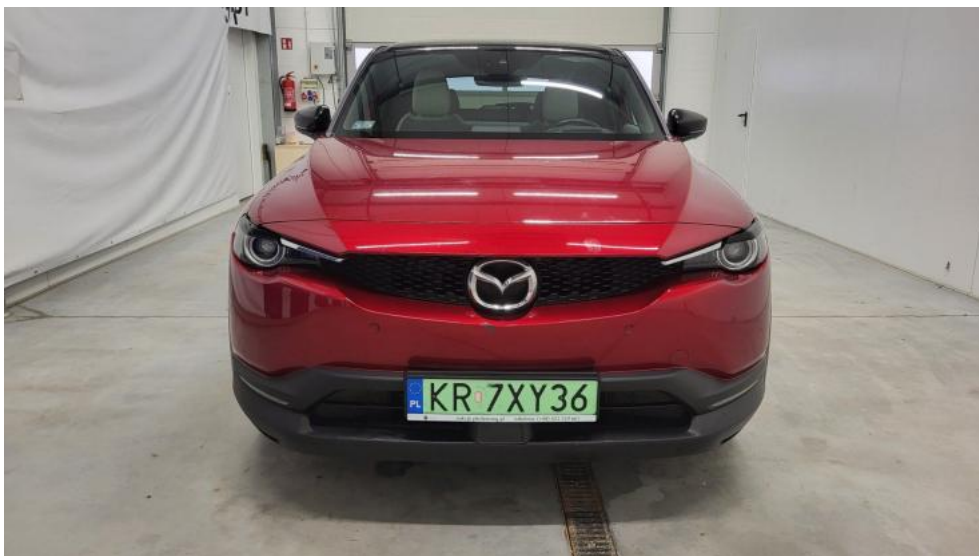
**Photo 2.**  
Przód

Zderzak - Rysa/odprysk 2

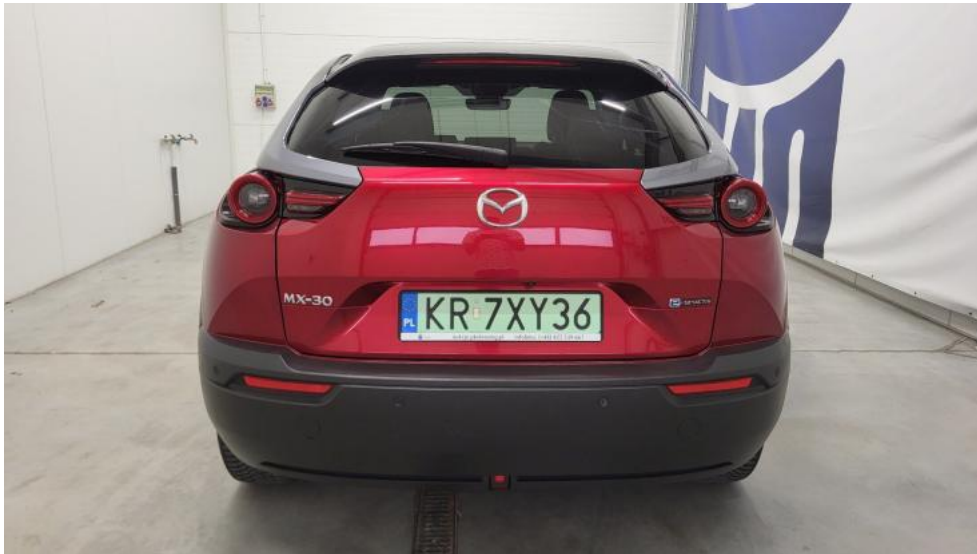
**Photo 7.**

Tył

Zderzak tylny - Rysa/odprysk 2

Zderzak tylny() - Rysa/odprysk 3

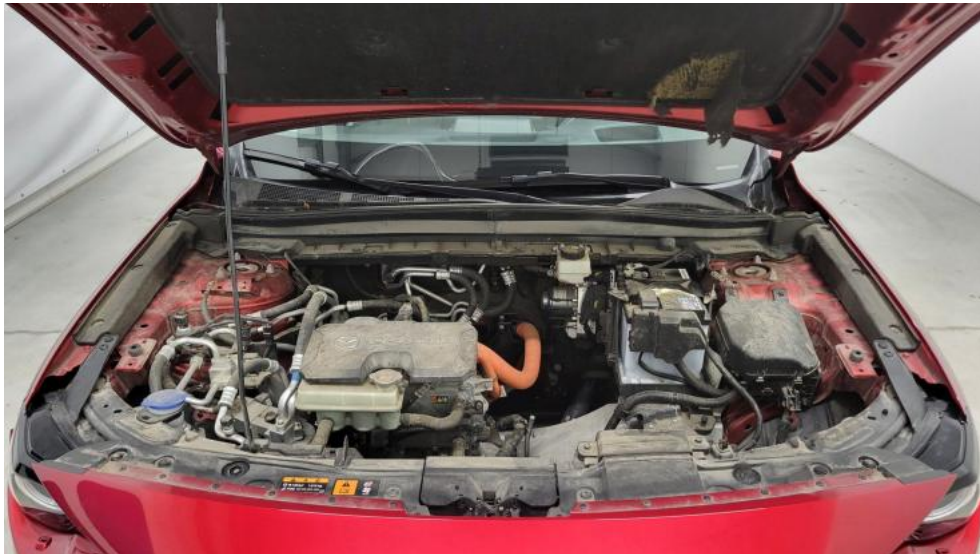
**Photo 21.**  
Komora silnika

Wykładzina pokrywy komory silnika - Pęknięcie/rozerwanie 1

Wykładzina pokrywy komory silnika - Pęknięcie/rozerwanie 2

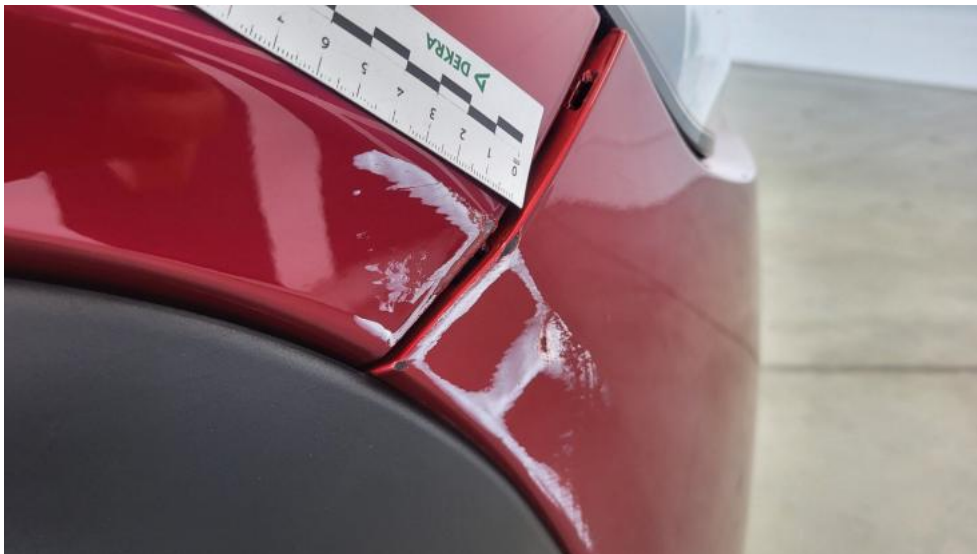
**Photo 55.**

Blotnik przedni P - Rysa/odprysk 1

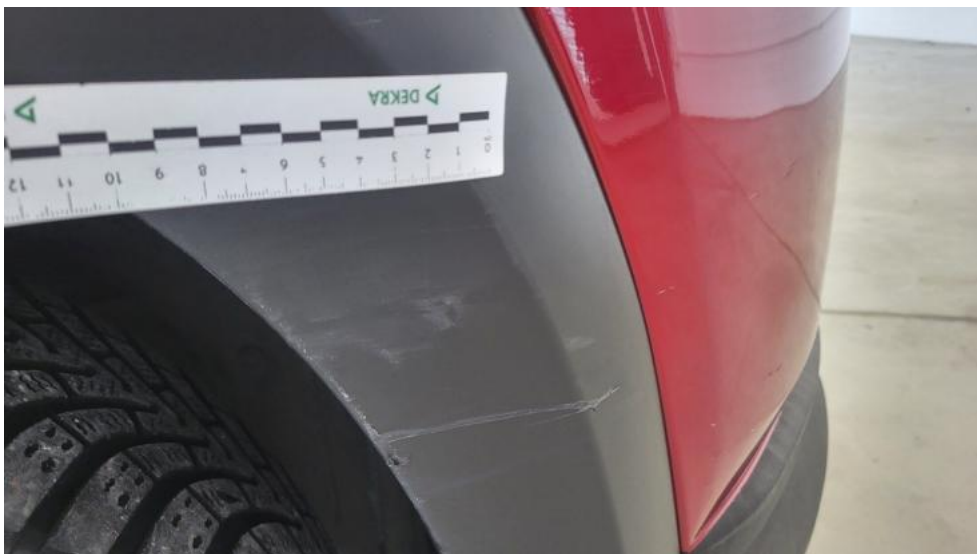
**Photo 57.**

Listwa krawędzi błotnika prz P - Rysa/odprysk 1

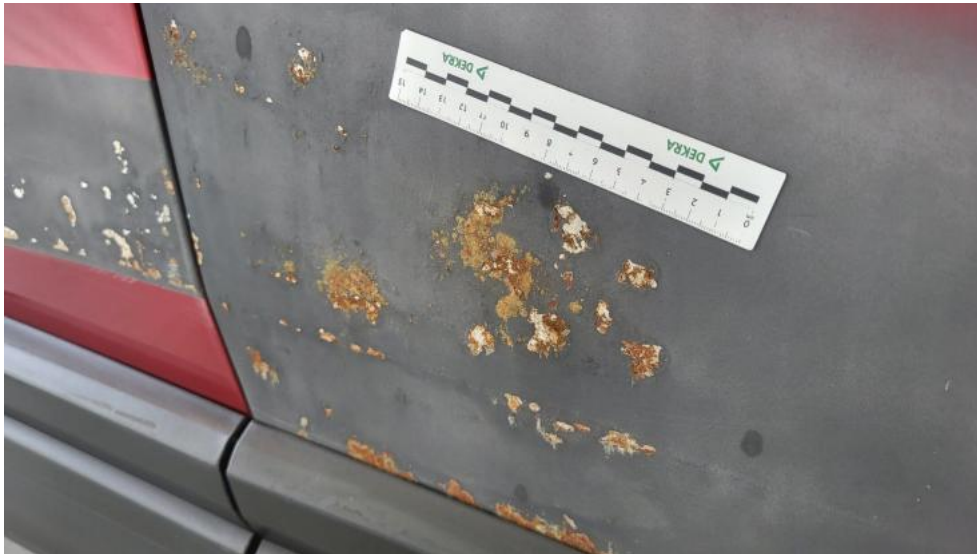
**Photo 61.**

Drzwi przednie P - Inne 2

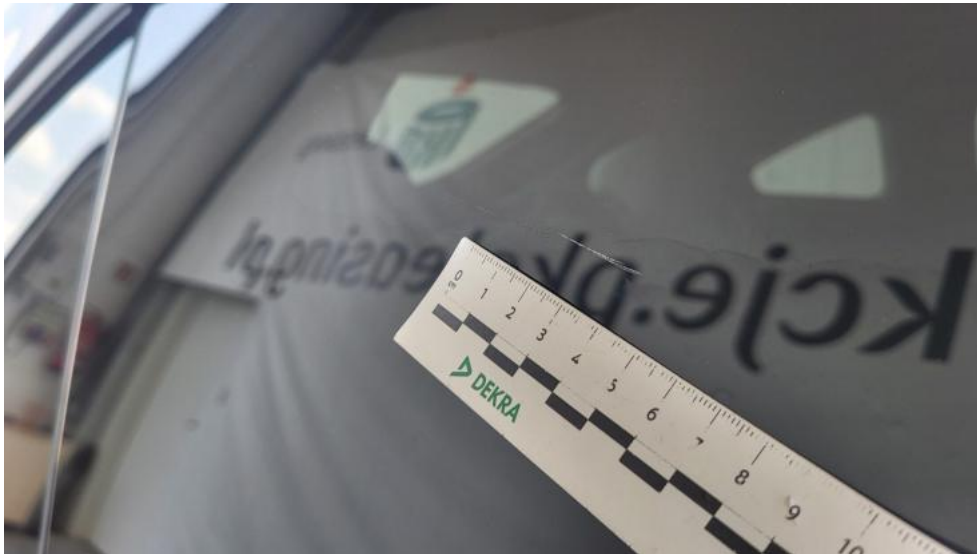
**Photo 69.**

Szyba boczna środkowa P - Rysa/odprysk 1

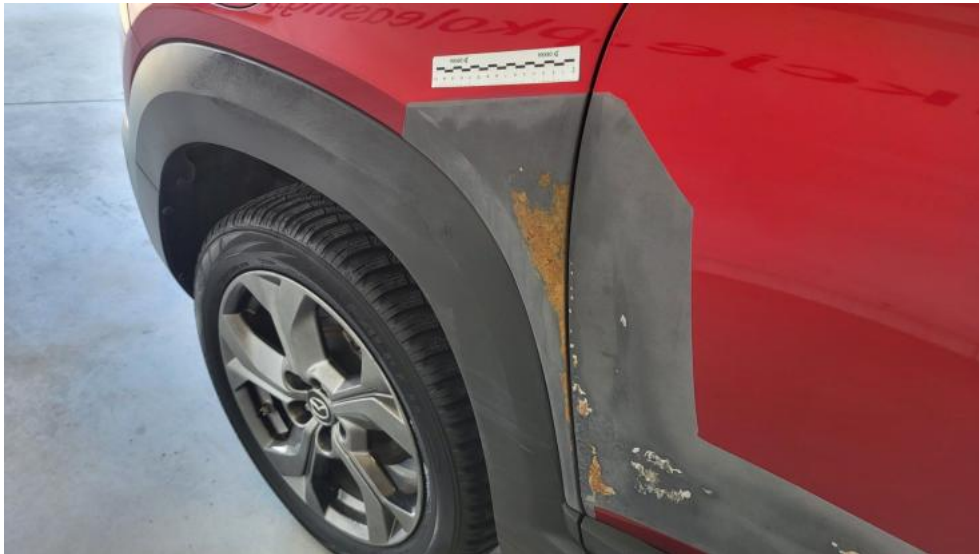
**Photo 71.**

Błotnik tylny P / Ściana boczna P - Inne 1

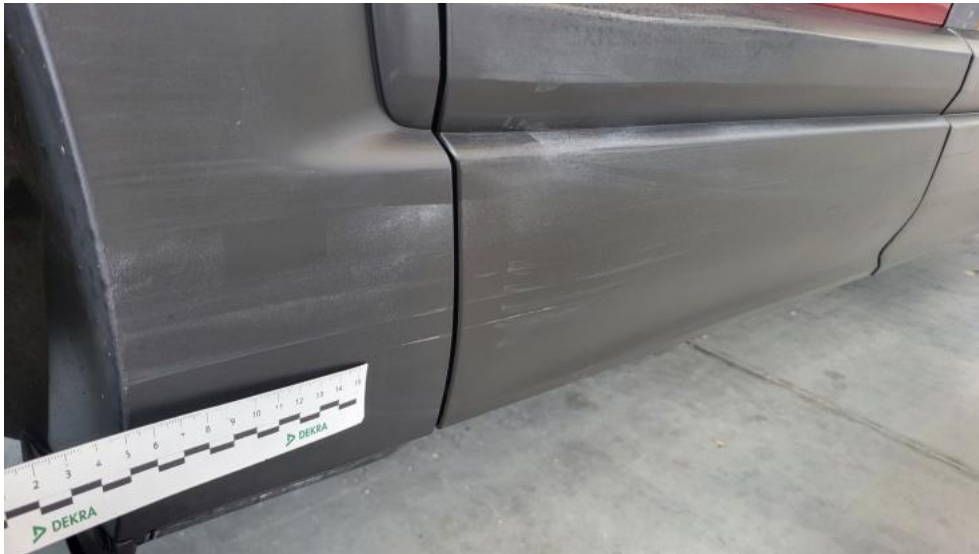
**Photo 73.**

Listwa krawędzi błotnika tyl P - Rysa/odprysk 1

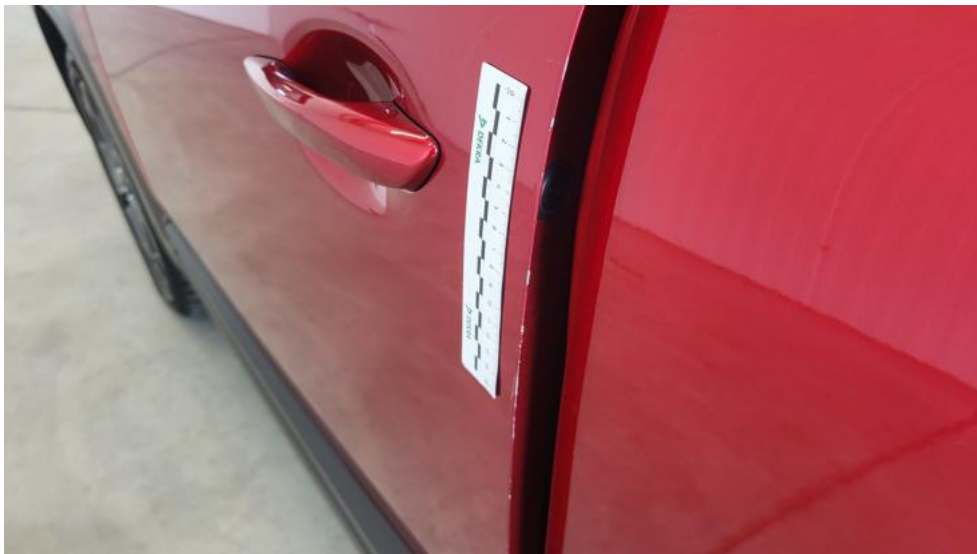
**Photo 83.**

Drzwi przed L - Rysa/odprysk 1

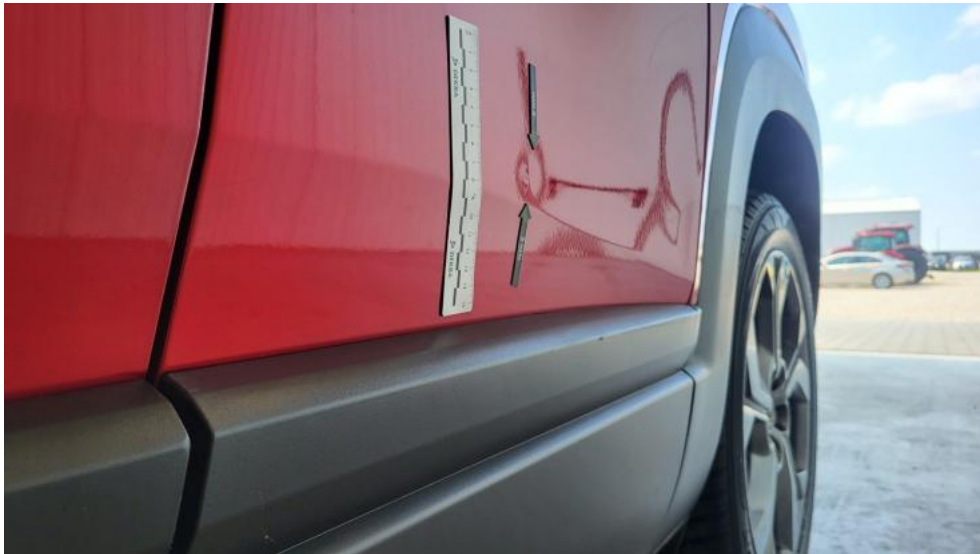
**Photo 85.**

Drzwi tylne L - Wgniecenie/odkształcenie 1

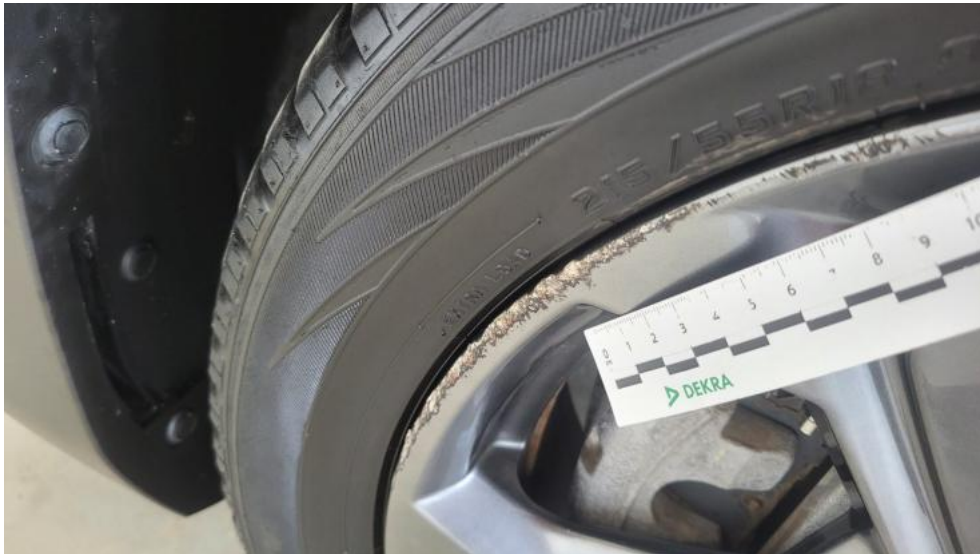
**Photo 89.**

Felga Aluminiowa przednia L - Rysa/odprysk 1
