DEKRA's commission No. : PKOL(W)/LODZ/67876/26/07/21  
commission/ damage No. : PS22/02298  
Date of commission: 21-07-2026

**DEKRA Poland - Headquarters**  
02-673 Warszawa, ul. Konstruktorska 12A

| Manufacturer | FORD |
| Model | Focus Kombi 18-21 |

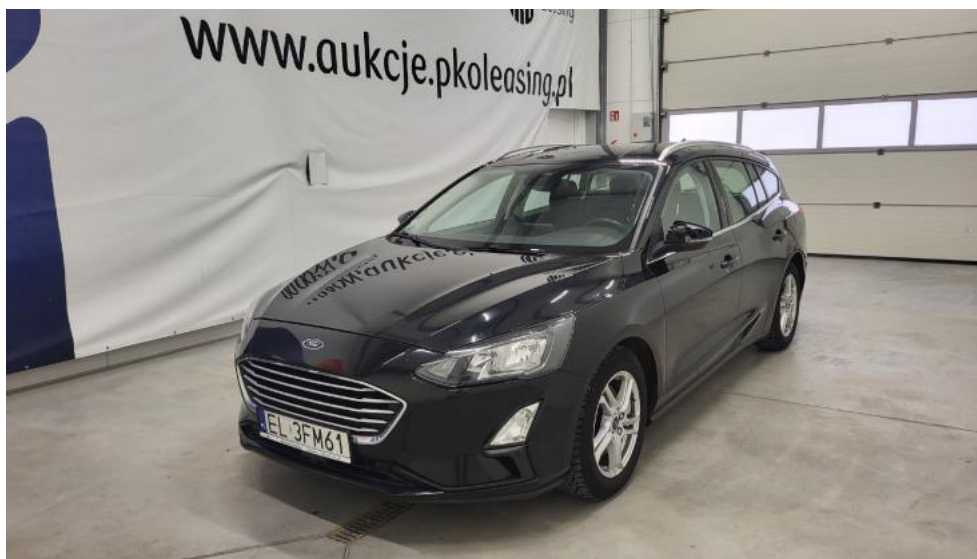
**Photo 1.**

Przekątna przednia lewa

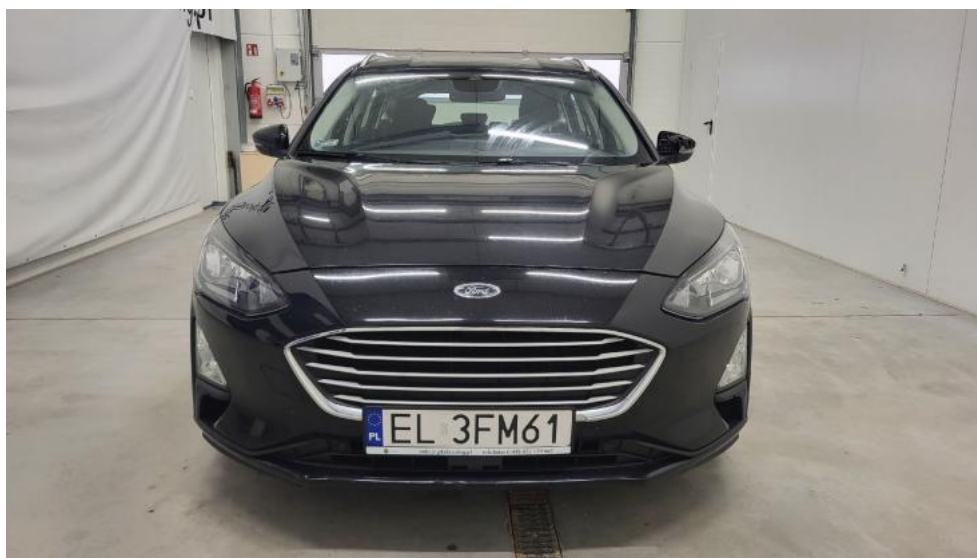
**Photo 2.**

Przód

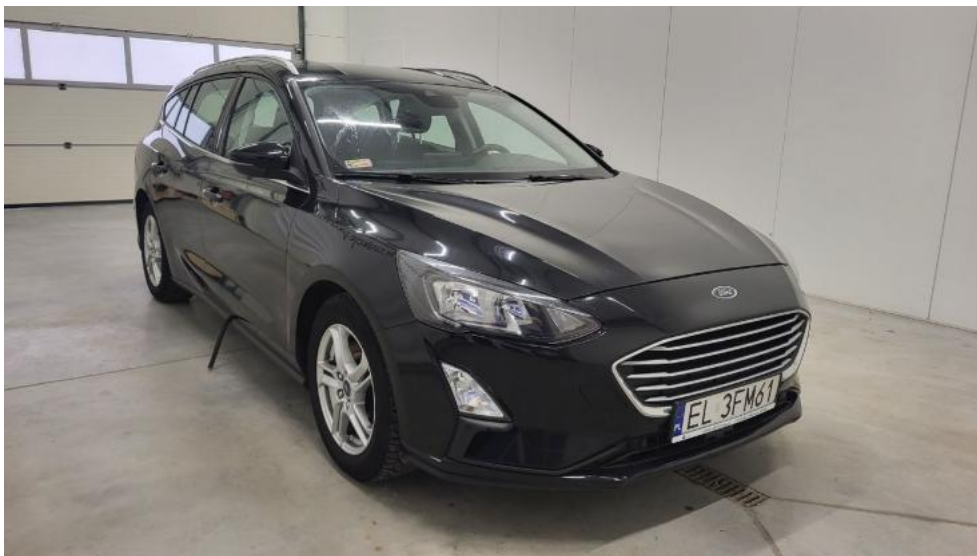
**Photo 3.**

Przekątna przednia prawa

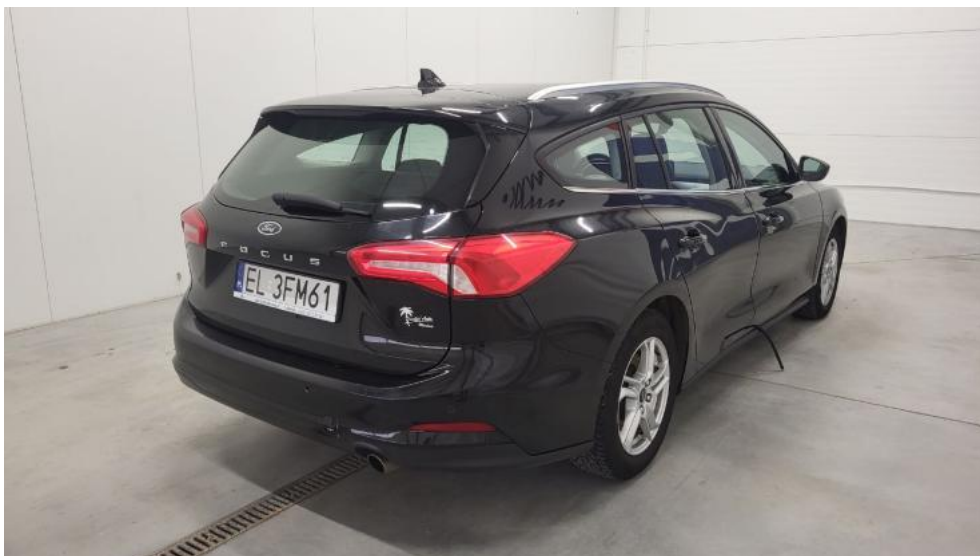
**Photo 6.**

Przekątna tylna prawa

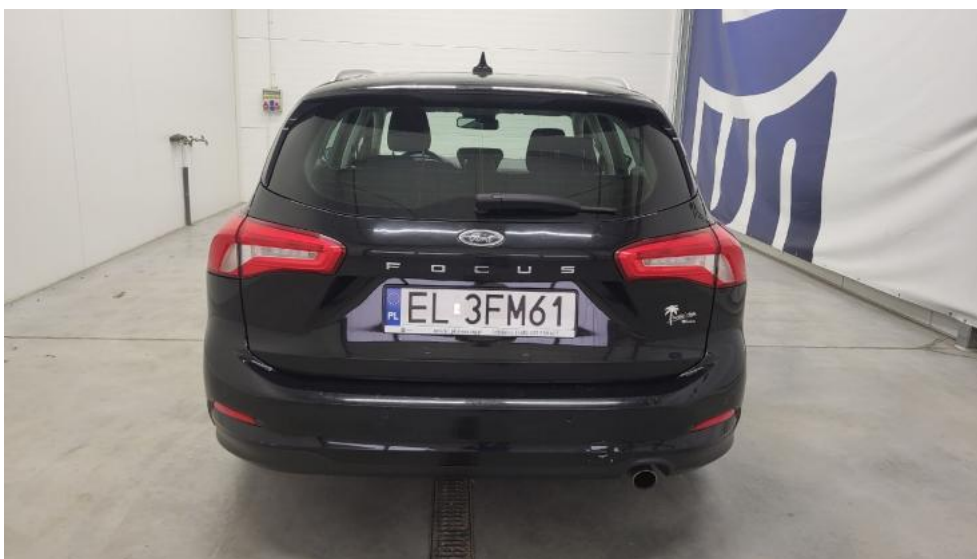
**Photo 7.**

Tył

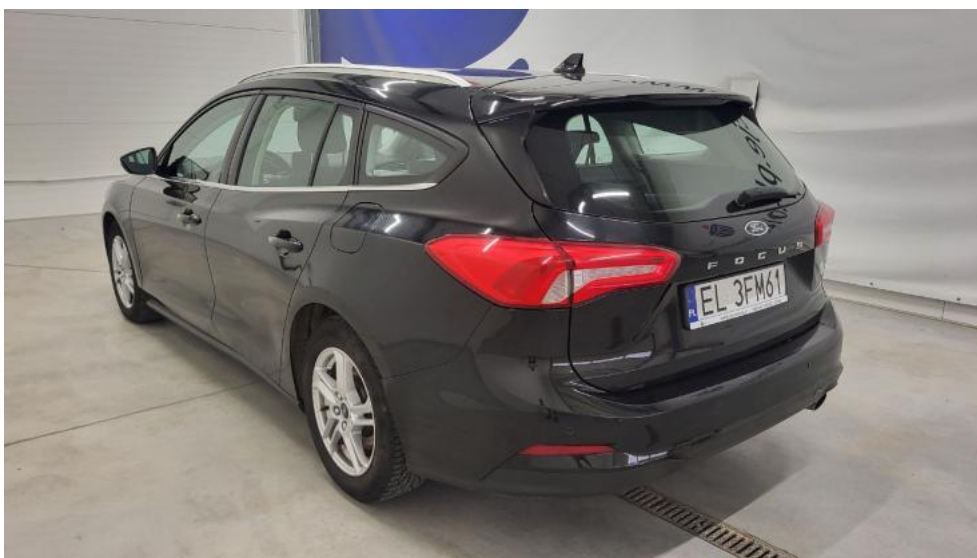
**Photo 8.**

Przekątna tylna lewa

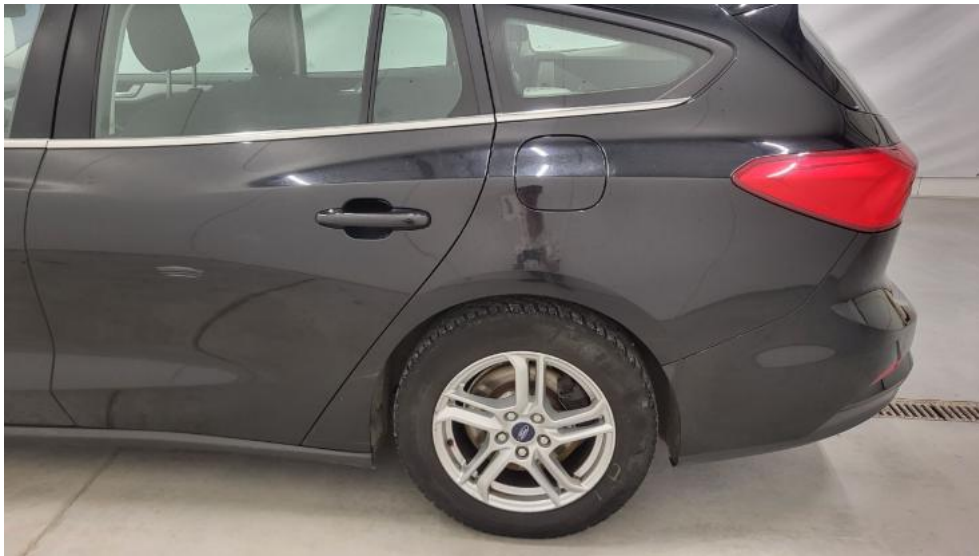
**Photo 9.**

Bok lewy z tyłu

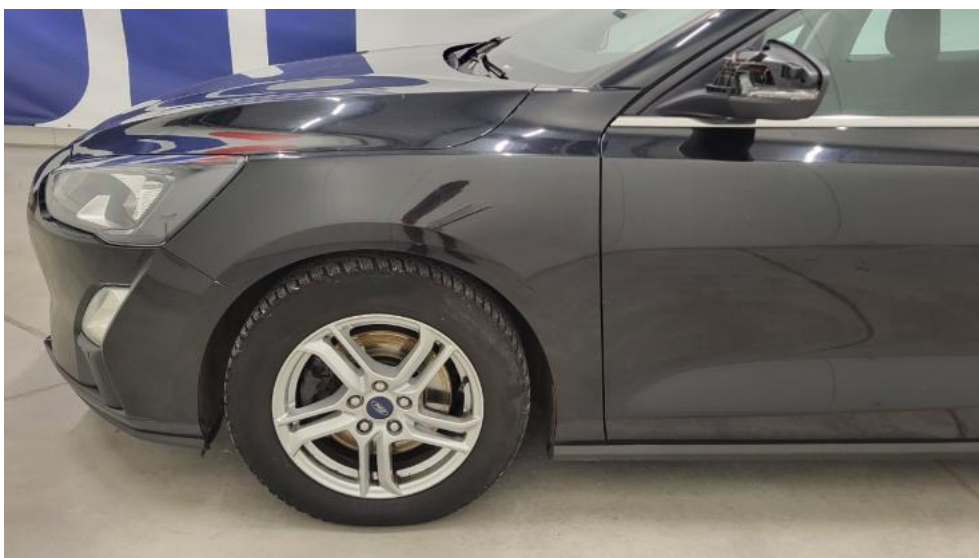
**Photo 10.**

Bok lewy z przodu

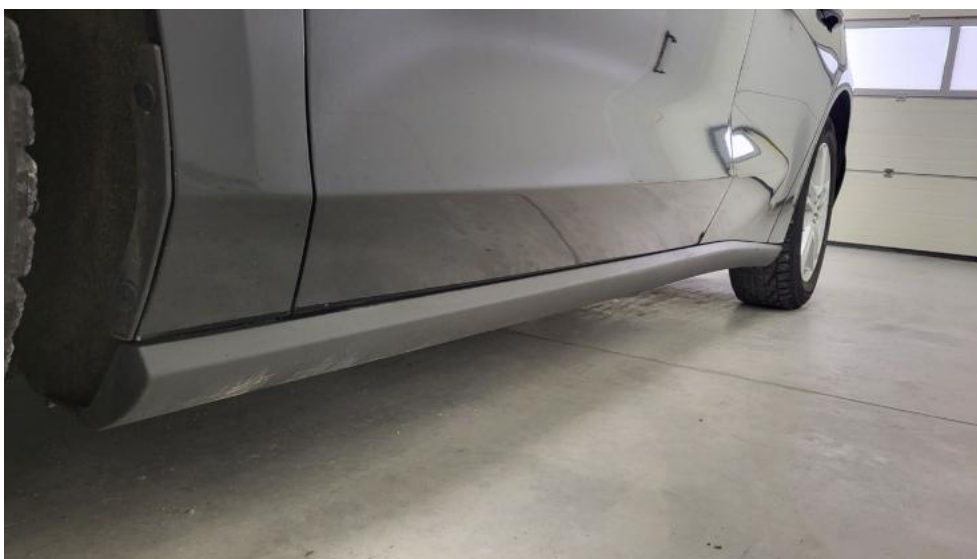
**Photo 11.**

Próg lewy (widok od przodu)

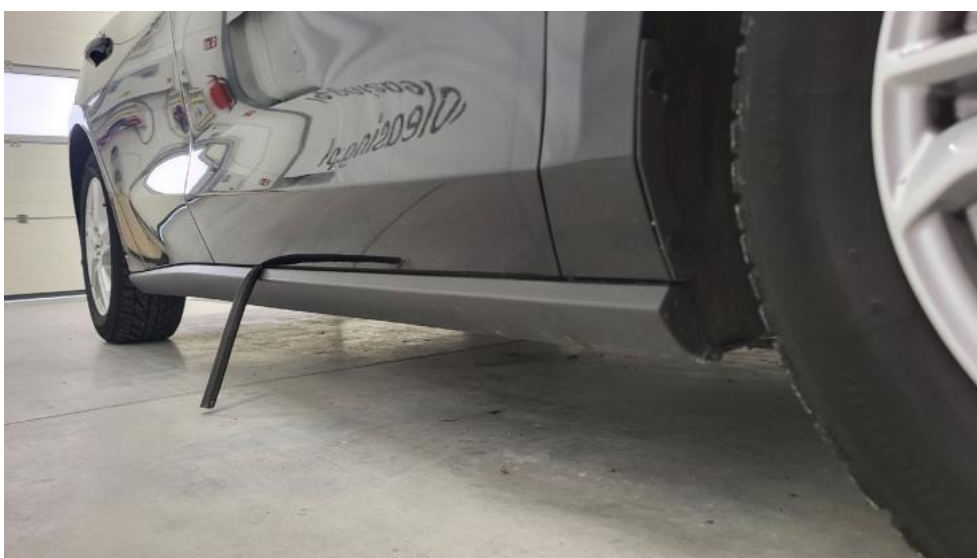
**Photo 12.**

Próg prawy (widok od przodu)

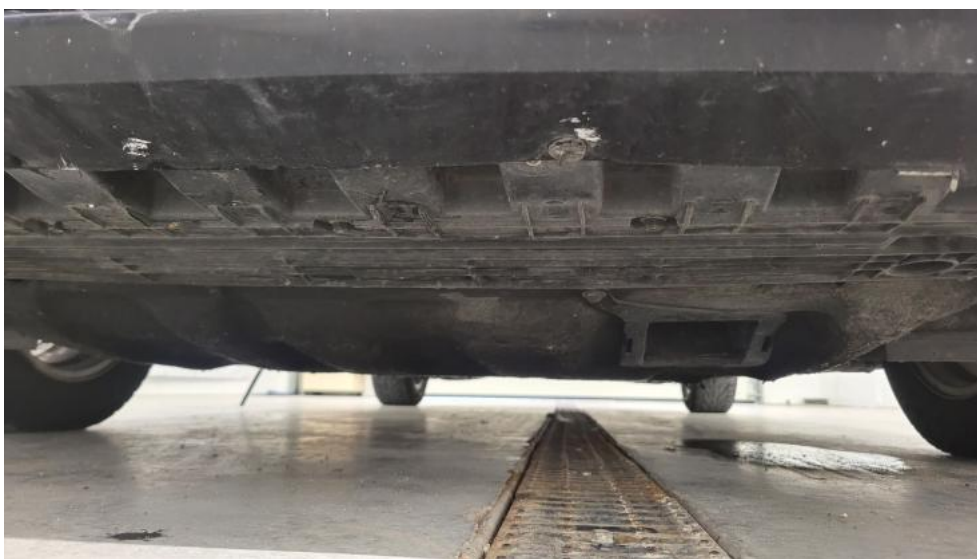
**Photo 13.**  
Spód pojazdu przód

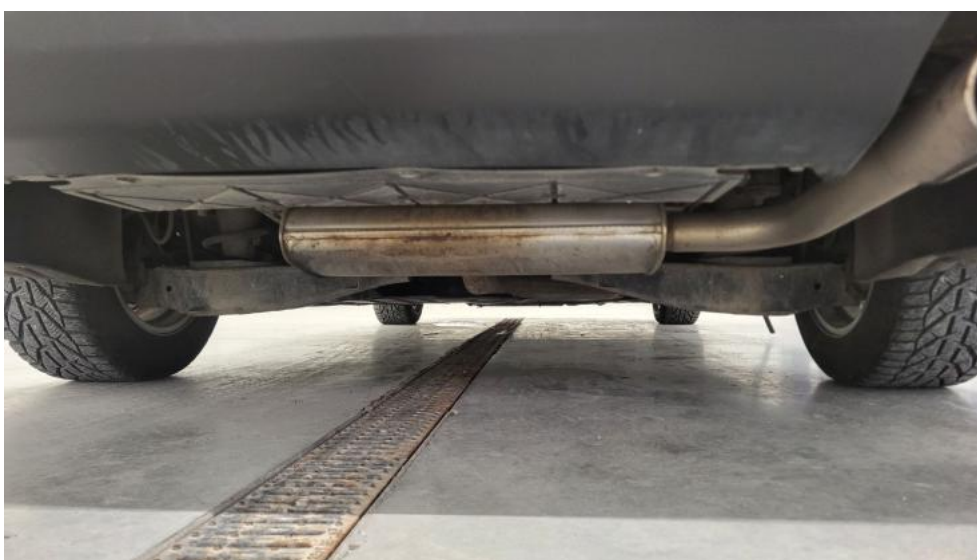
**Photo 14.**  
Spód pojazdu tył

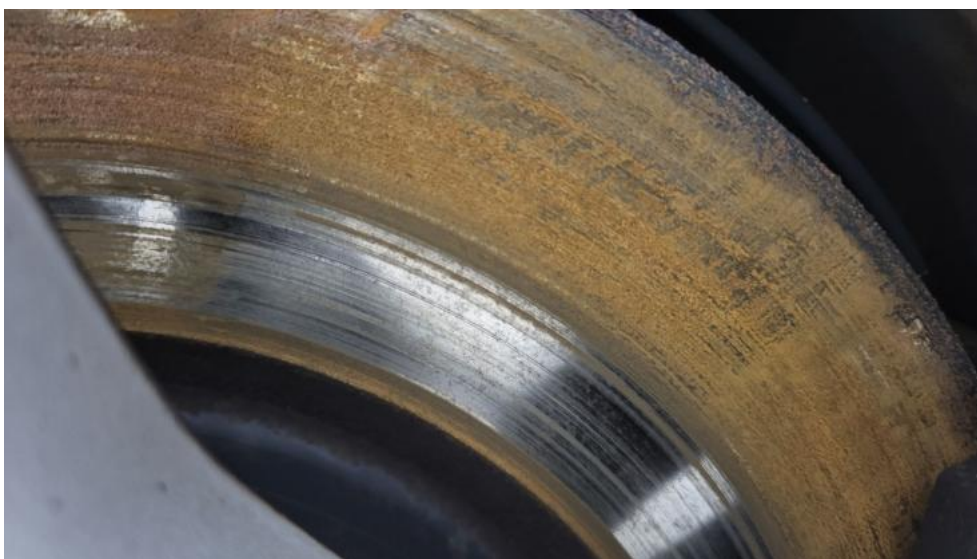
**Photo 15.**

Tarcza hamulcowa przednia prawa

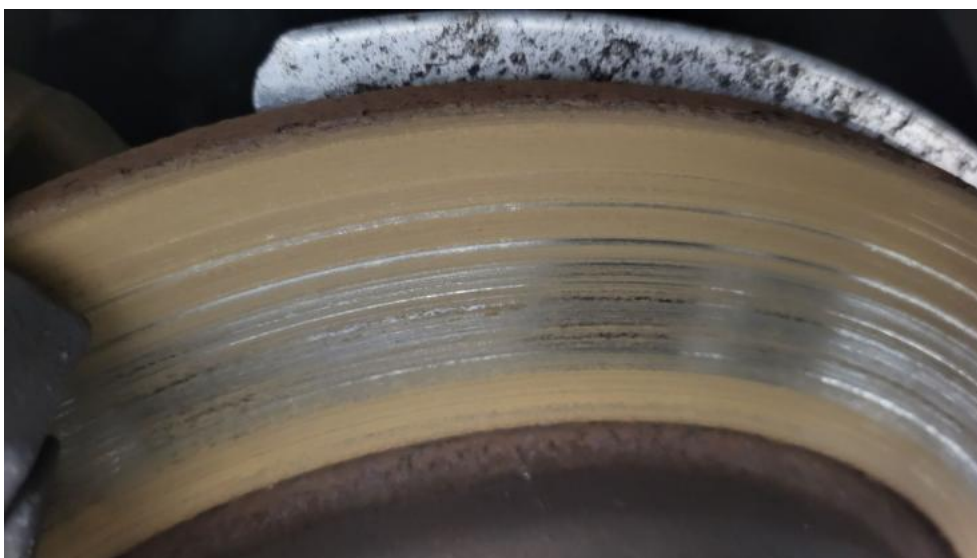
**Photo 16.**

Tarcza hamulcowa tylna prawa

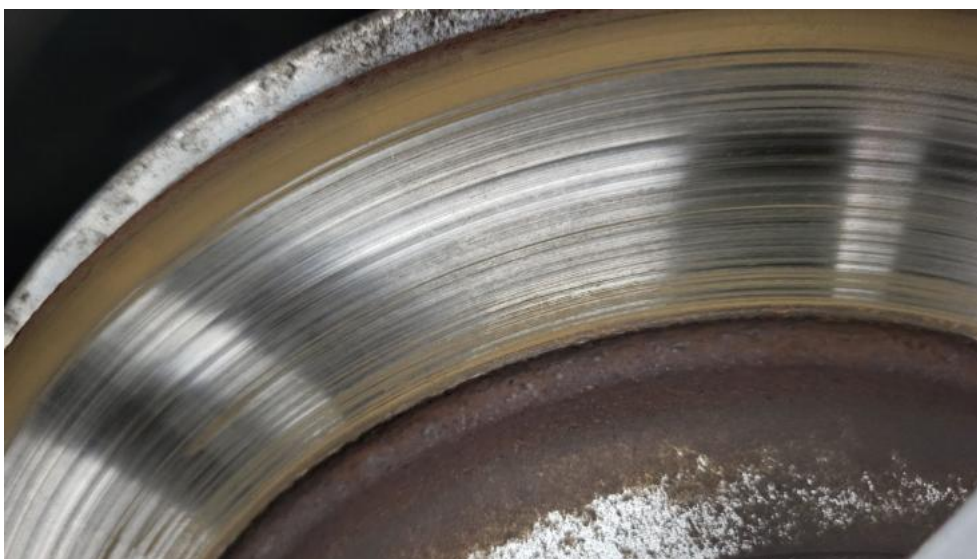
**Photo 17.**

Tarcza hamulcowa tylna lewa

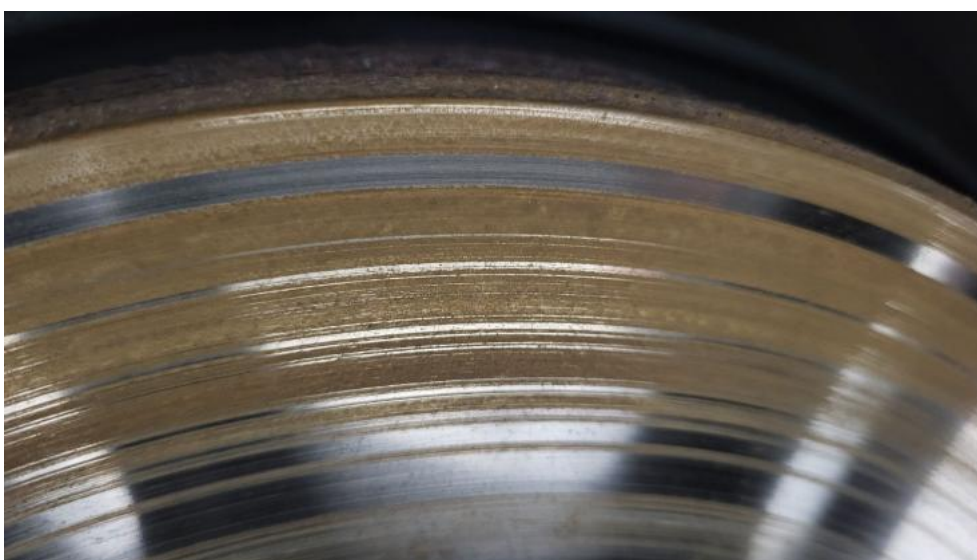
**Photo 18.**

Tarcza hamulcowa przednia lewa

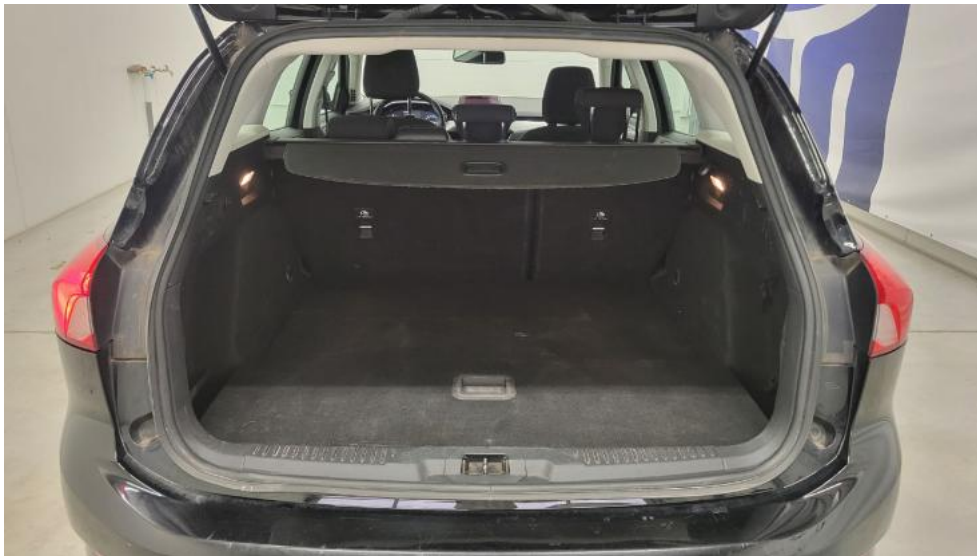
**Photo 19.**  
Bagażnik

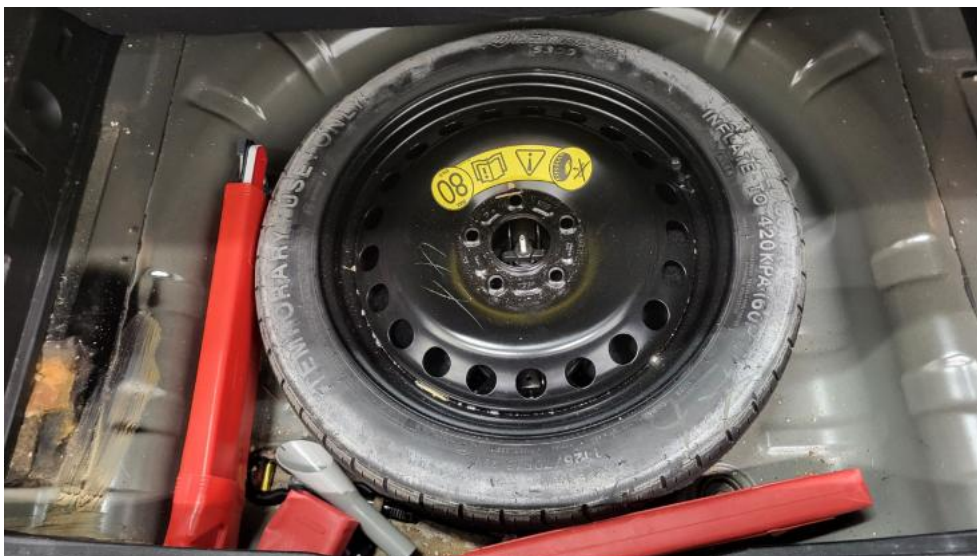
**Photo 20.**  
Koło zapasowe

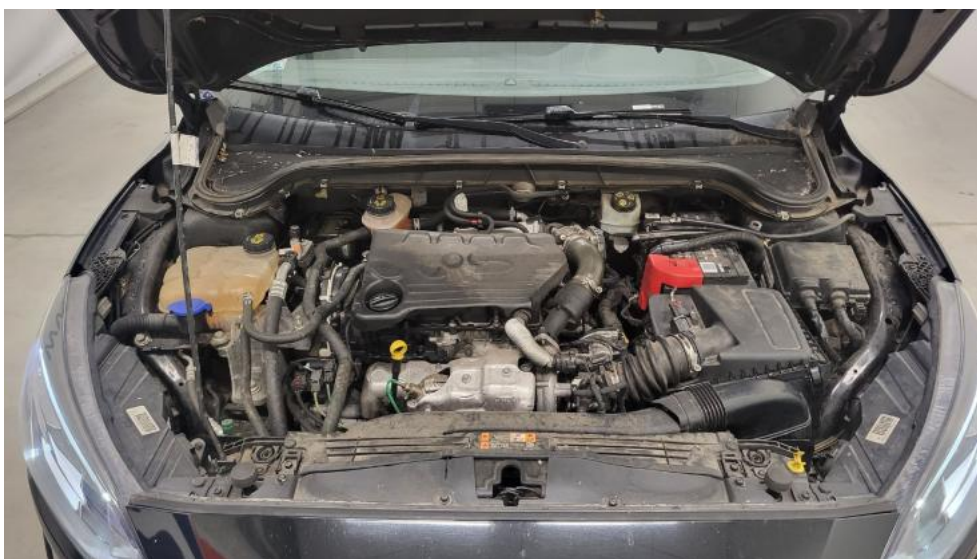
**Photo 21.**  
Komora silnika

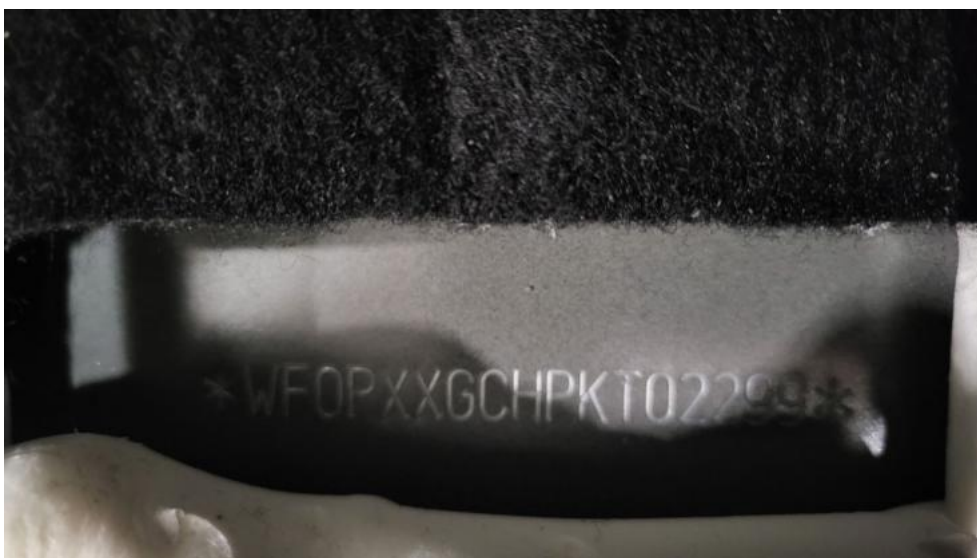
**Photo 22.**  
Numer identyfikacyjny

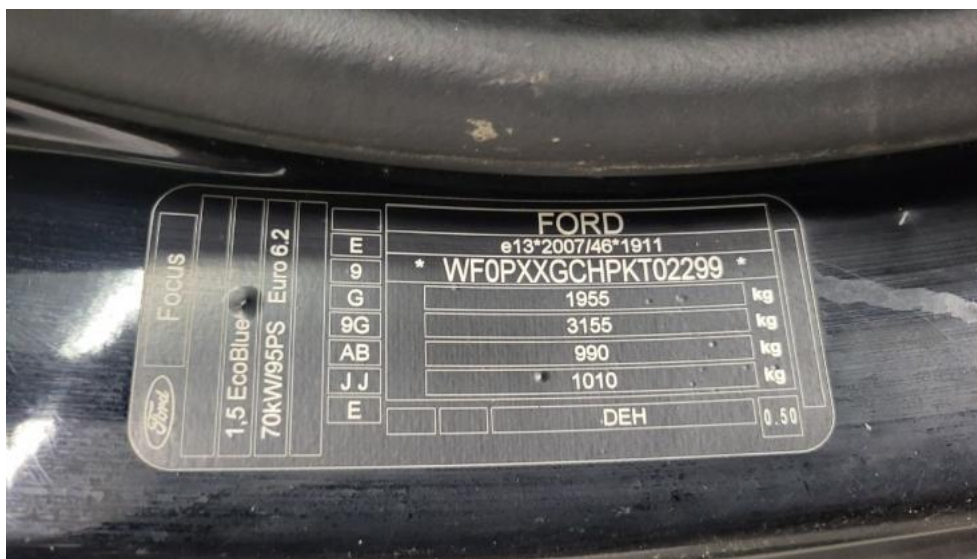
**Photo 23.**

Tabliczka znamionowa

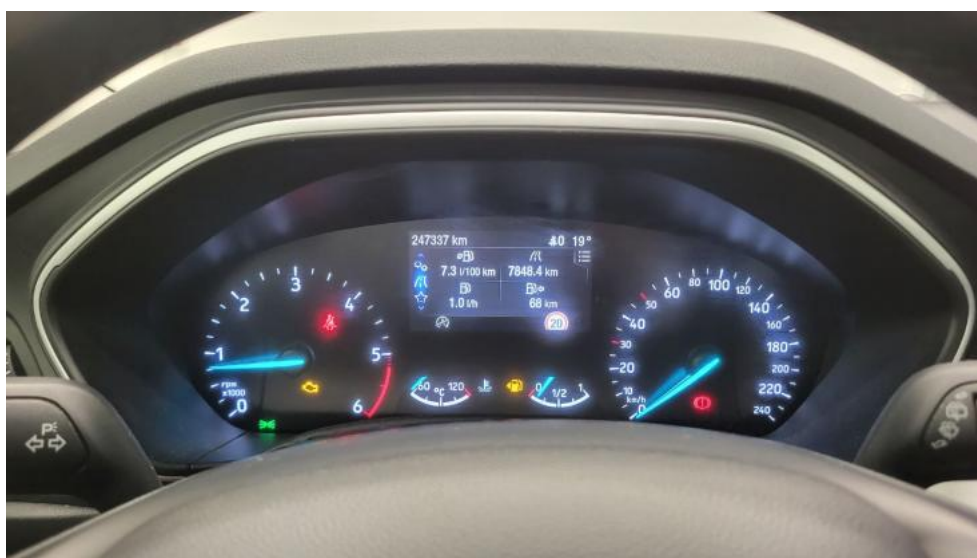
**Photo 24.**

Zestaw wskaźników - przebieg

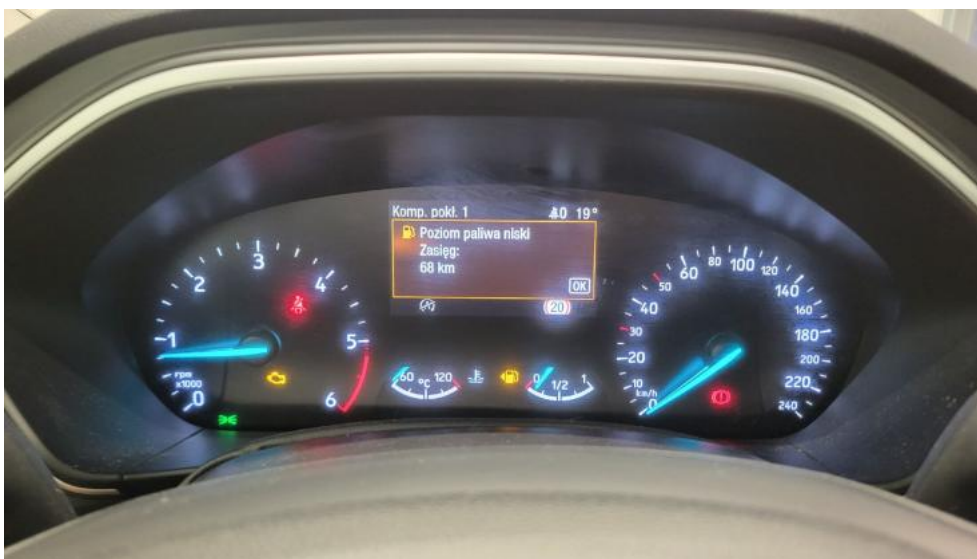
**Photo 25.**

Zestaw wskaźników - serwis

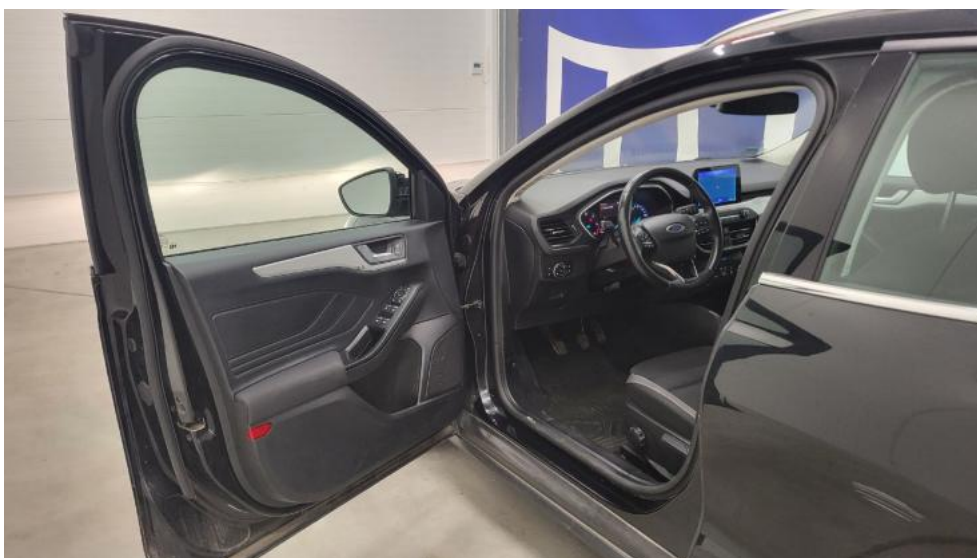
**Photo 26.**

Widok przez otwarte drzwi przednie lewe

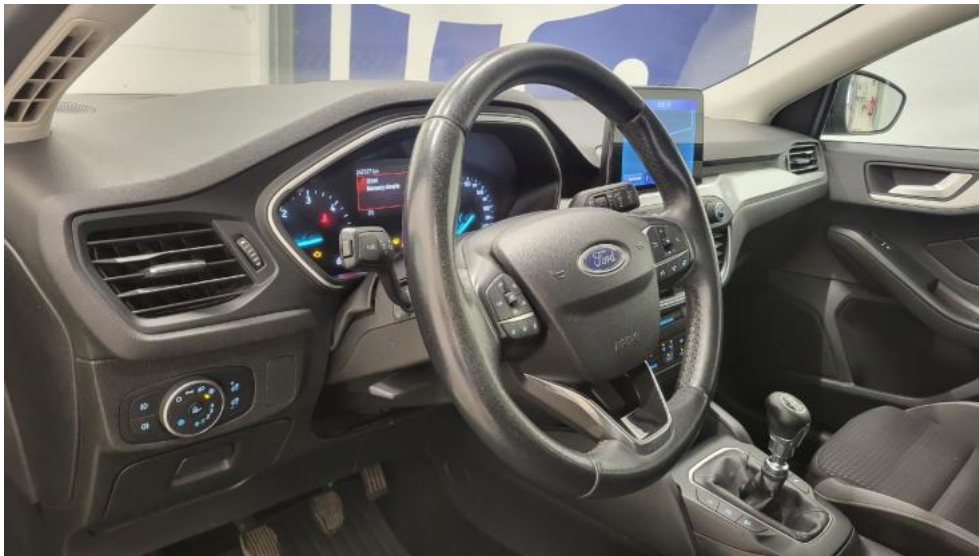
**Photo 27.**

Kierownica z lewej strony

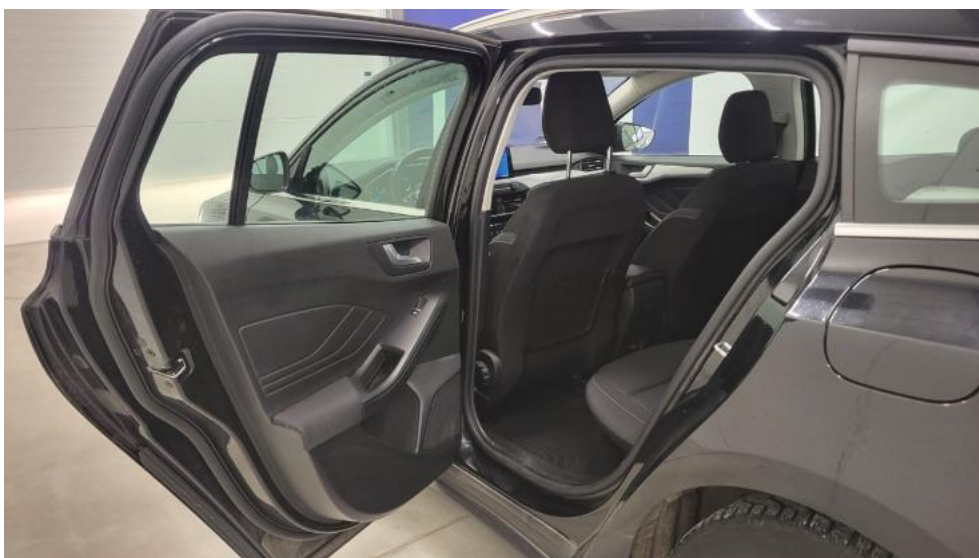
**Photo 28.**

Widok przez otwarte drzwi tylne lewe

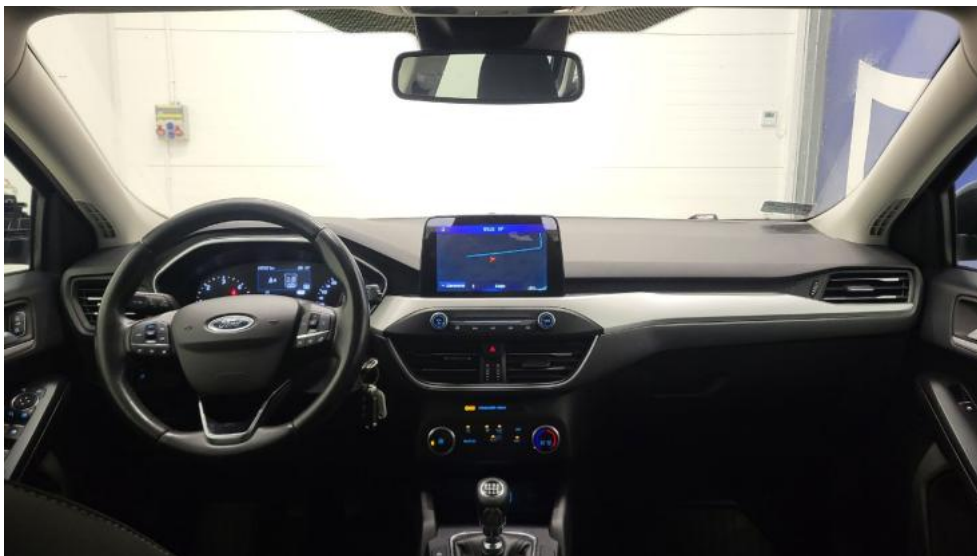
**Photo 29.**

Widok z tylnej kanapy na deskę rozd.

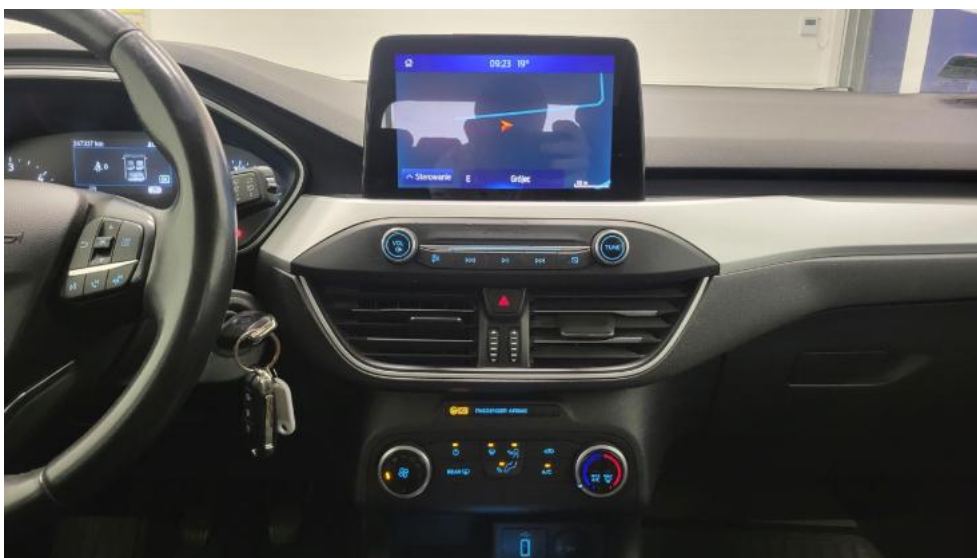
**Photo 30.**

Konsola środkowa

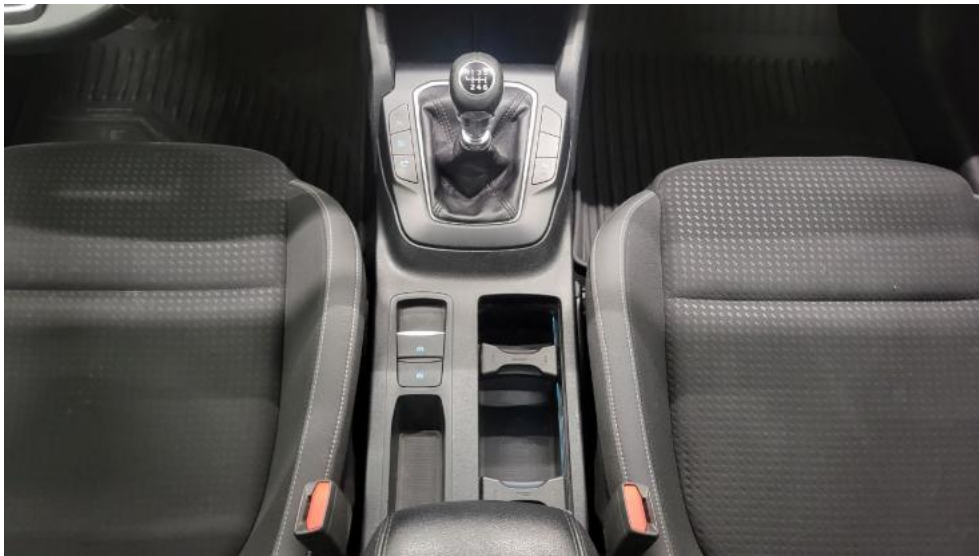
**Photo 31.**  
Tunel środkowy

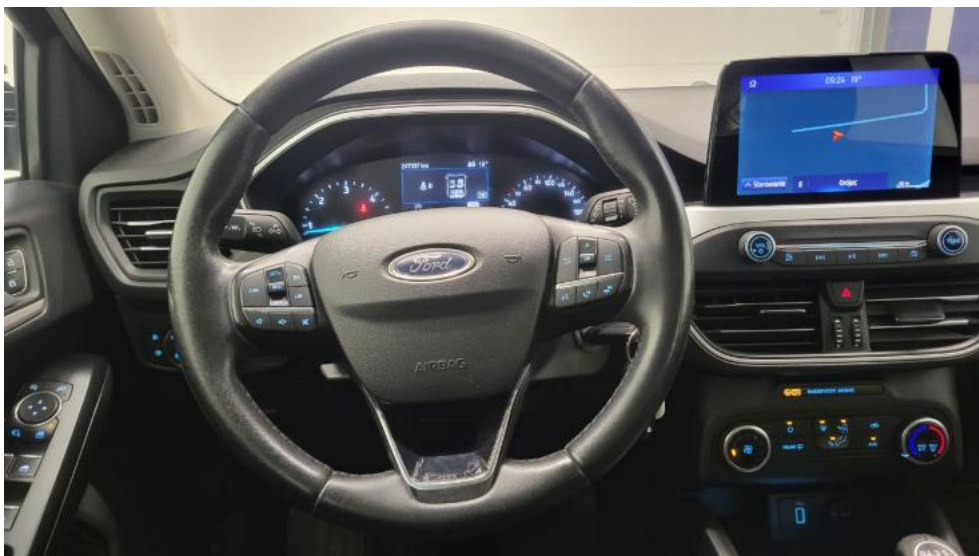
**Photo 32.**  
Kierownica (na wprost)

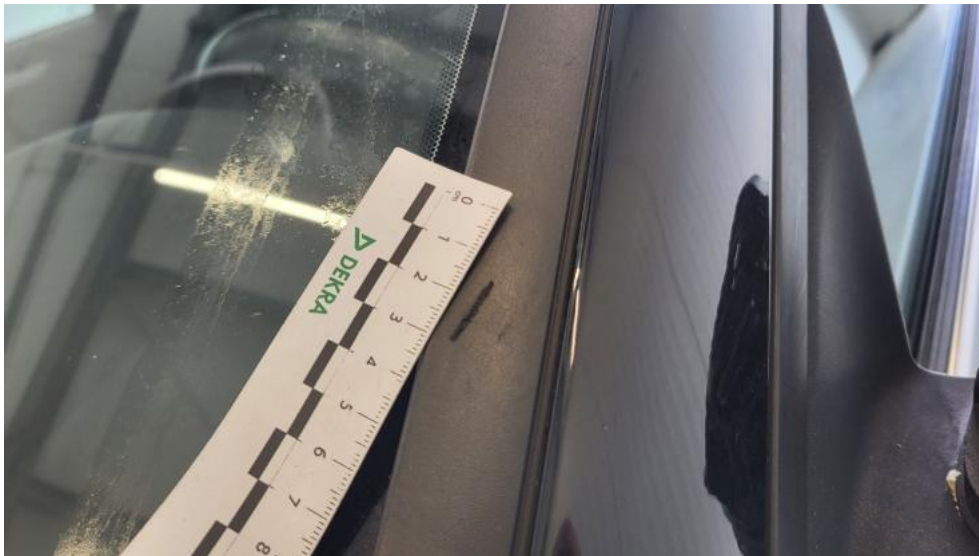
**Photo 43.**

Uszczelka/listwa szyby czołowej - Rysa/odprysk 1

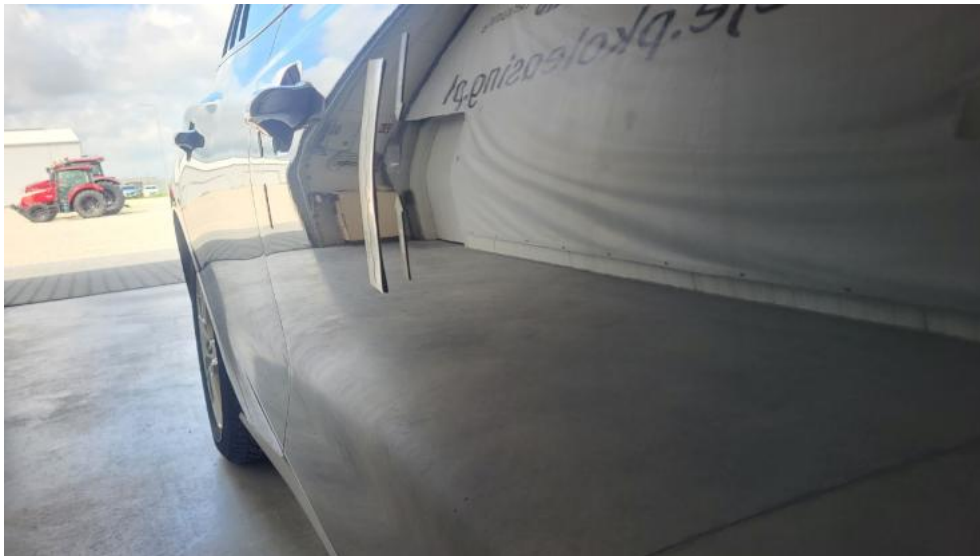
**Photo 53.**

Drzwi przednie P - Wgniecenie/odkształcenie 1

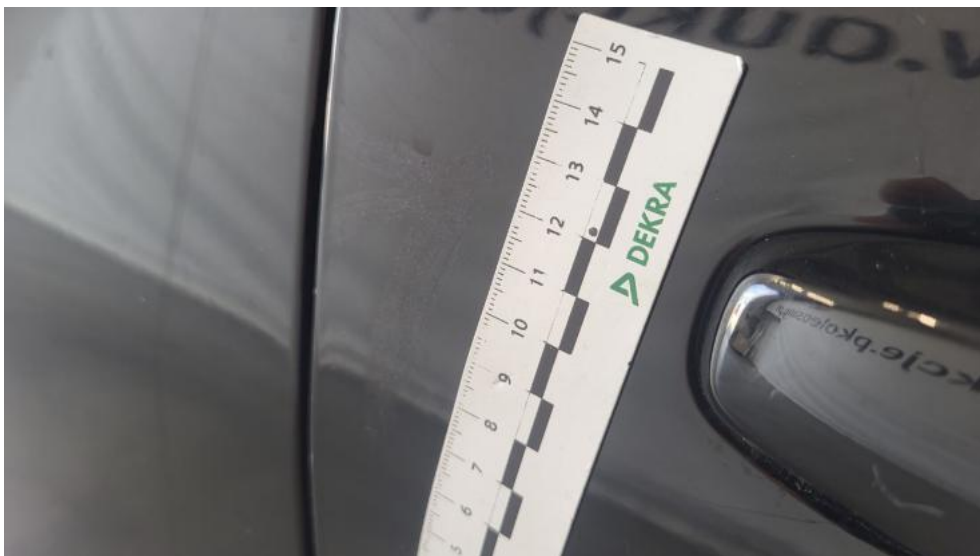
**Photo 54.**

Drzwi przednie P - Inne 1

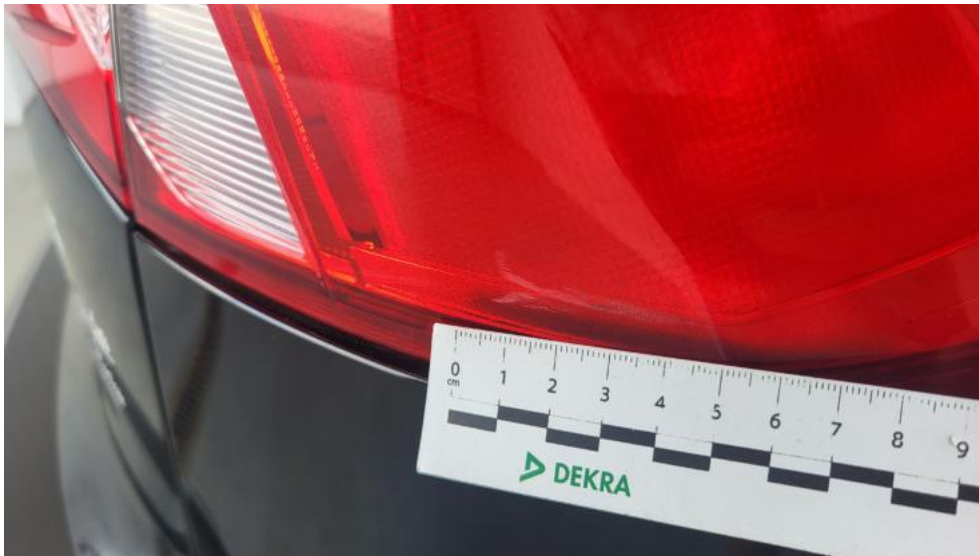
**Photo 65.**

Lampa tylna zew P - Rysa/odprysk 1

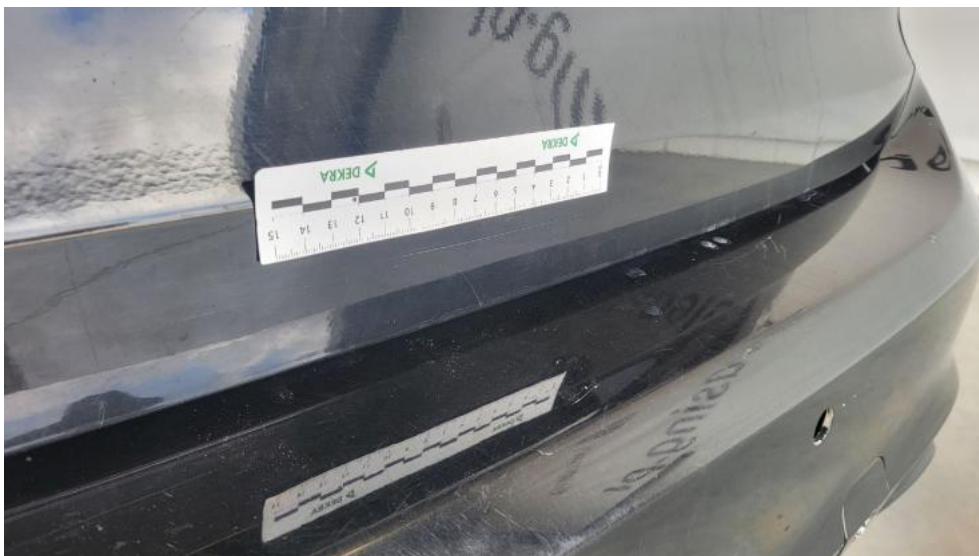
**Photo 66.**

Pokrywy bagażnika - Rysa/odprysk 1

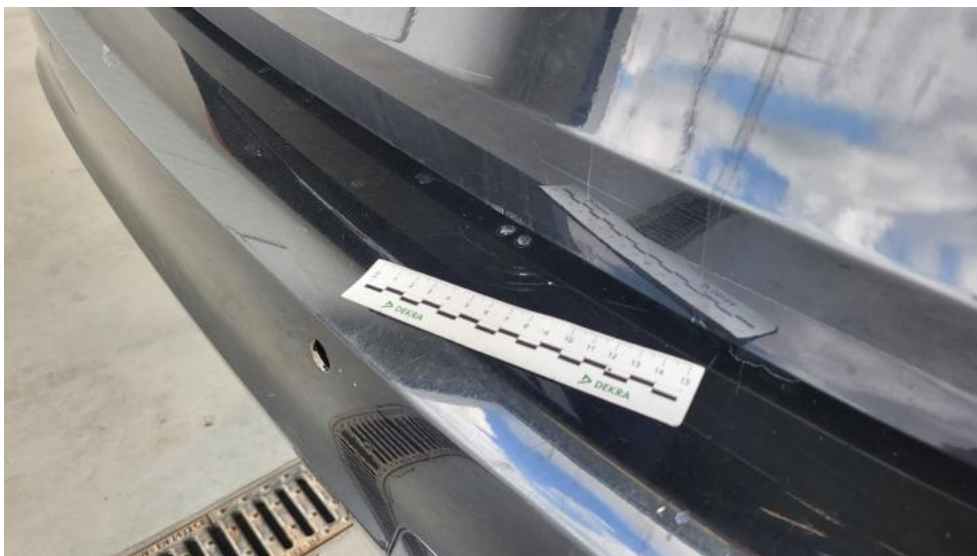
**Photo 72.**

Zderzak tylny - Rysa/odprysk 2

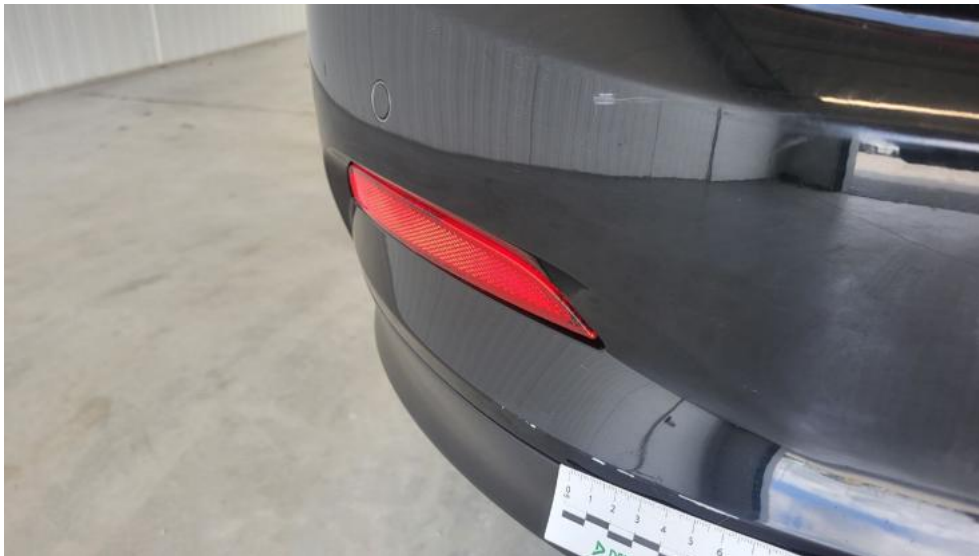
**Photo 73.**

Zderzak tylny() - Rysa/odprysk 3

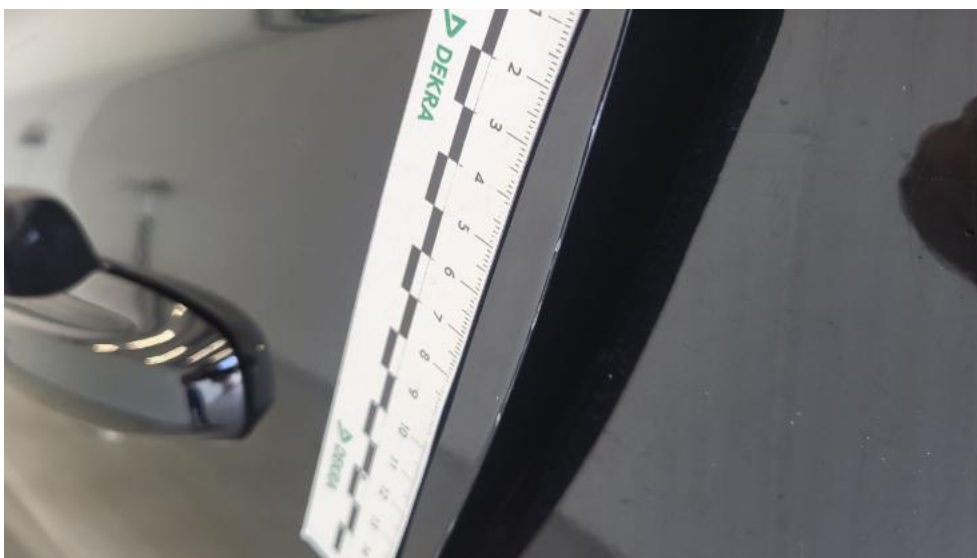
**Photo 84.**

Drzwi tylne L - Rysa/odprysk 1

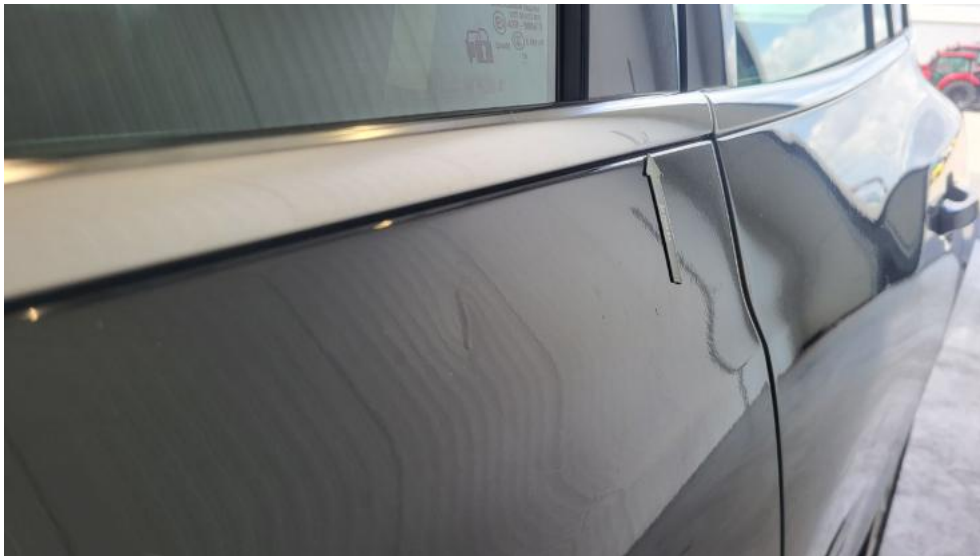
**Photo 87.**

Listwa drzwi przednich L - Wgniecenie/odkształcenie 1

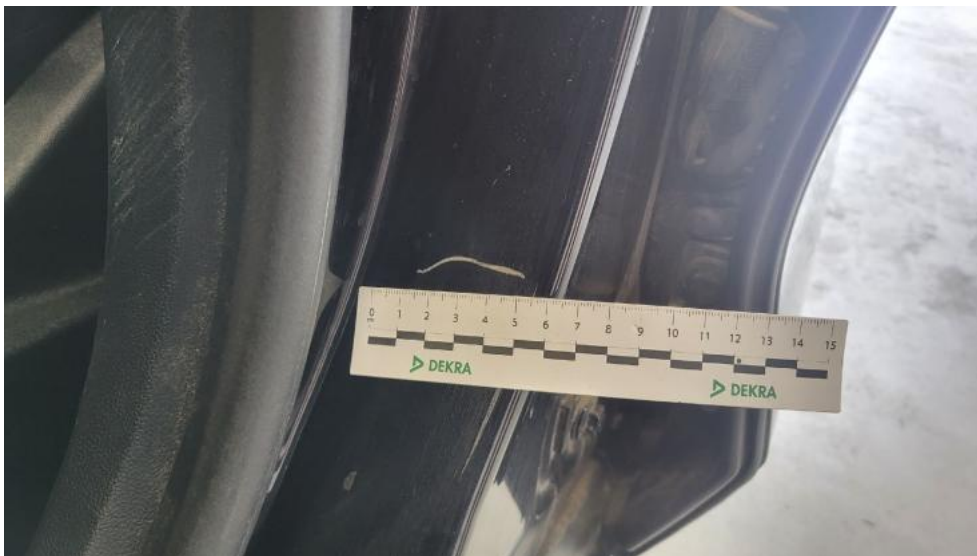
**Photo 91.**

Słupki środkowy L - Rysa/odprysk 1

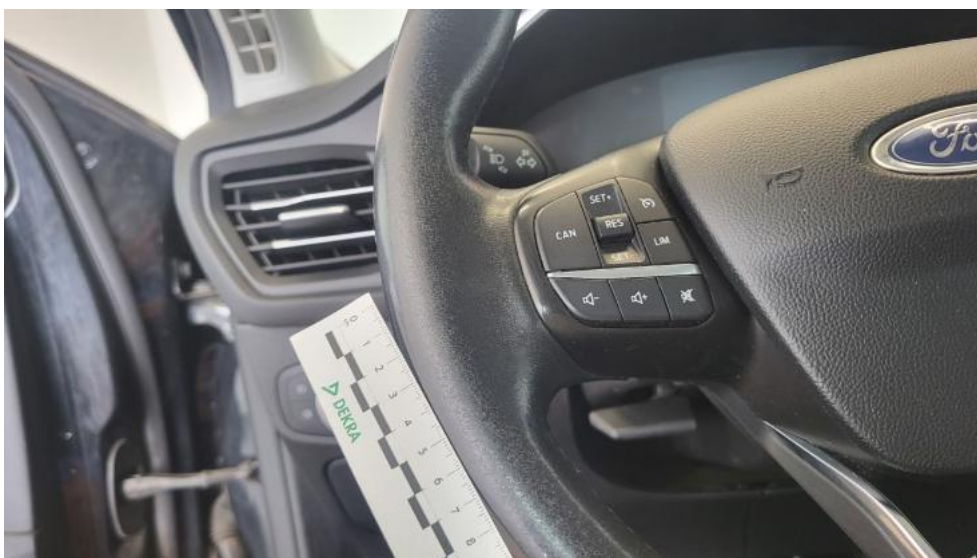
**Photo 94.**

Koło kierownicy - Rysa/odprysk 1
