DEKRA's commission No. : PKOL(W)/LODZ/67876/26/07/21  
commission/ damage No. : PS22/02298  
Date of commission: 21-07-2026

**DEKRA Poland - Headquarters**  
02-673 Warszawa, ul. Konstruktorska 12A

| Manufacturer | FORD |
| Model | Focus Kombi 18-21 |

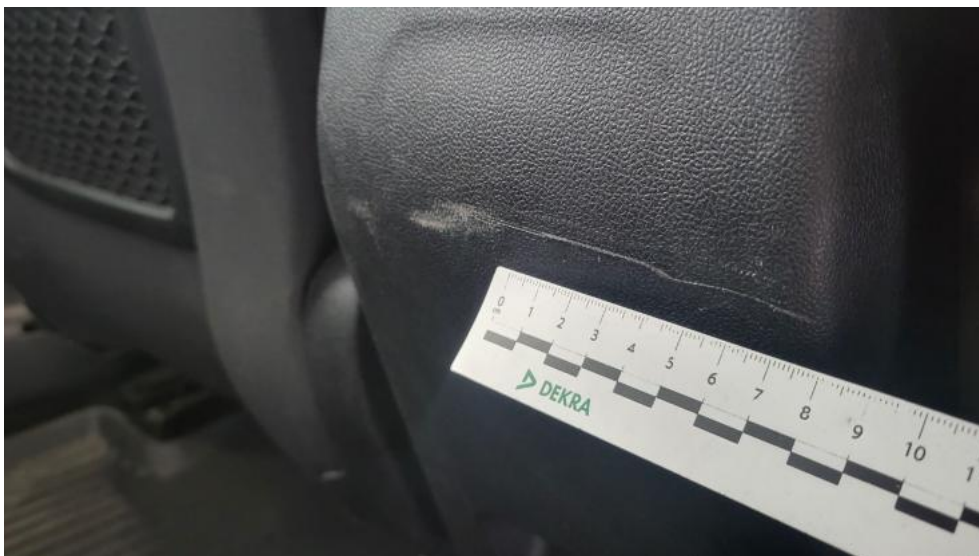
**Photo 96.**

Podłokietnik środkowy przedni - Rysa/odprysk 1

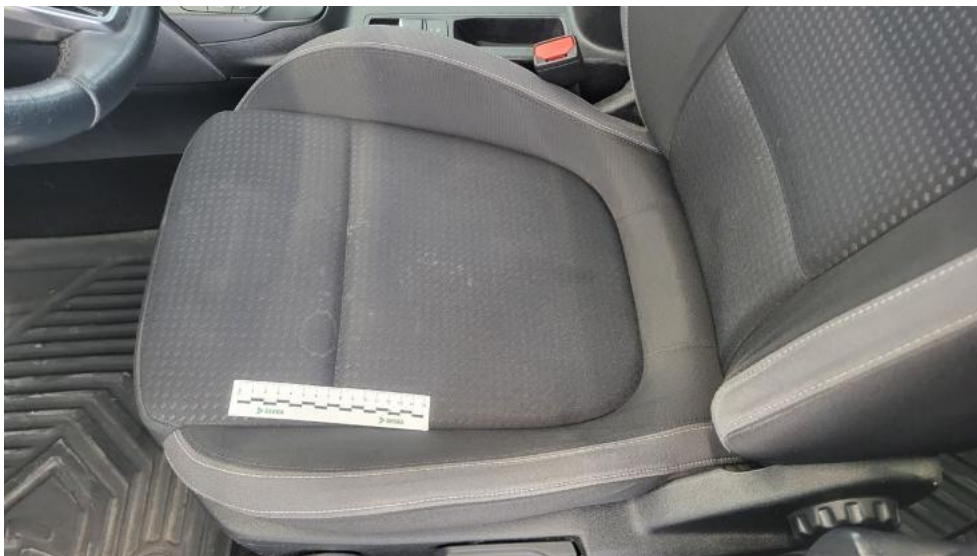
**Photo 97.**

Fotel prz. lew. - Inne 1

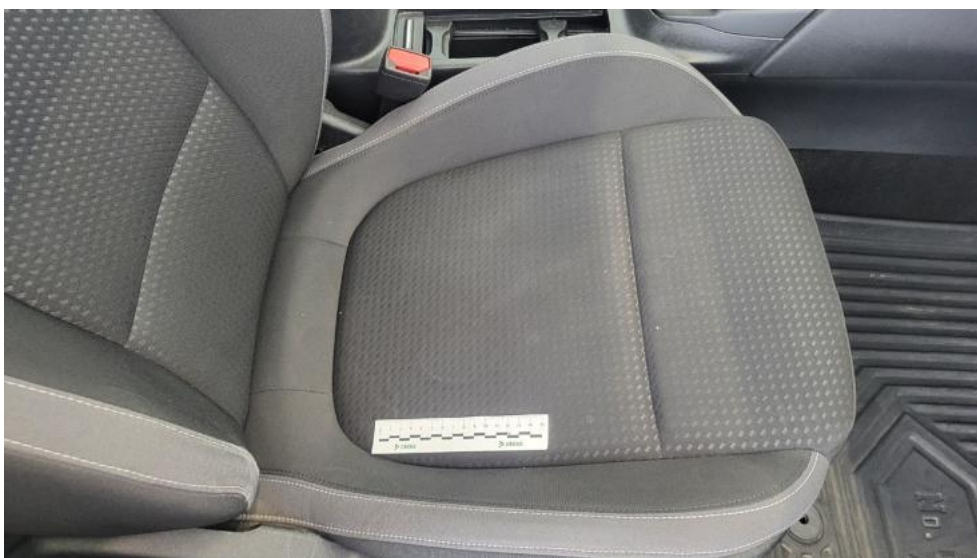
**Photo 98.**

Fotel prz. praw. - Inne 1

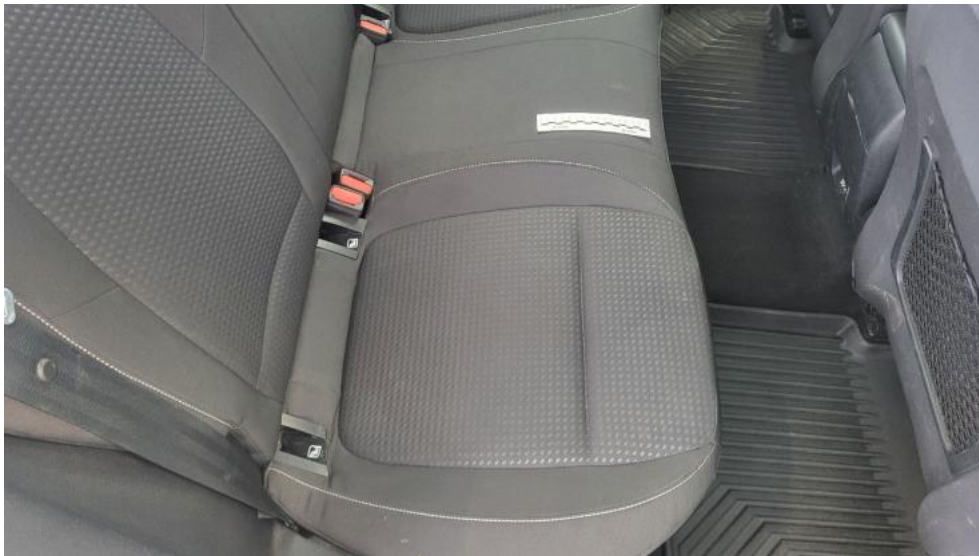
**Photo 99.**  
Kanapa tyl. - Inne 1

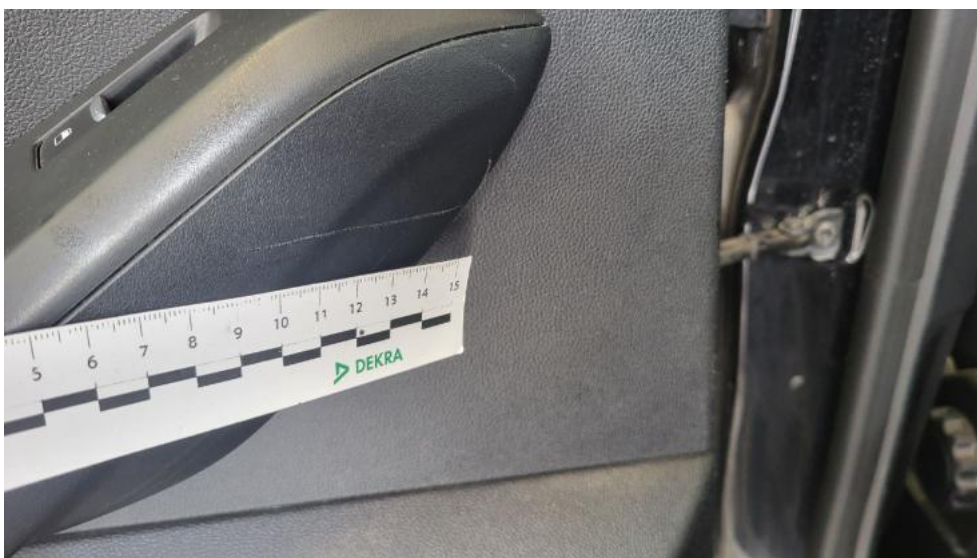
**Photo 102.**

Uchwyt drzwi tyl L - Rysa/odprysk 1

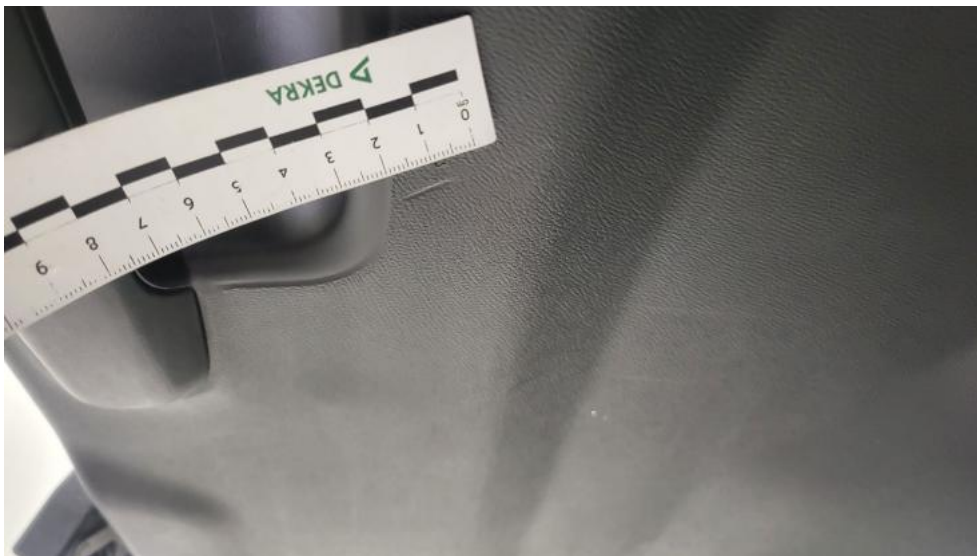
**Photo 107.**

Wykładzina pokrywy tylnej - Rysa/odprysk 1
