DEKRA's commission No. : PKOL(W)/LODZ/68614/26/07/23  
commission/ damage No. : 22/009233  
Date of commission: 23-07-2026

| Manufacturer | MAZDA |
| Model | MX-30 EV 20- |
| VIN / serial number | JMZDR1WBJ00117587 |

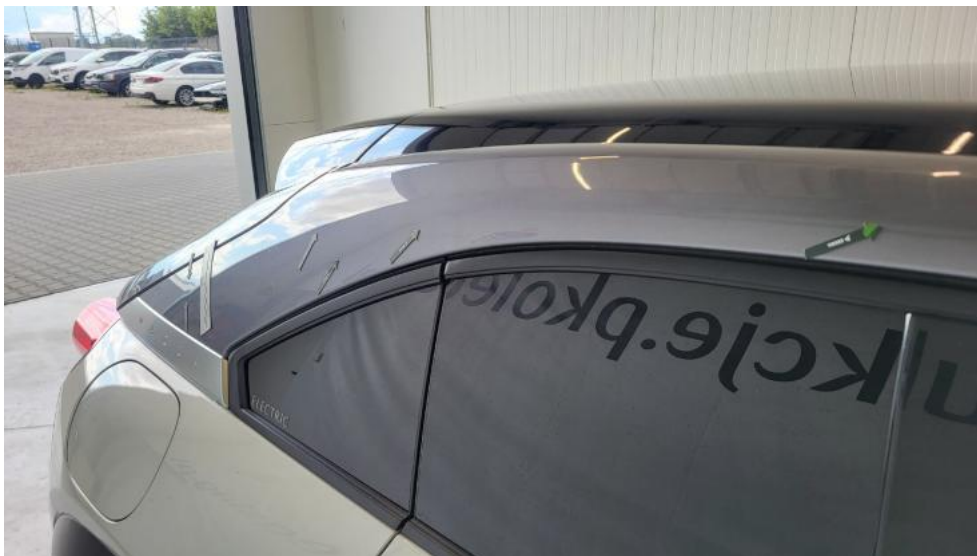
**Photo 57.**

Błotnik tylny P / Ściana boczna P - Wgniecenie/odkształcenie 1

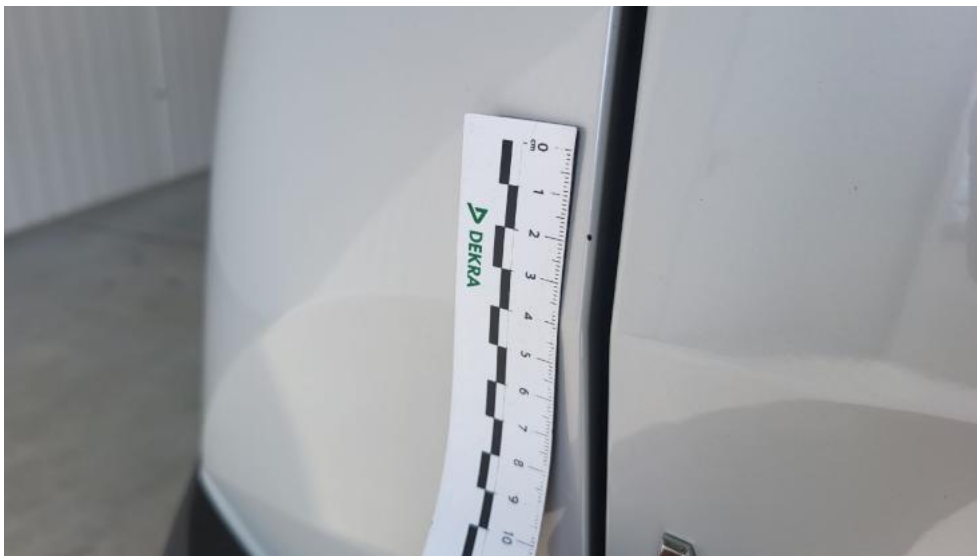
**Photo 61.**

Zderzak tylny cz L - Rysa/odprysk 1

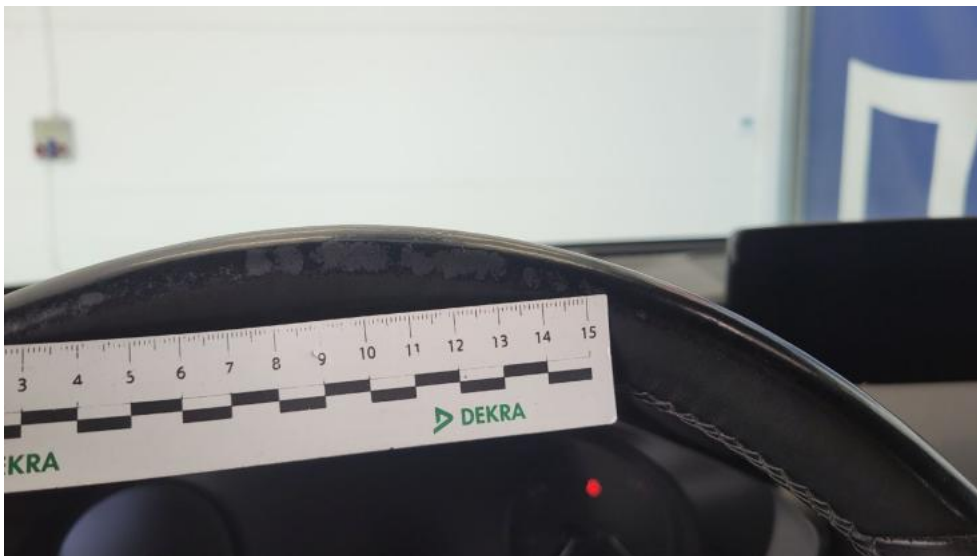
**Photo 73.**

Koło kierownicy - Rysa/odprysk 1
