DEKRA's commission No. : PKOL(W)/LODZ/89518/25/11/19  
commission/ damage No. : 23/040509  
Date of commission: 19-11-2025

**Vehicle data**

| Type / version | Grandland X 1.5 CDTI Innovation S&S aut |
| Registration /record No. | KK3907C |

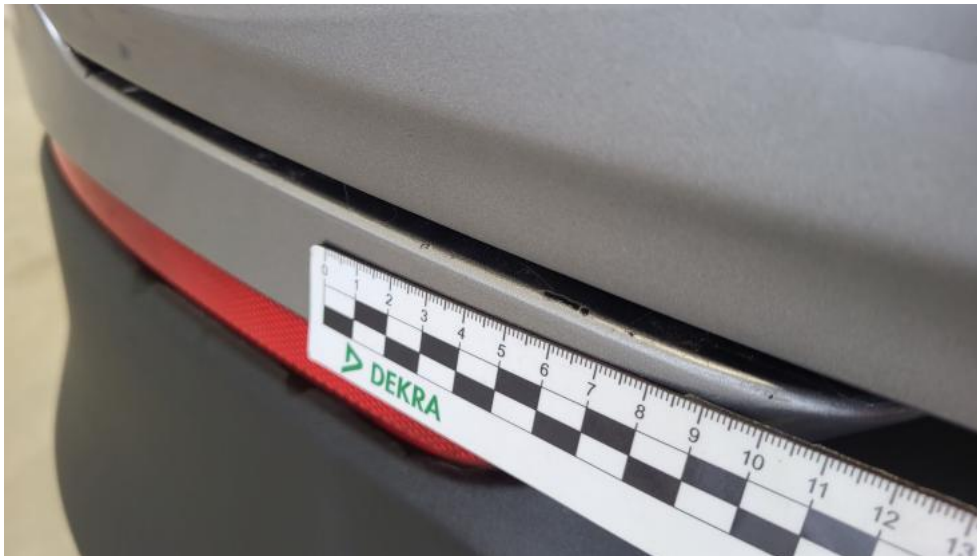
**Photo 55.**

Zderzak tylny cz L - Rysa/odprysk 2

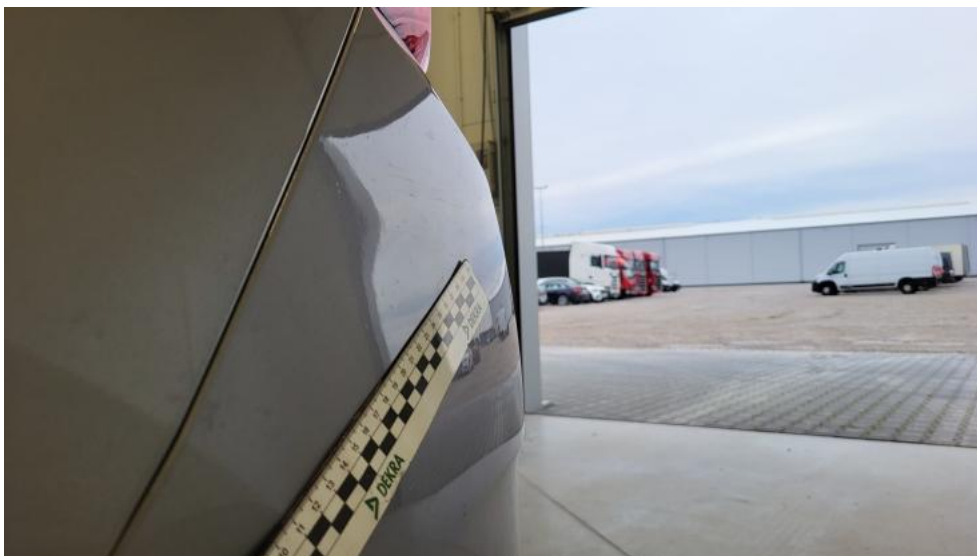
**Photo 56.**

Zderzak tylny cz L - Wgniecenie/odkształcenie 1

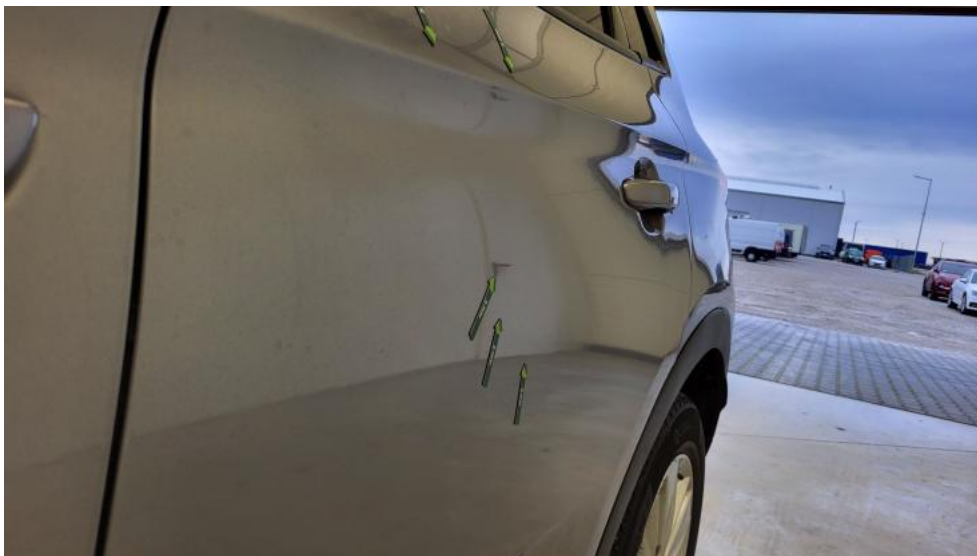
**Photo 63.**

Drzwi tylne L - Wgniecenie/odkształcenie 1

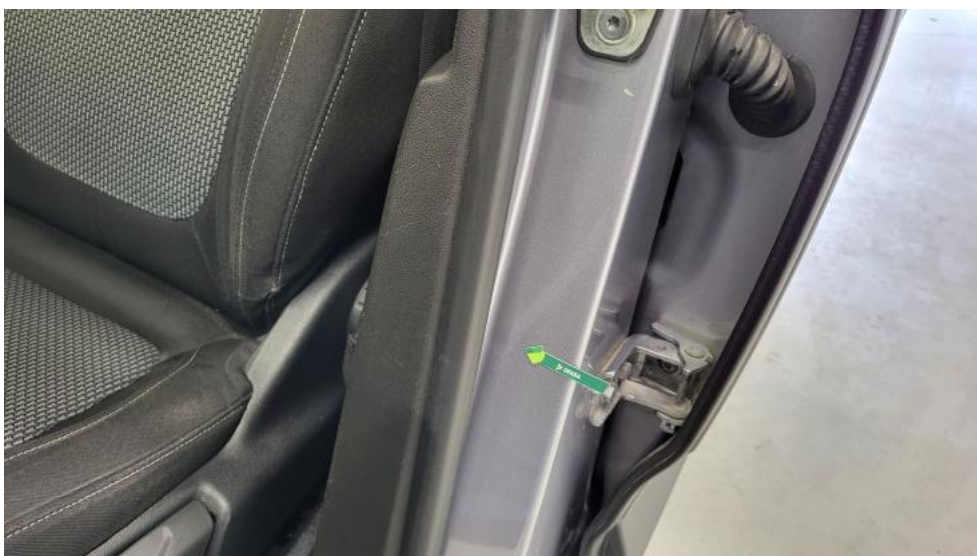
**Photo 64.**

Słupek środkowy L - Wgniecenie/odkształcenie 1

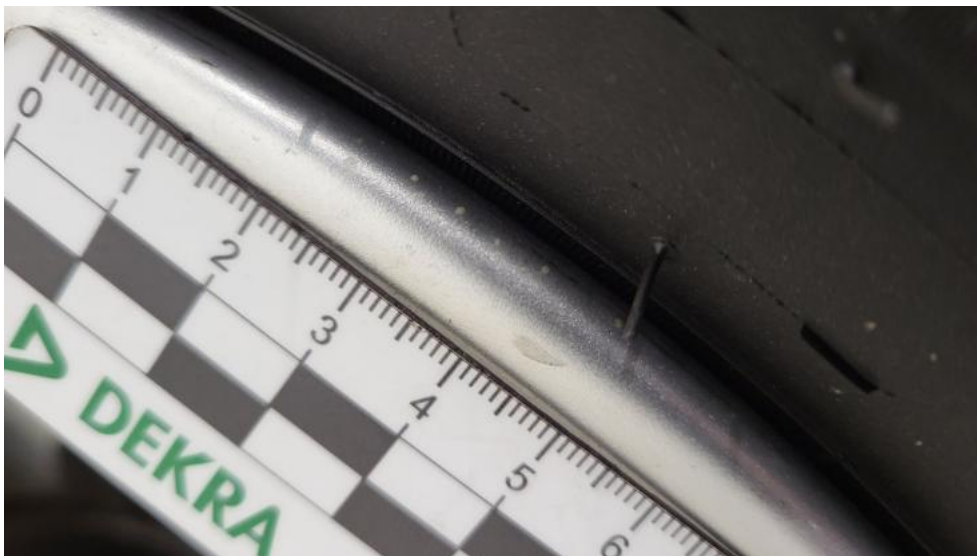
**Photo 65.**

Felga Aluminiowa przednia L - Rysa/odprysk 1

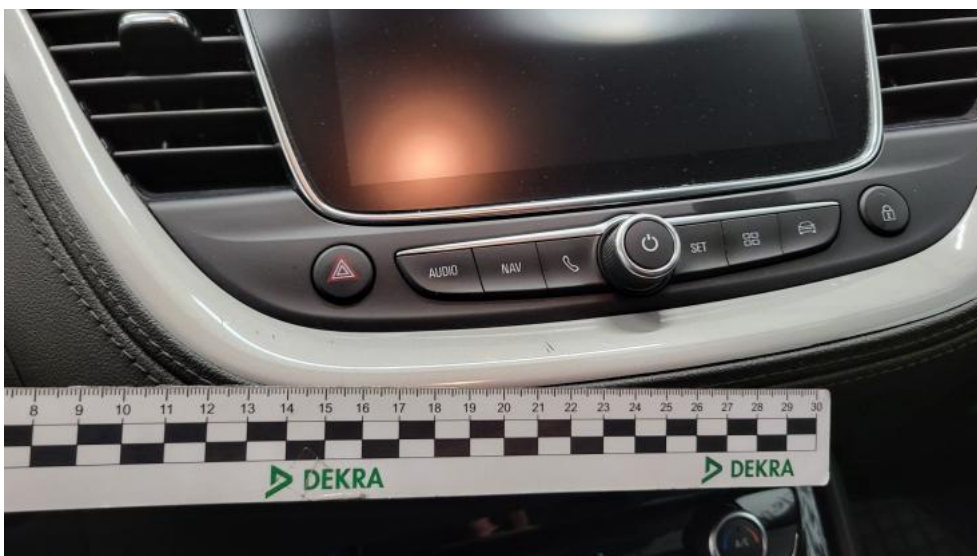
**Photo 66.**

Konsola środkowa - Rysa/odprysk 1

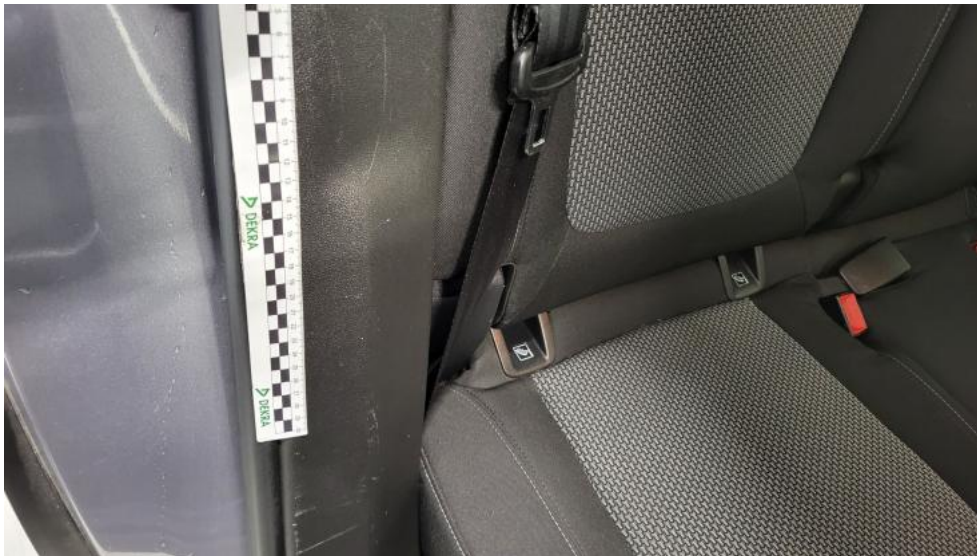
**Photo 79.**

Wykładzina(y) słupka tylnego P - Rysa/odprysk 1
