DEKRA's commission No. : PKOL(W)/LODZ/95349/25/12/04  
commission/ damage No. : 22/024500  
Date of commission: 04-12-2025

| Type / version | Superb 1.4 TSI Plug-In Hybrid L&K DSG |

Measurement of thickness of the vehicle lacquer coating

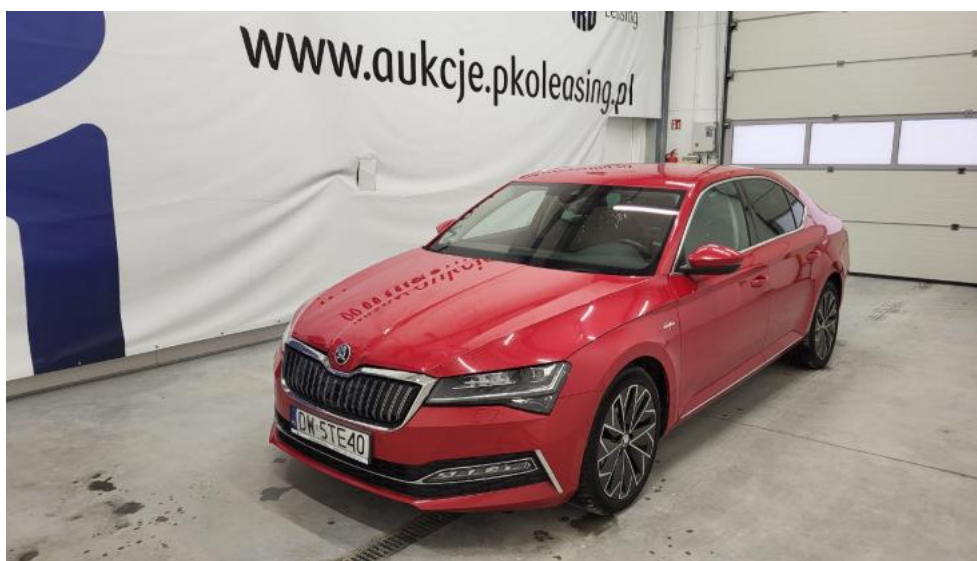
**Photo 1.**

Przekątna przednia lewa

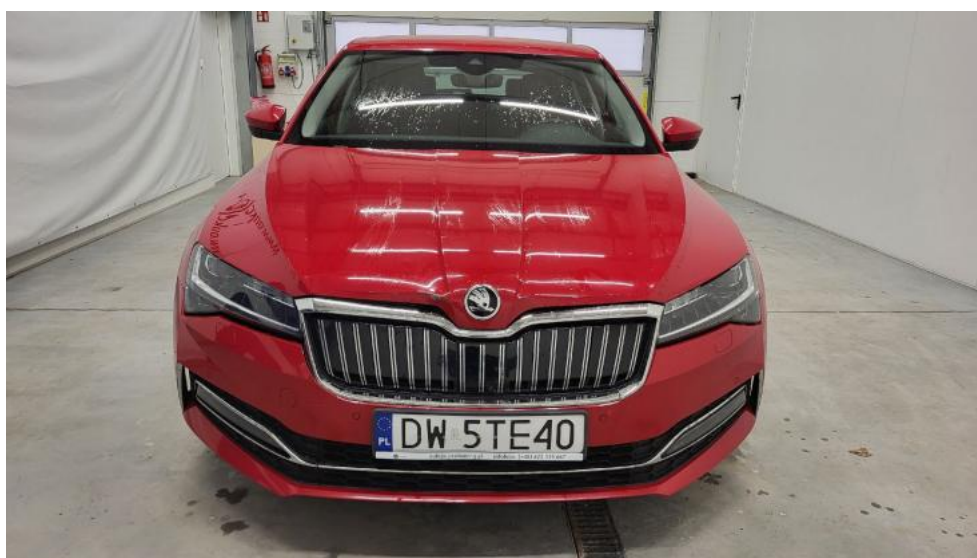
**Photo 2.**

Przód

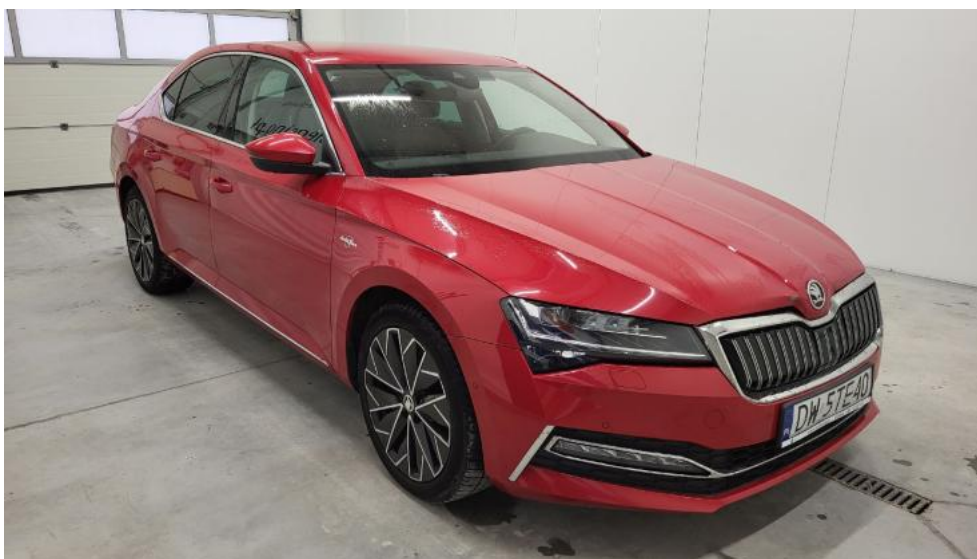
**Photo 3.**

Przekątna przednia prawa

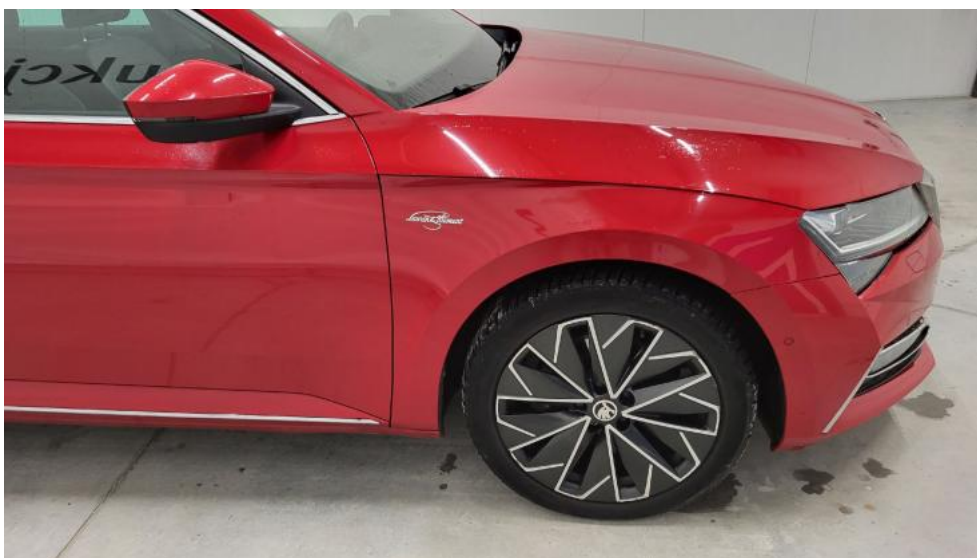
**Photo 4.**

Bok prawy z przodu

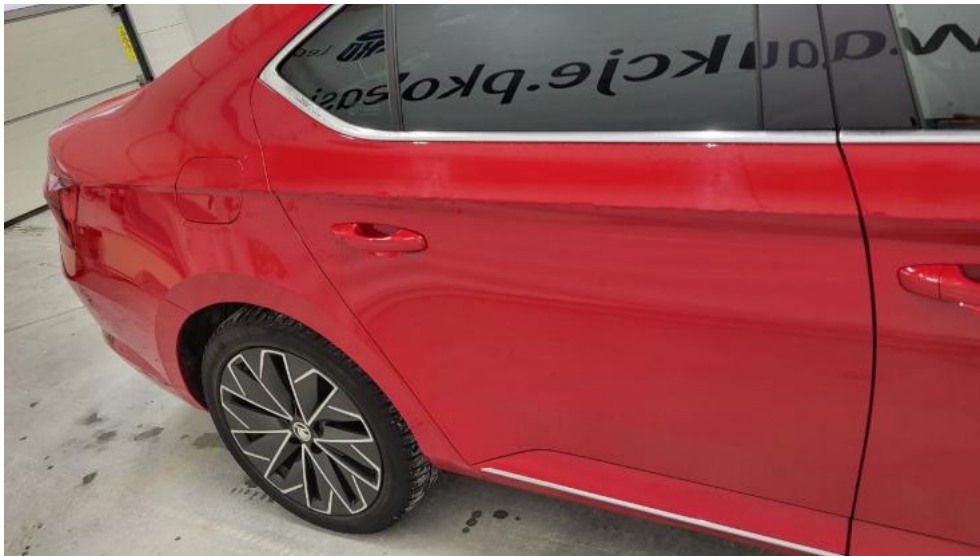
**Photo 5.**

Bok prawy z tyłu

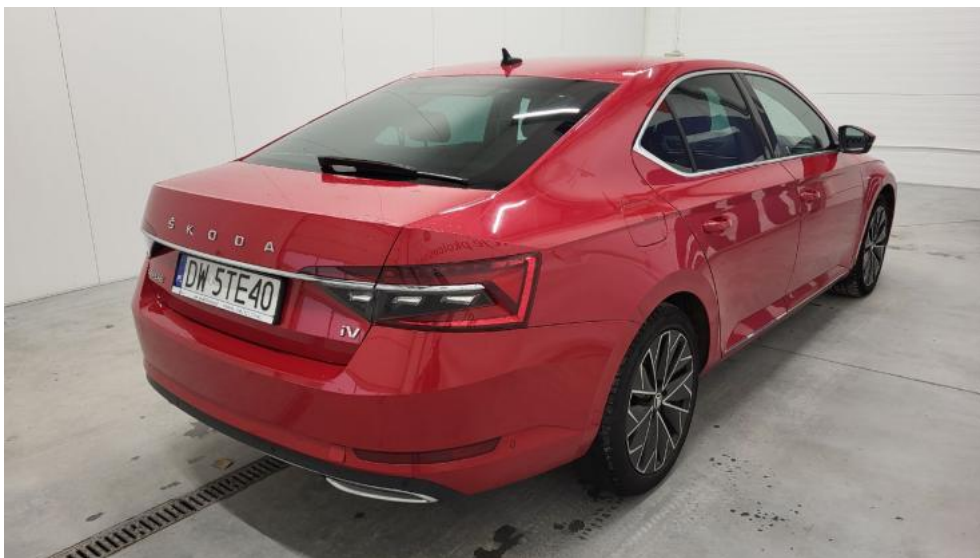
**Photo 6.**

Przekątna tylna prawa

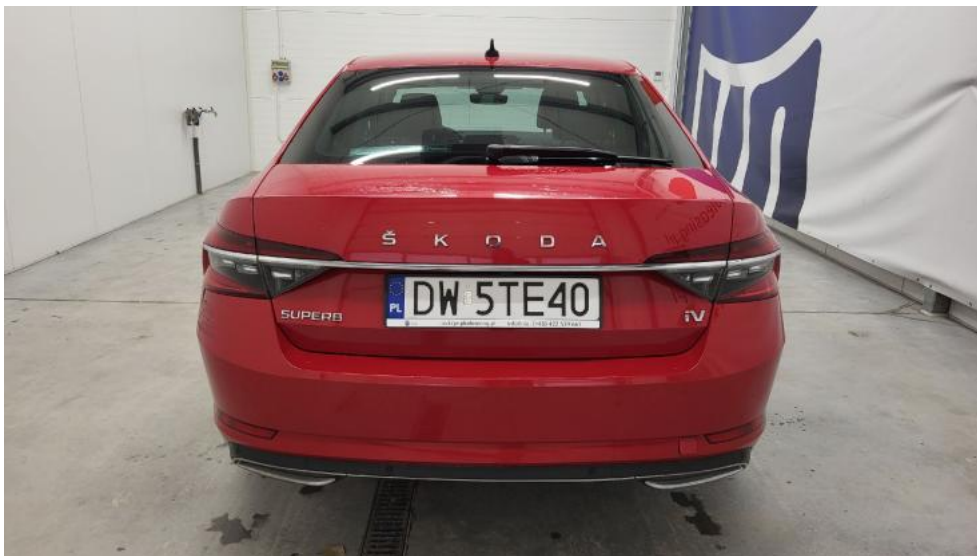
**Photo 7.**

Tył

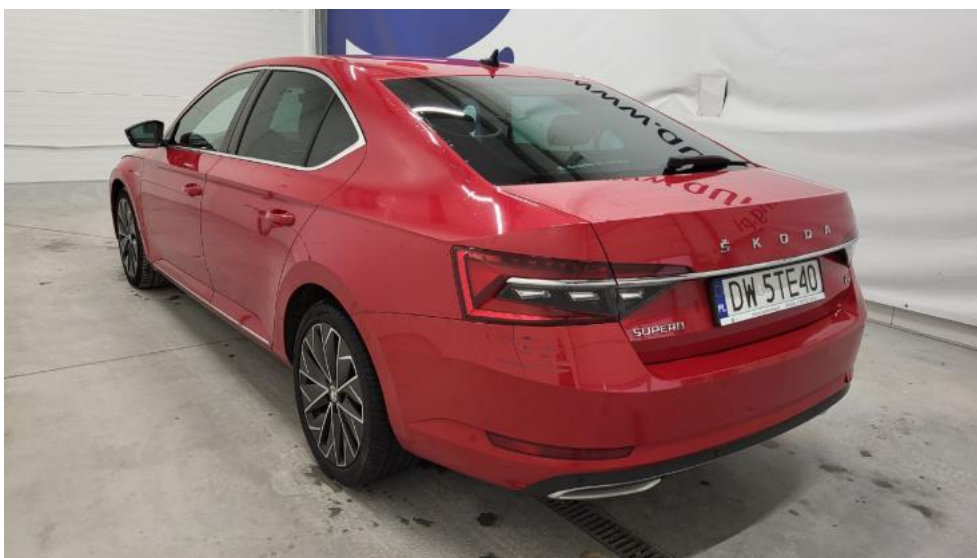
**Photo 8.**

Przekątna tylna lewa

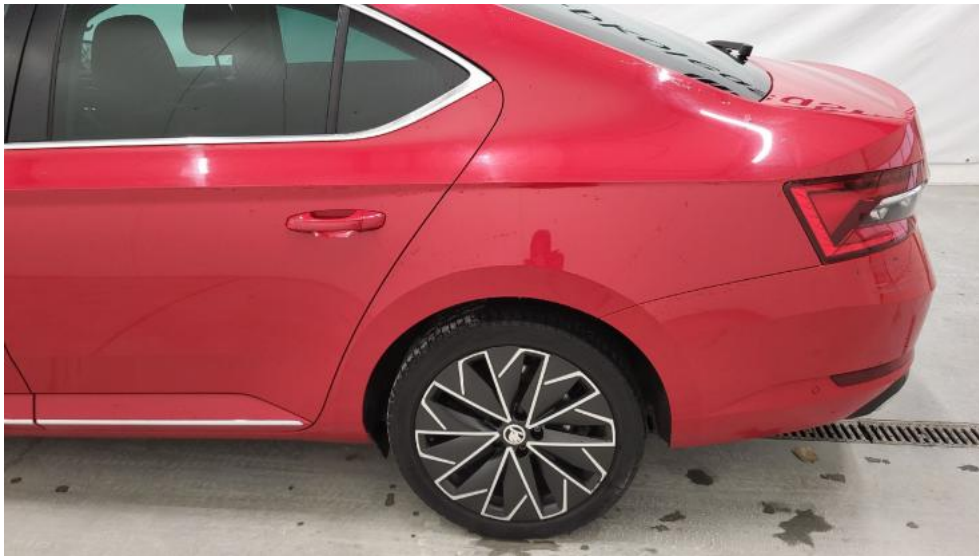
**Photo 9.**

Bok lewy z tyłu

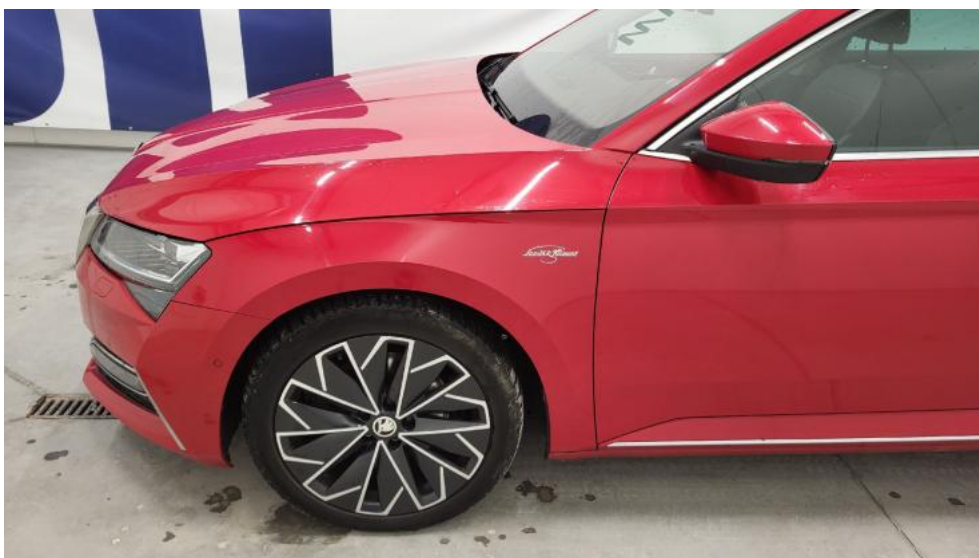
**Photo 10.**

Bok lewy z przodu

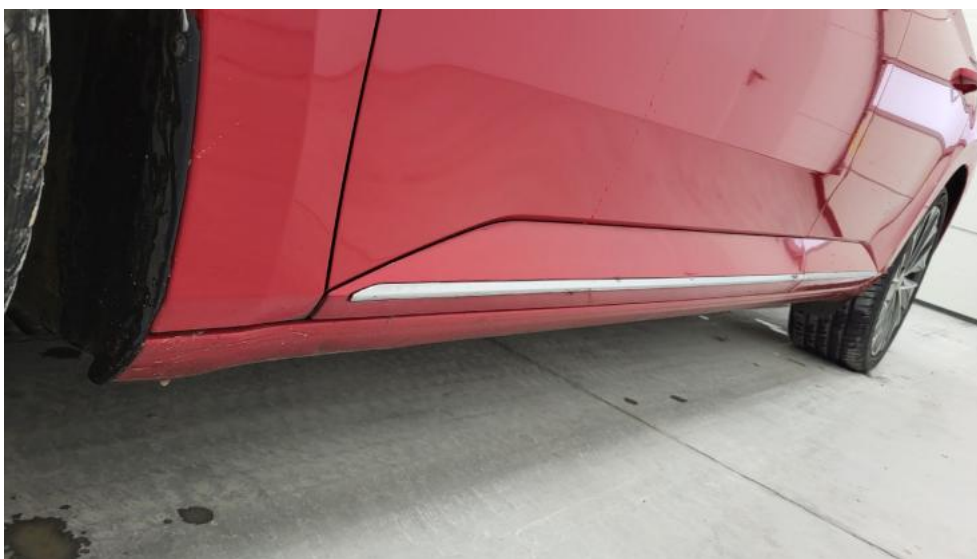
**Photo 11.**

Próg lewy (widok od przodu)

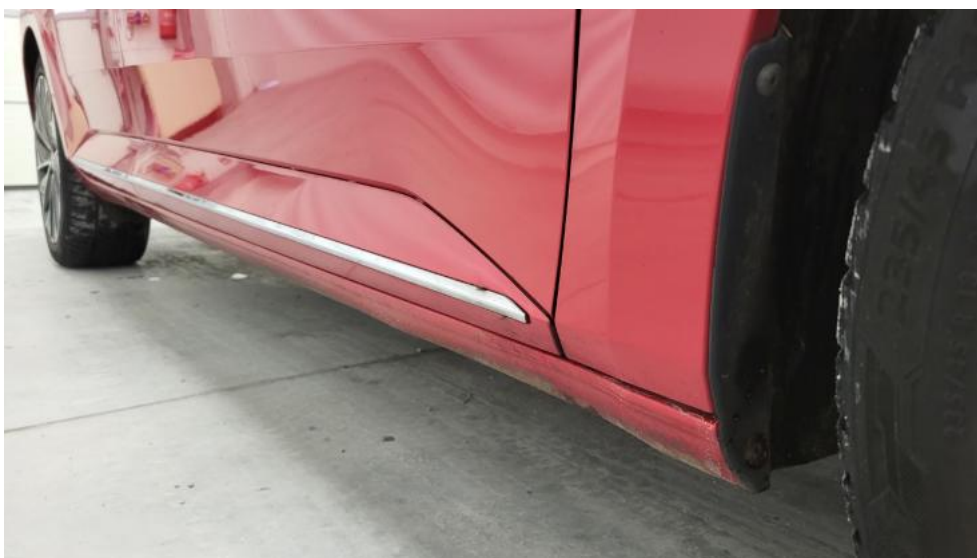
**Photo 12.**

Próg prawy (widok od przodu)

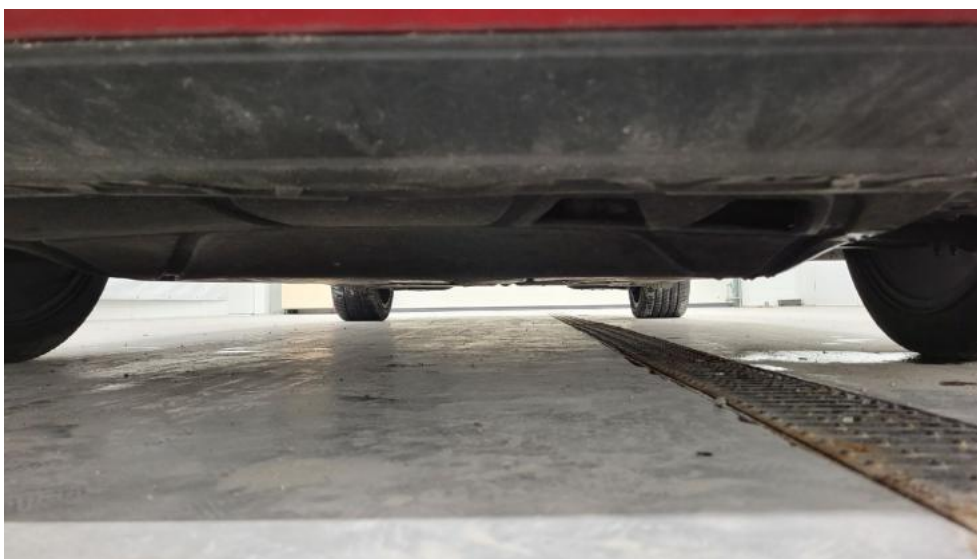
**Photo 13.**  
Spód pojazdu przód

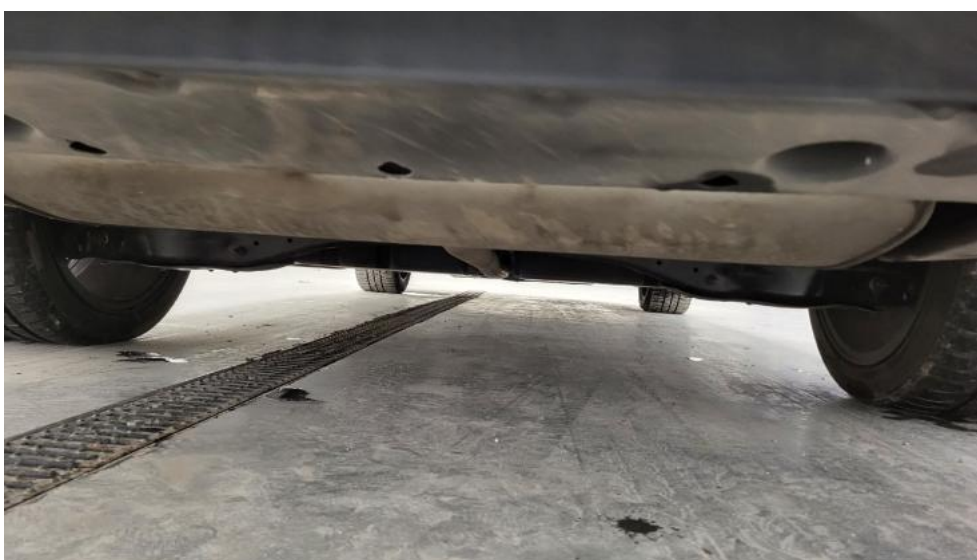
**Photo 14.**  
Spód pojazdu tył

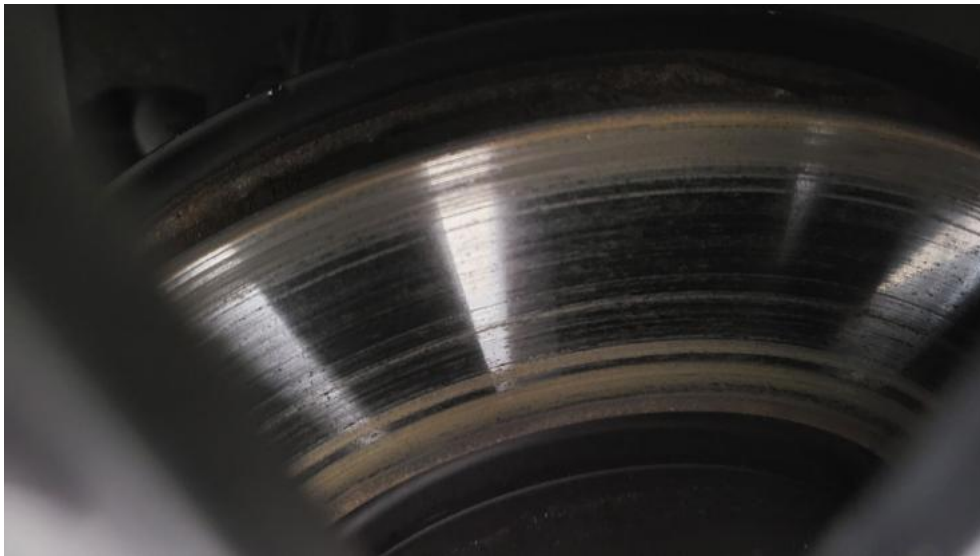
**Photo 15.**

Tarcza hamulcowa przednia prawa

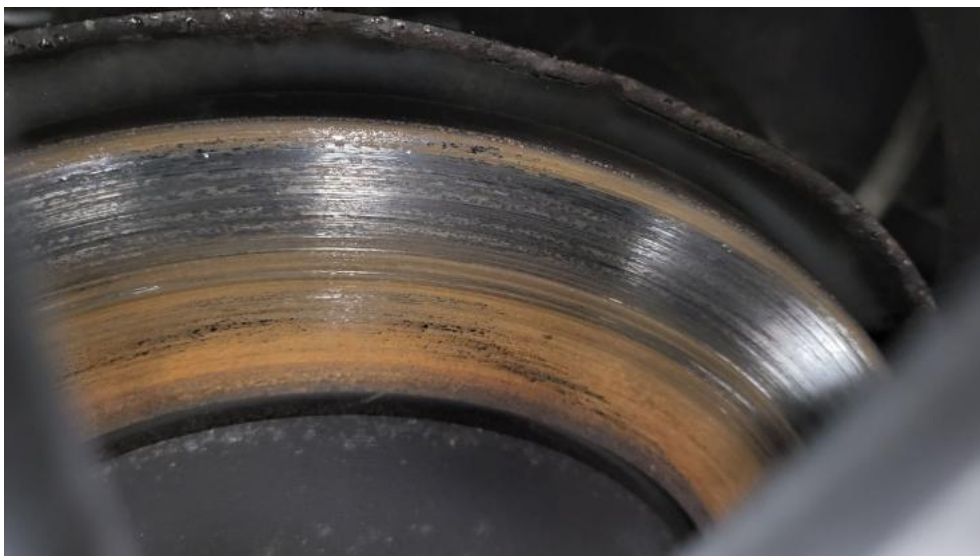
**Photo 16.**

Tarcza hamulcowa tylna prawa

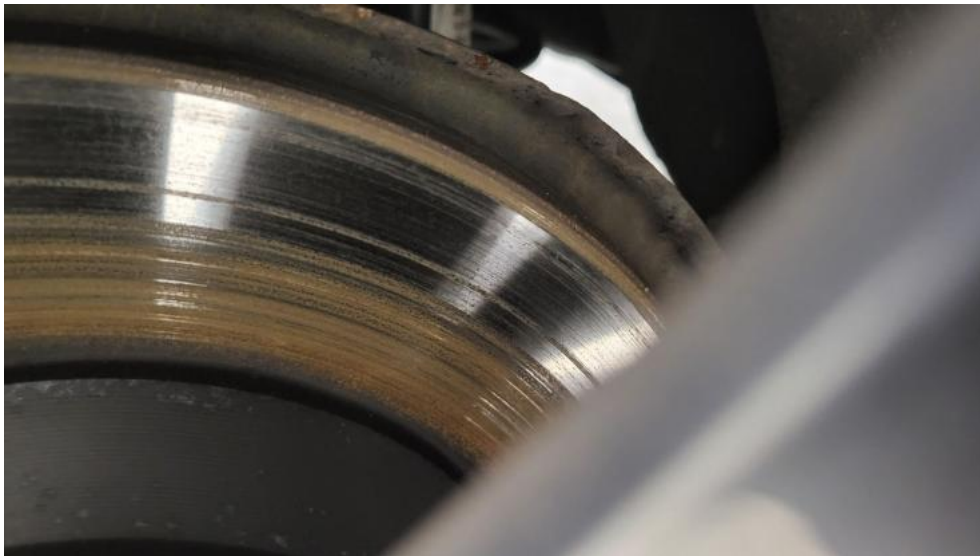
**Photo 17.**

Tarcza hamulcowa tylna lewa

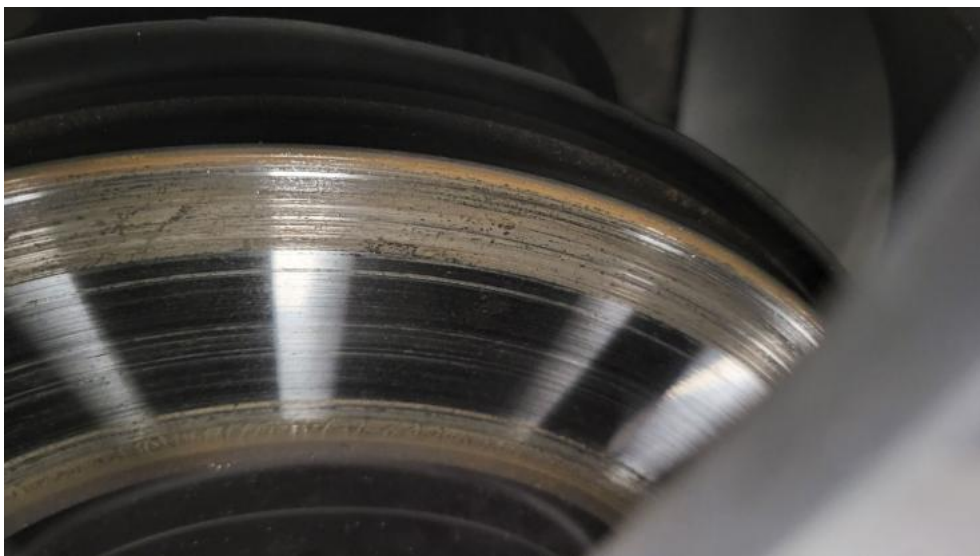
**Photo 18.**

Tarcza hamulcowa przednia lewa

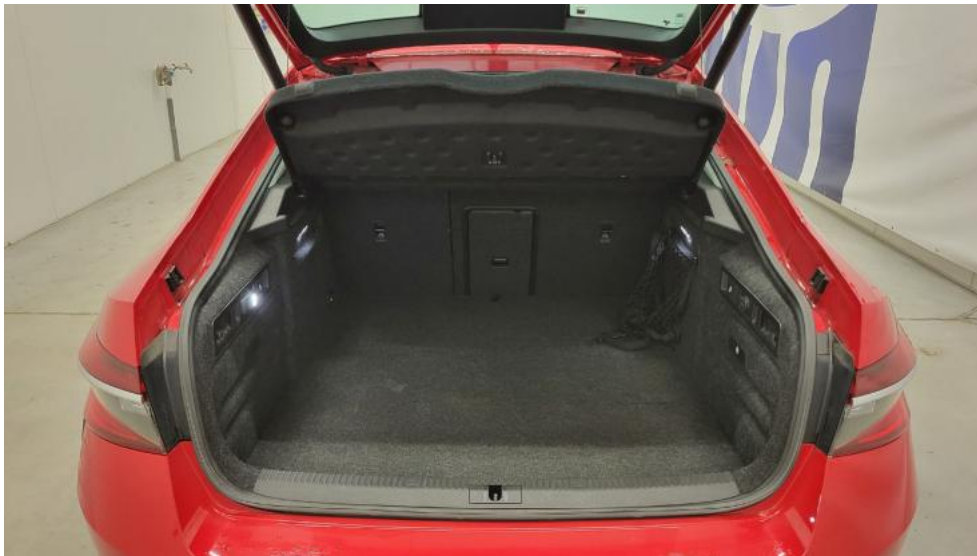
**Photo 19.**  
Bagażnik

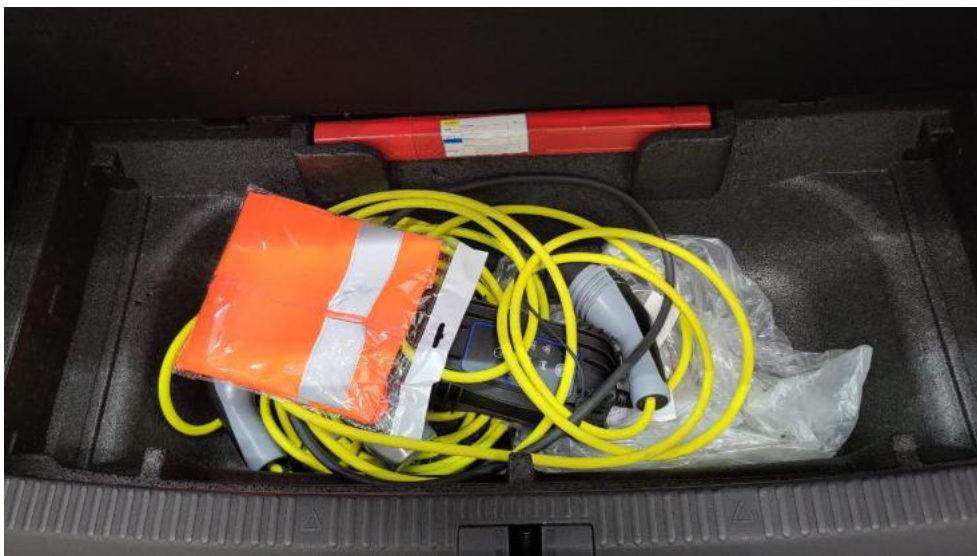
**Photo 20.**  
Koło zapasowe

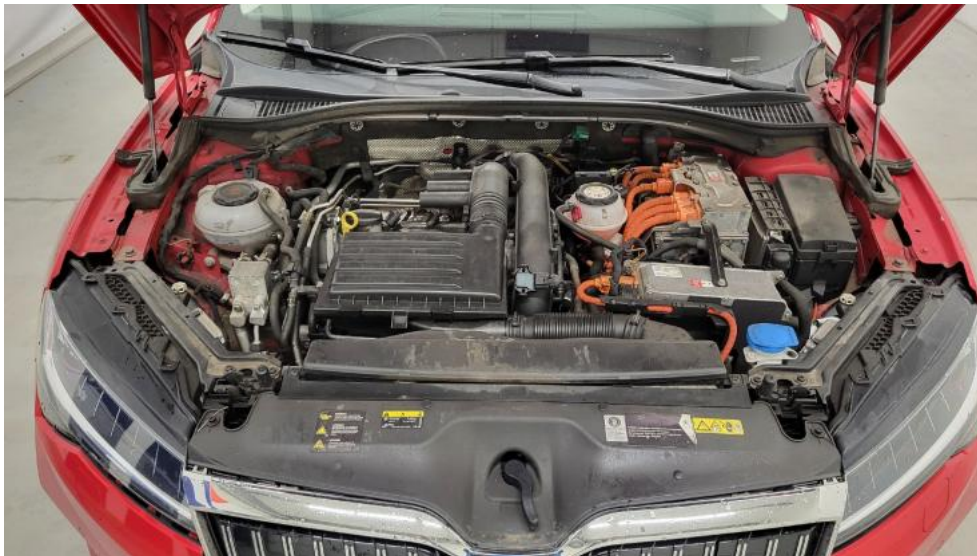
**Photo 21.**  
Komora silnika

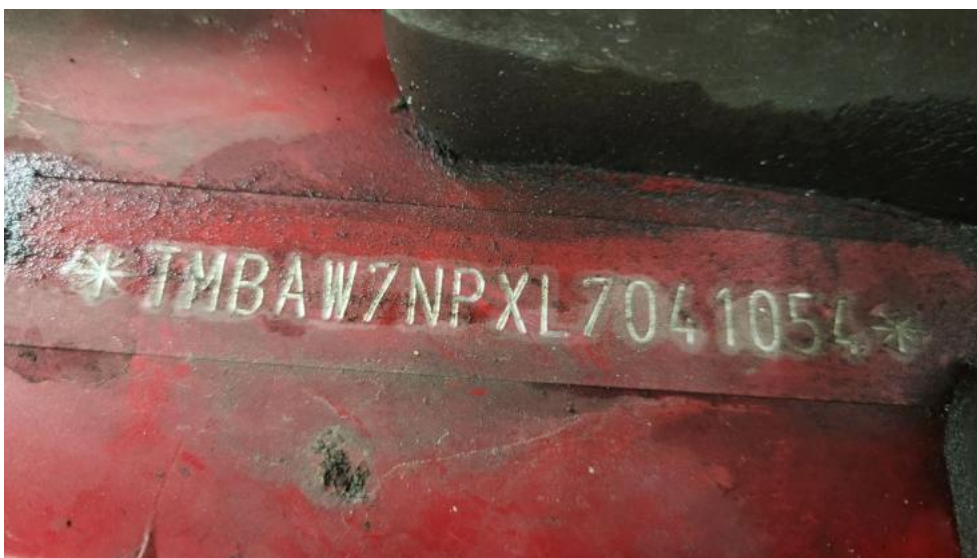
**Photo 22.**  
Numer identyfikacyjny

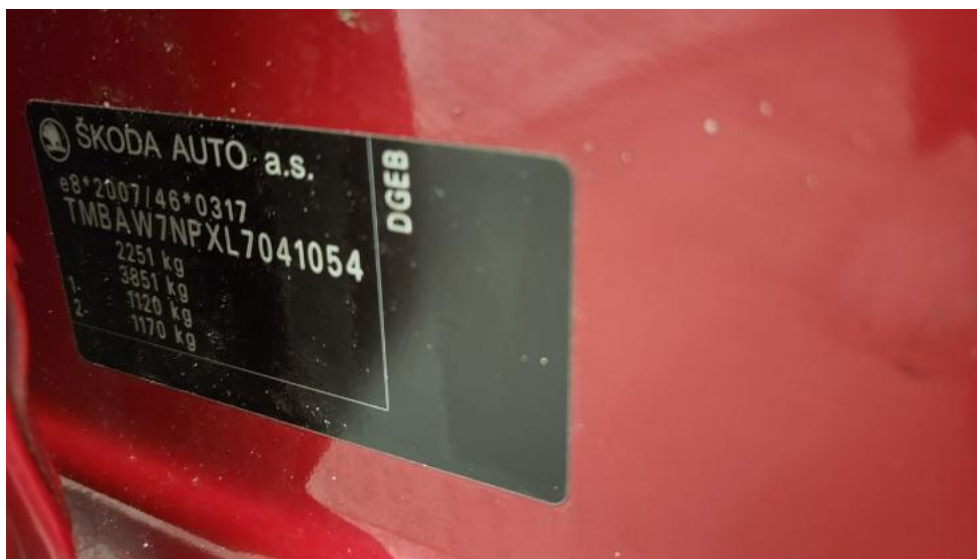
**Photo 23.**  
Tabliczka znamionowa

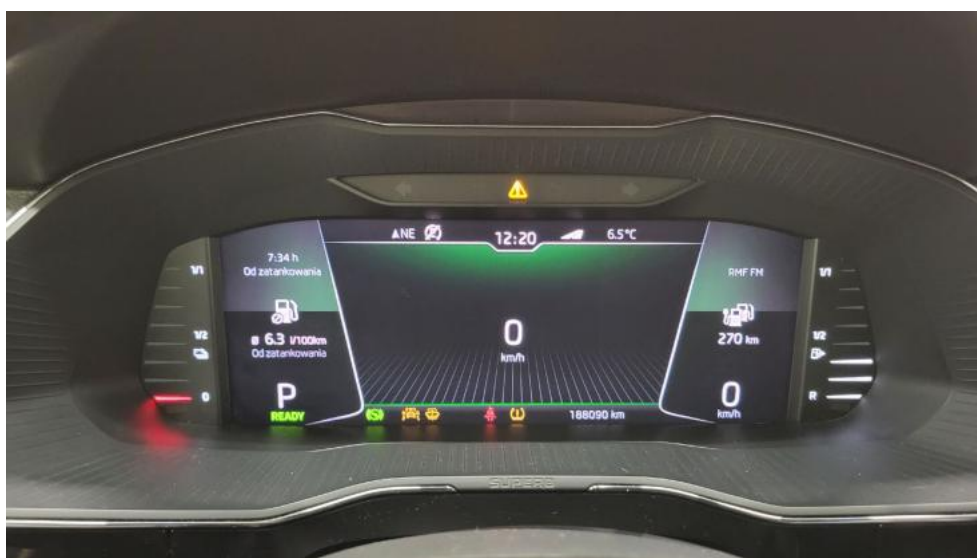
**Photo 24.**  
Zestaw wskaźników - przebieg

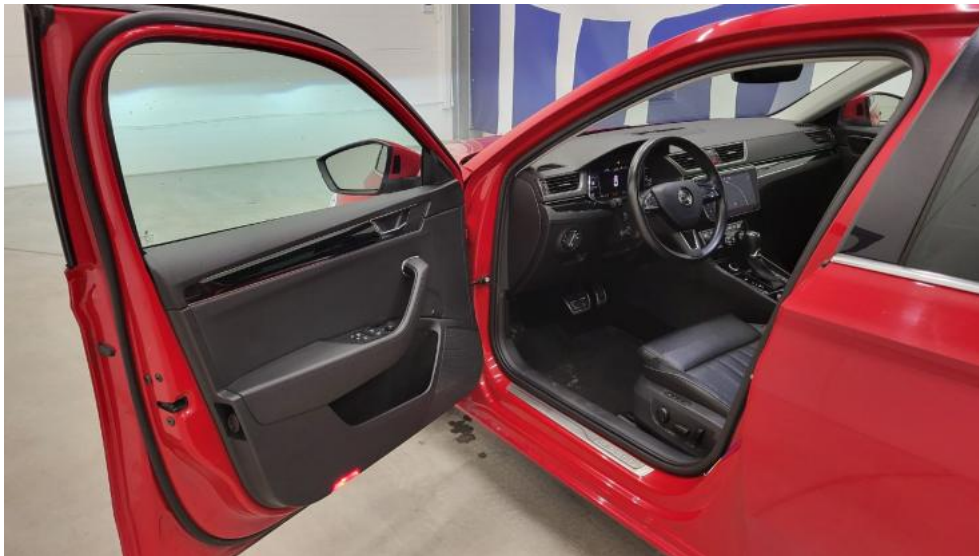
**Photo 25.**

Widok przez otwarte drzwi przednie lewe

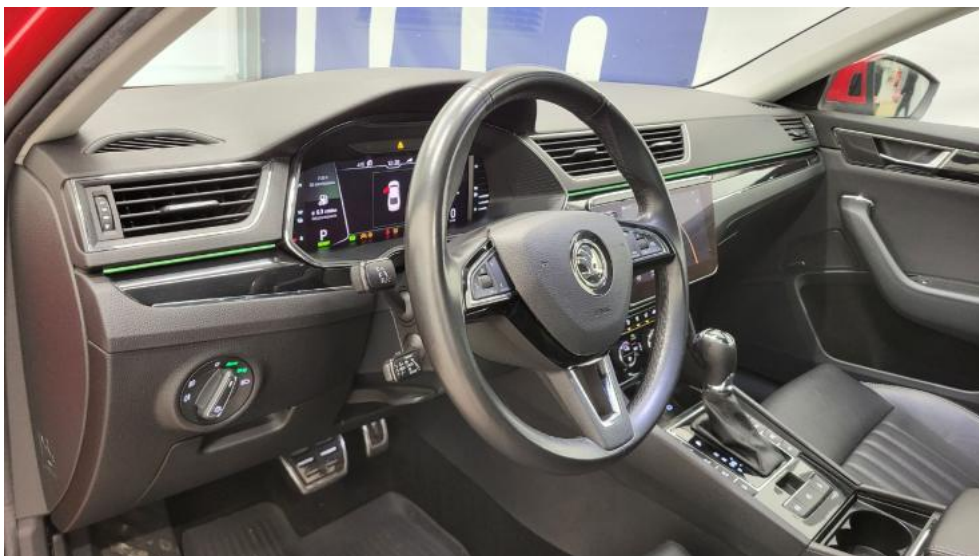
**Photo 26.**

Kierownica z lewej strony

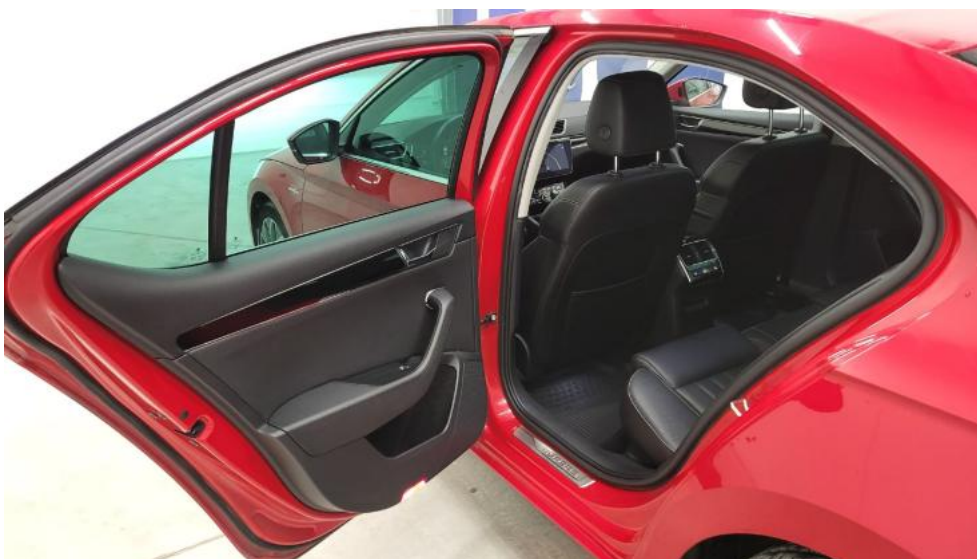
**Photo 27.**

Widok przez otwarte drzwi tylne lewe

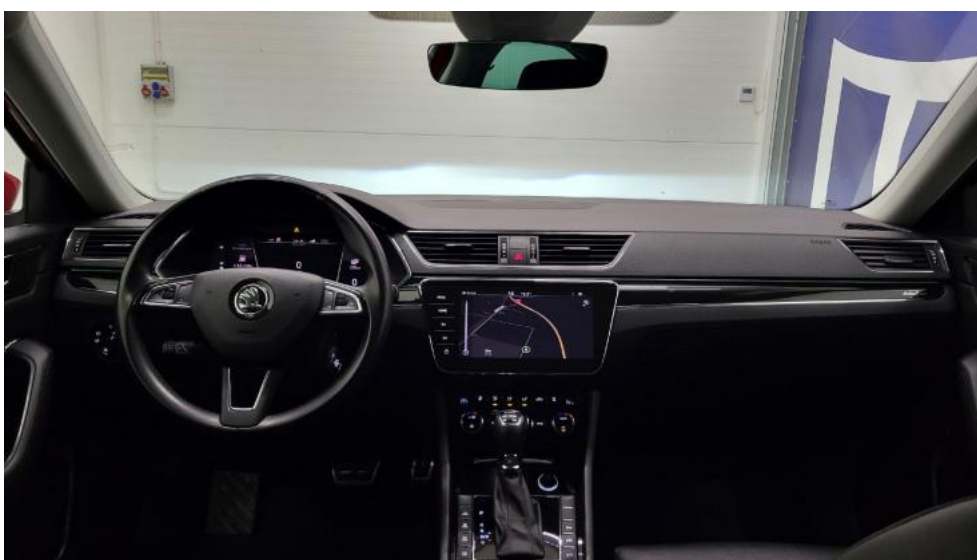
**Photo 28.**

Widok z tylnej kanapy na deskę rozd.

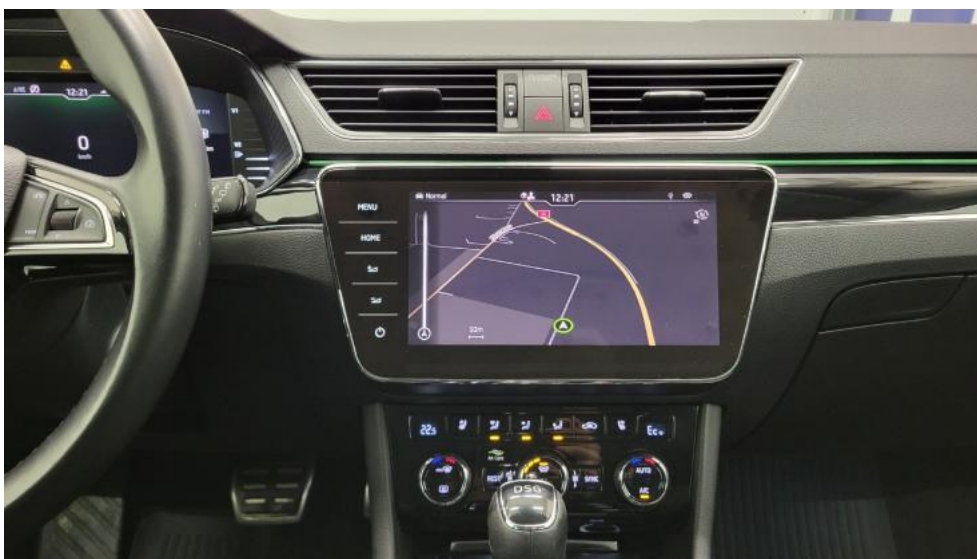
**Photo 29.**  
Konsola środkowa

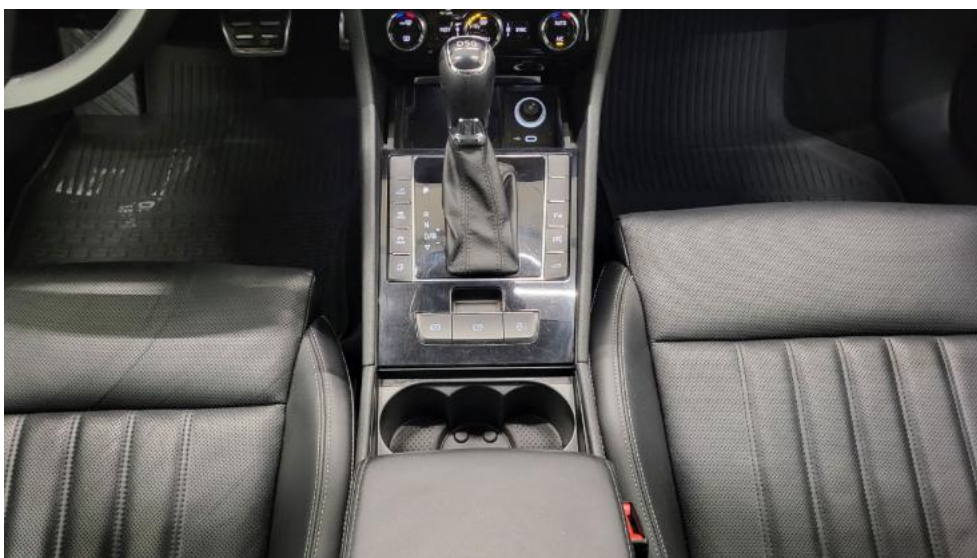
**Photo 30.**  
Tunel środkowy

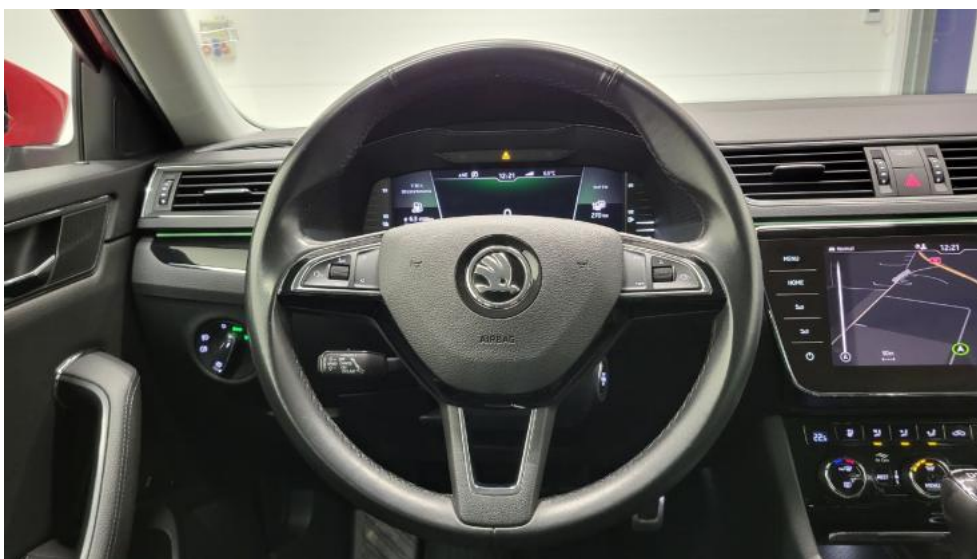
Photo 31.

Kierownica (na wprost)

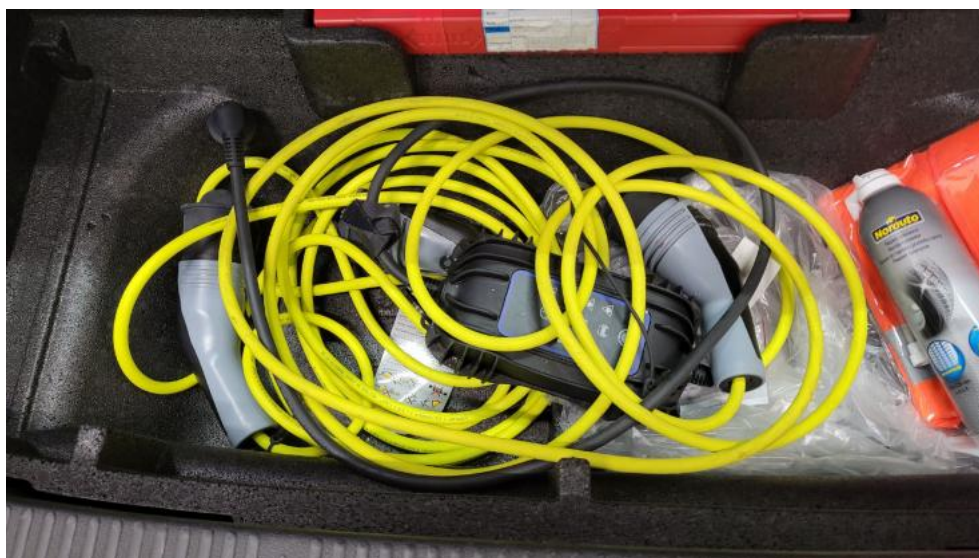
**Photo 36.**

Przewód ładowania baterii trakcyjnej

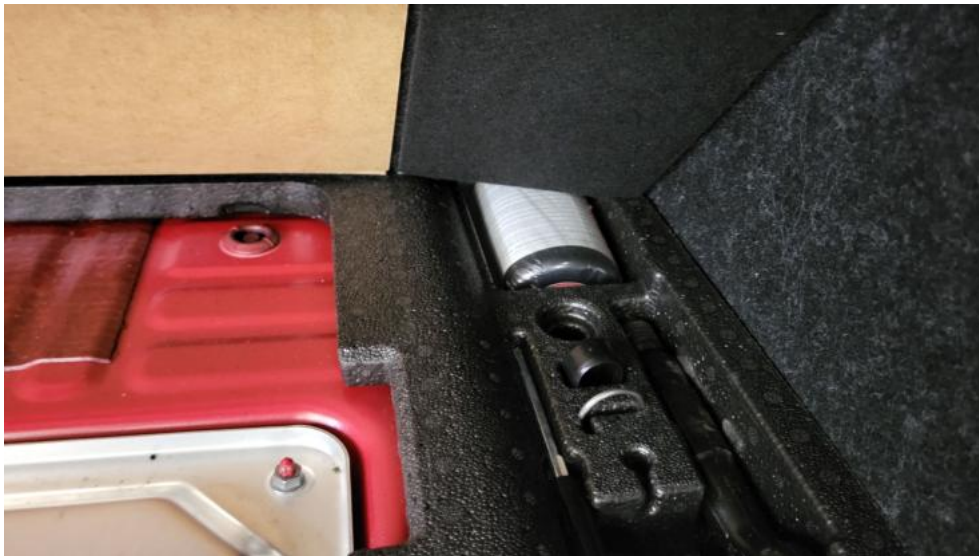
**Photo 37.**

Zestaw naprawczy koła

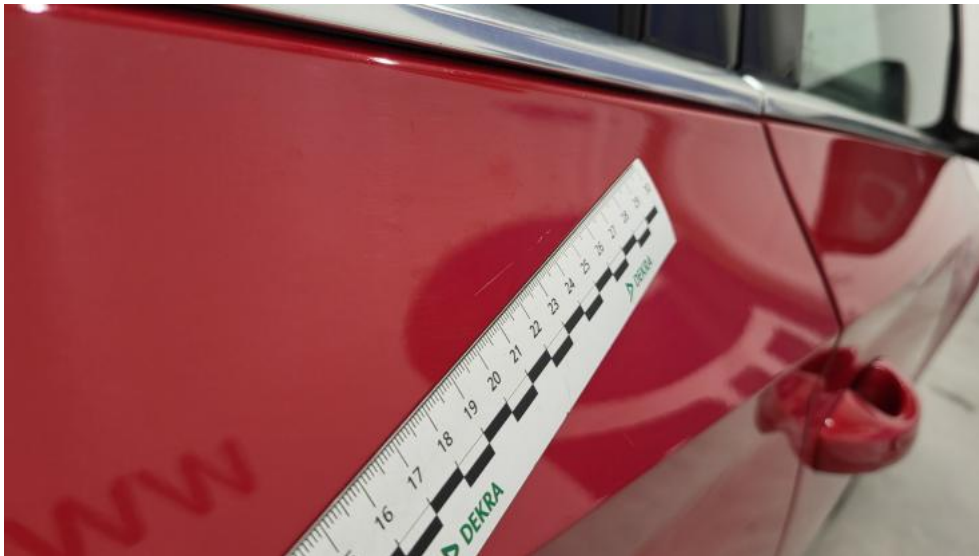
**Photo 63.**

Drzwi tylne P - Rysa/odprysk 1

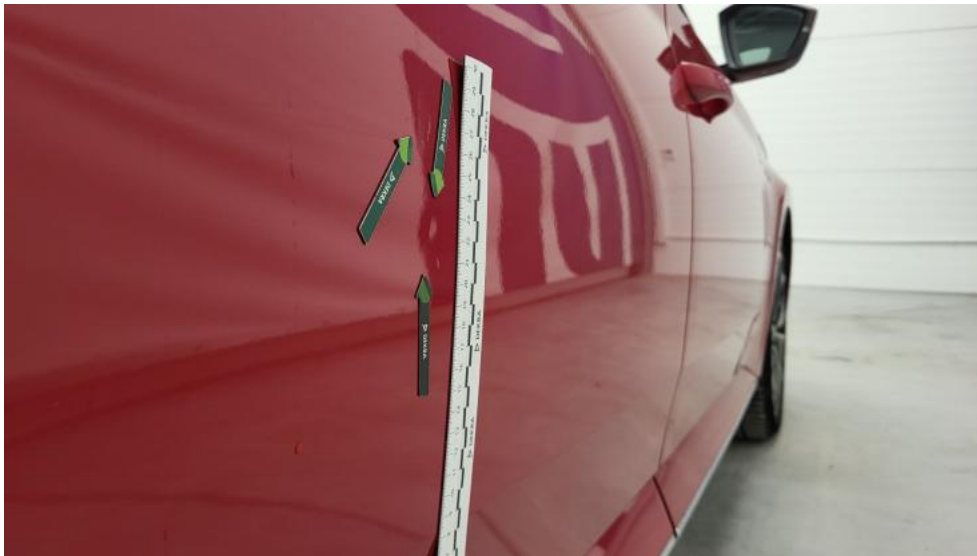
**Photo 65.**

Drzwi tylne P - Wgniecenie/odkształcenie 1

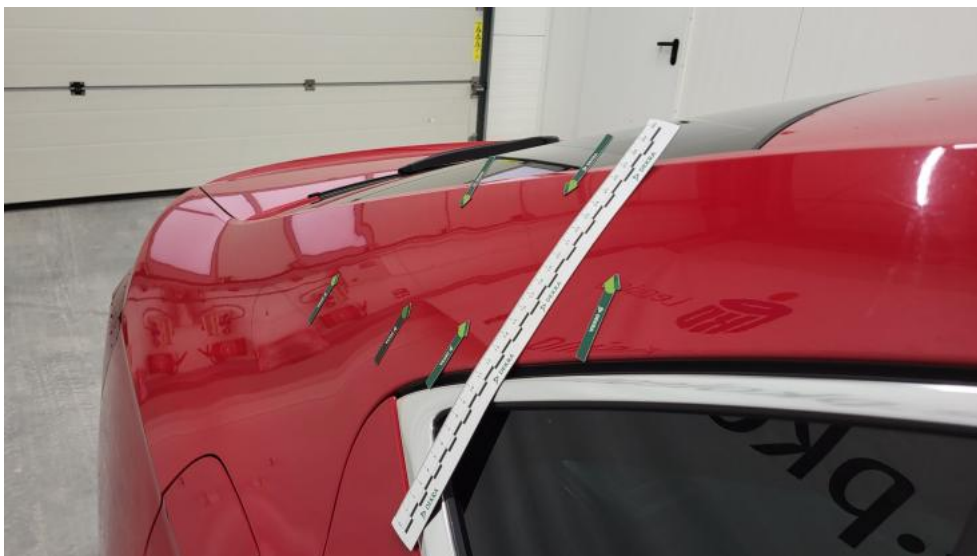
**Photo 66.**

Łotnik tylny P / Ściana boczna P - Wgniecenie/odkształcenie 1

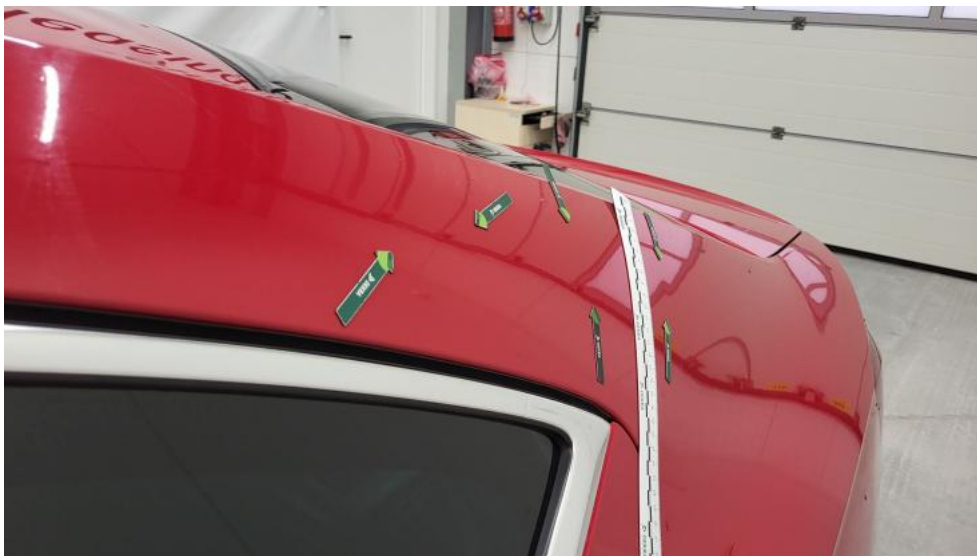
**Photo 73.**

Błotnik tylny L / Ściana boczna L - Wgniecenie/odkształcenie 2

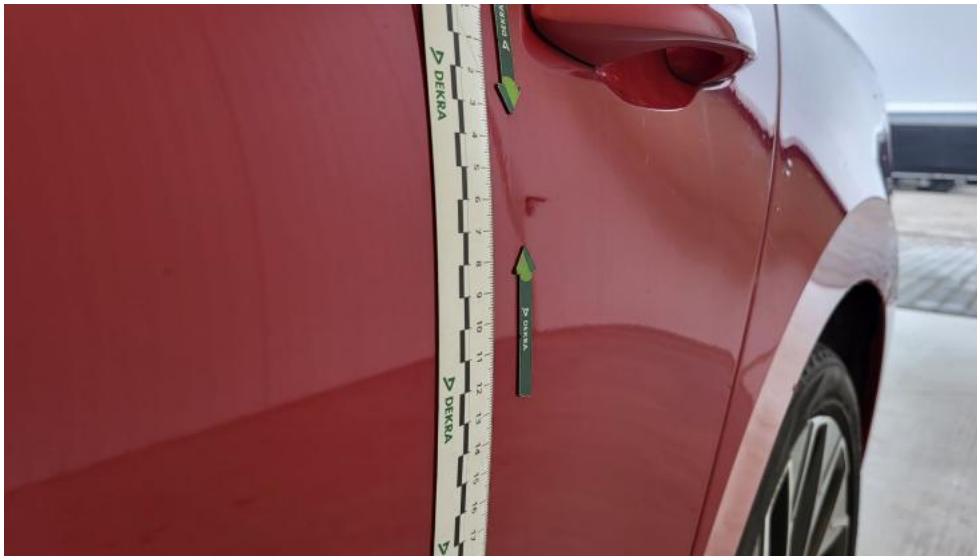
**Photo 79.**

Drzwi tylne L - Wgniecenie/odkształcenie 1

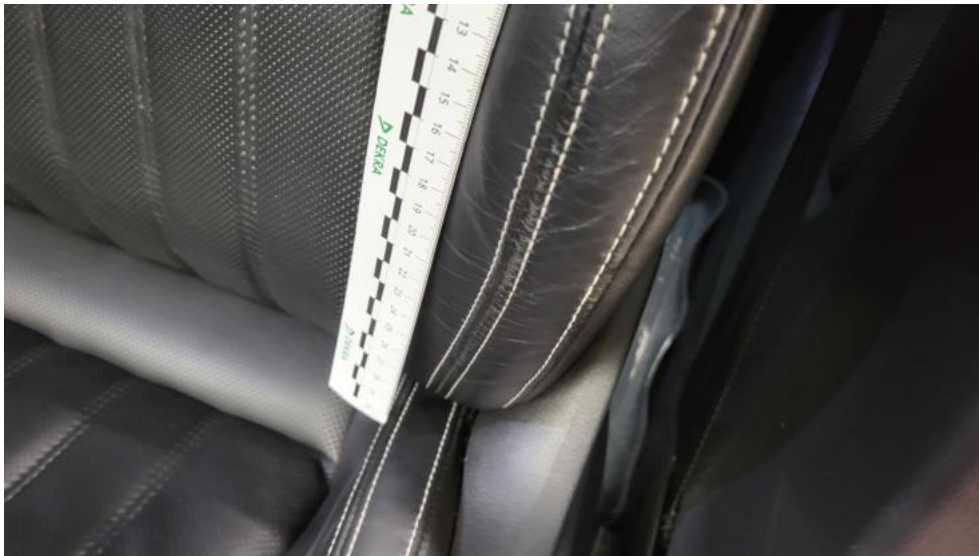
**Photo 81.**

Fotel prz. lew. - Inne 1

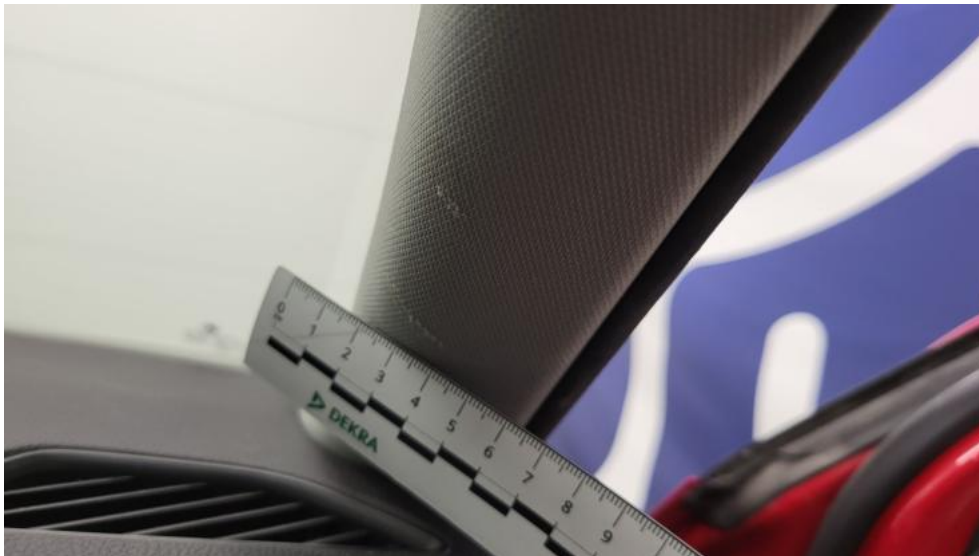
**Photo 83.**

Wykładzina(y) słupka przedniego P - Rysa/odprysk 1

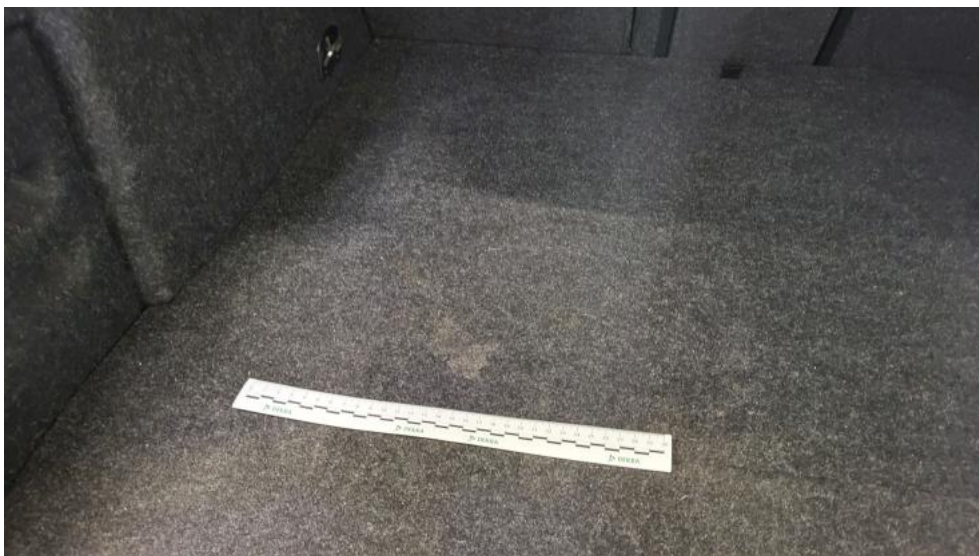
**Photo 84.**

Wykładzina podłogi bagażnika - Inne 1
