DEKRA's commission No. : PKOL(W)/LODZ/82237/24/10/23  
 commission/ damage No. : B/O/WR/2018/08/0014  
 Date of commission: 23-10-2024

**Vehicle data**

Group of objects (Eurotax)	jeeps
EC code (Eurotax)	0103316
Manufacturer	BMW
Model	X5 [F15/F85] 13-18
Type / version	X5 xDrive40d
Body type	KOM
Number of doors / seats	5/5
Curb weight [kg]	2110
Gross vehicle weight [kg]	2865
Wheelbase 1/2	2933
Engine type	Automatic ignition
Pollution reduction system	DPF
Engine capacity [ccm]	2993
Engine Power [hp/kW]	313/230
Gearbox	automatic 8- gear
Registration /record No.	DSWJH87
VIN / serial number	WBAKS610200N68039
Date of first registration	17-03-2017
Date of next. tech. test	15-03-2025
Year of manufacture	2017 (year has been verified with the manufacturer's base)
Readout [km]	220 608 (read)
Body color / type of coating	black/double-layered, metallized

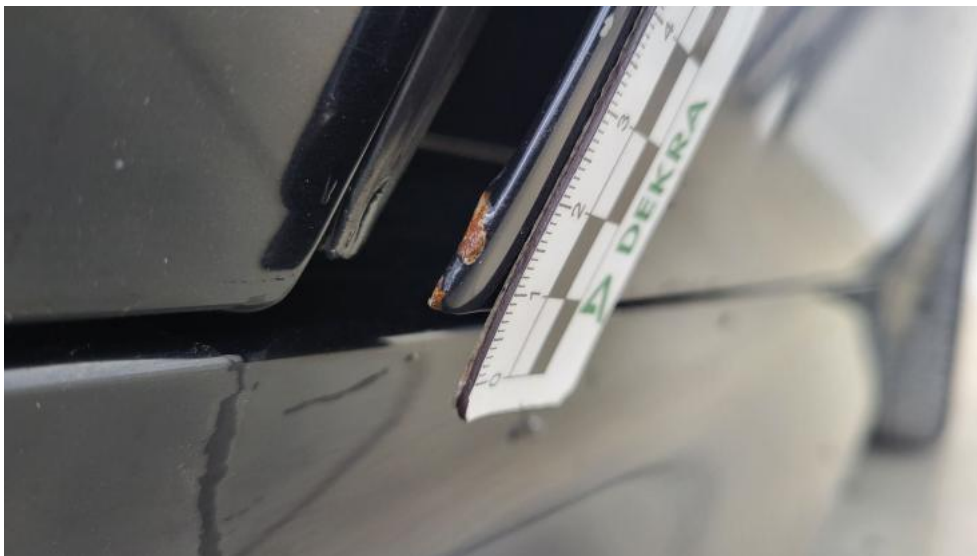
**Photo 53.**

Drzwi przednie P - Inne 1

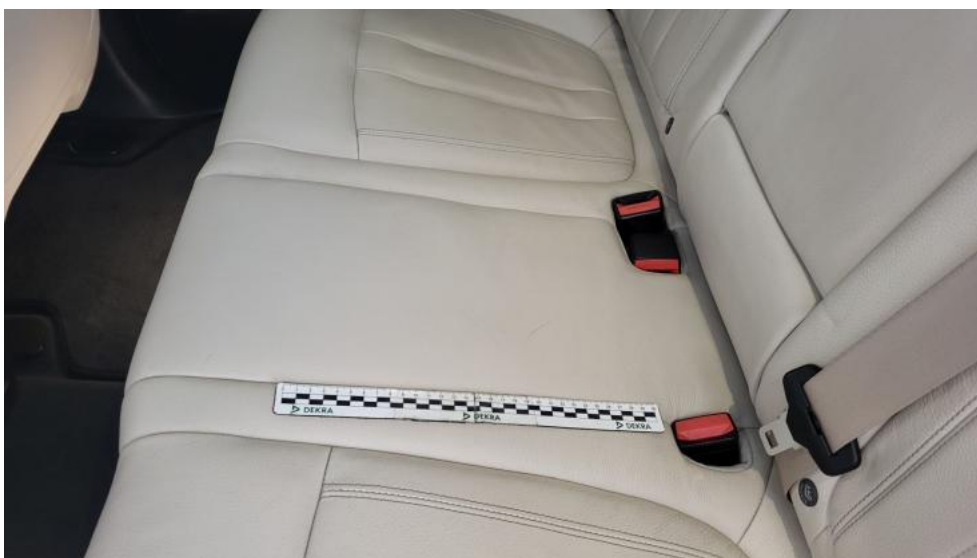
**Photo 84.**  
Kanapa tyl. - Inne 2

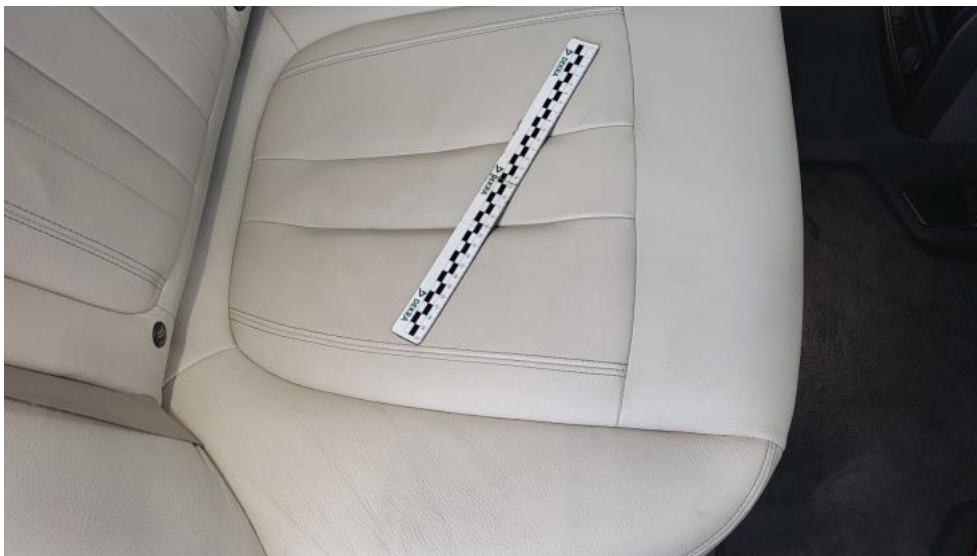
**Photo 85.**  
Kanapa tyl.(.) - Inne 3

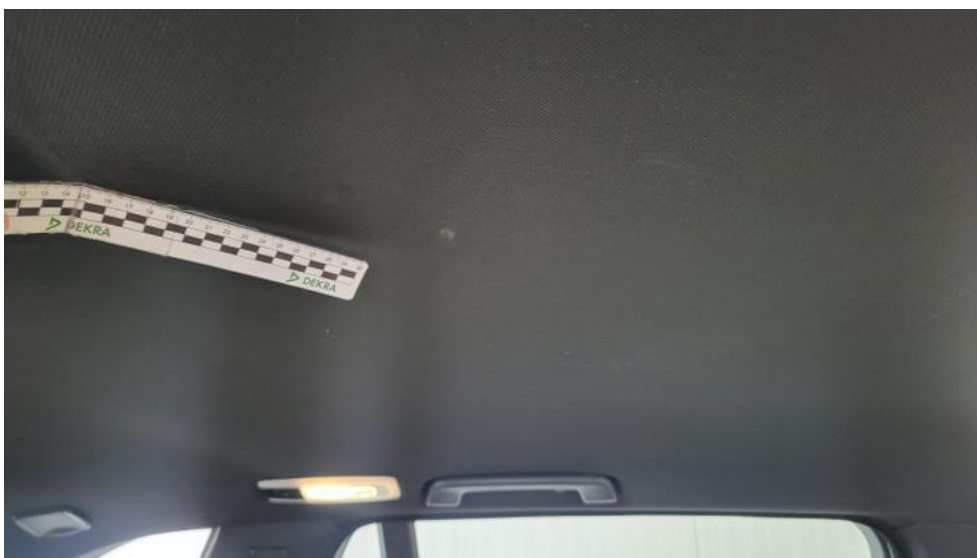
**Photo 86.**  
Podsufitka - Inne 1

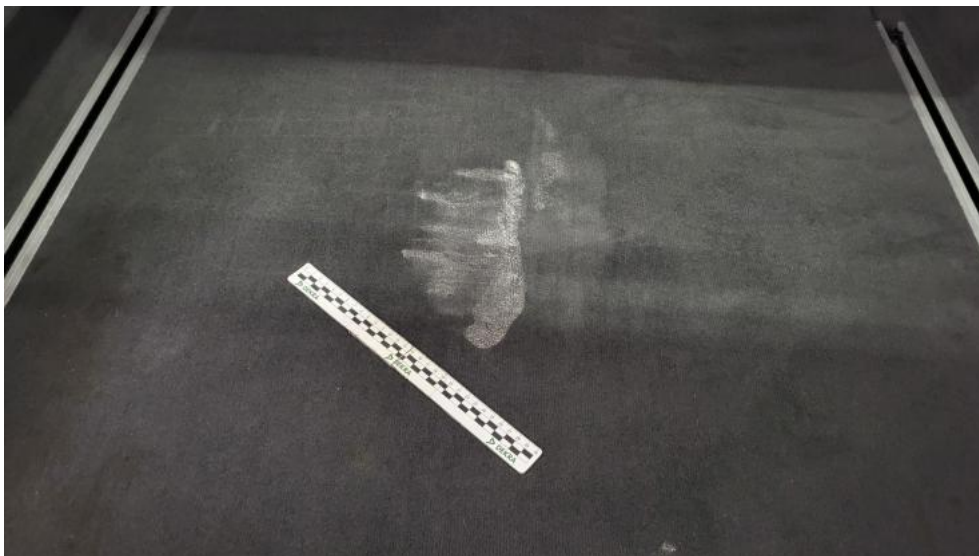
**Photo 87.**

Wykładzina podłogi bagażnika - Inne 1
