DEKRA's commission No. : PKOL(W)/LODZ/73884/25/09/30  
commission/ damage No. : 24/038139  
Date of commission: 30-09-2025

**DEKRA Poland - Headquarters**  
02-673 Warszawa, ul. Konstruktorska 12A

| Model | Camry 18-20 |
| Type / version | Camry 2.5 Hybrid Executive CVT |

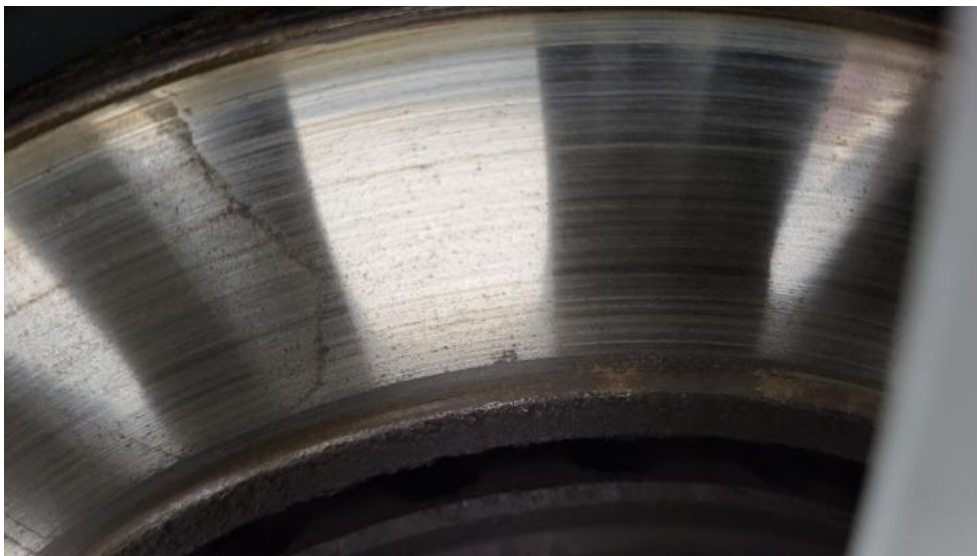
**Photo 15.**

Tarcza hamulcowa przednia prawa

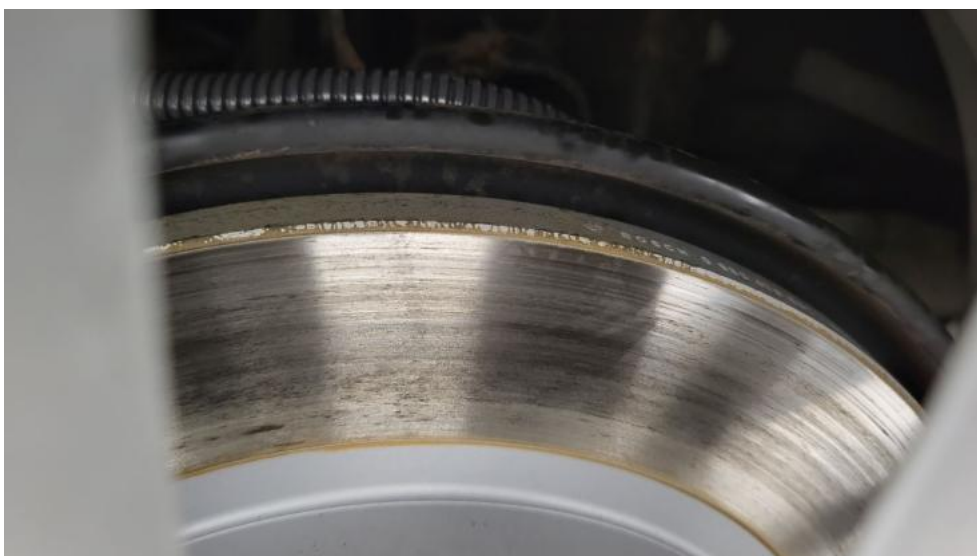
**Photo 16.**

Tarcza hamulcowa tylna prawa

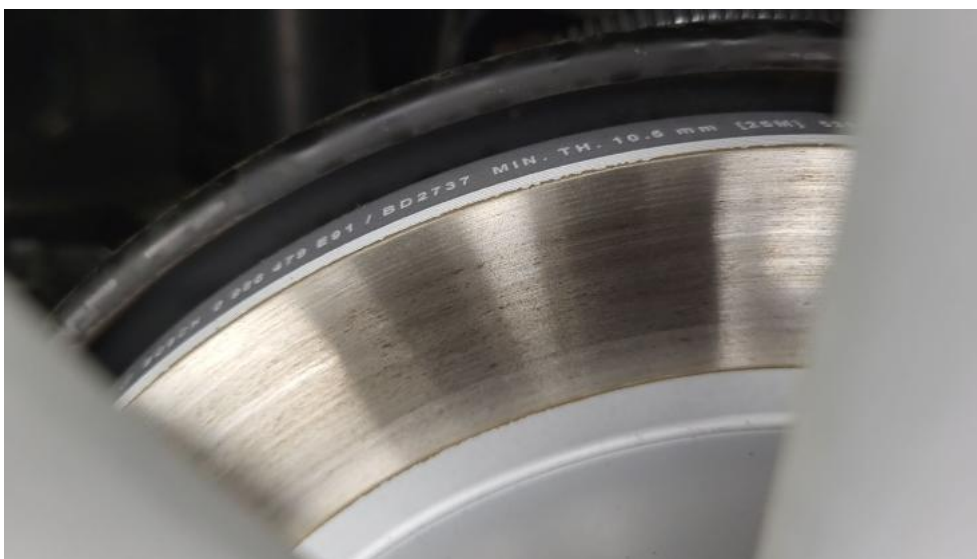
**Photo 17.**

Tarcza hamulcowa tylna lewa

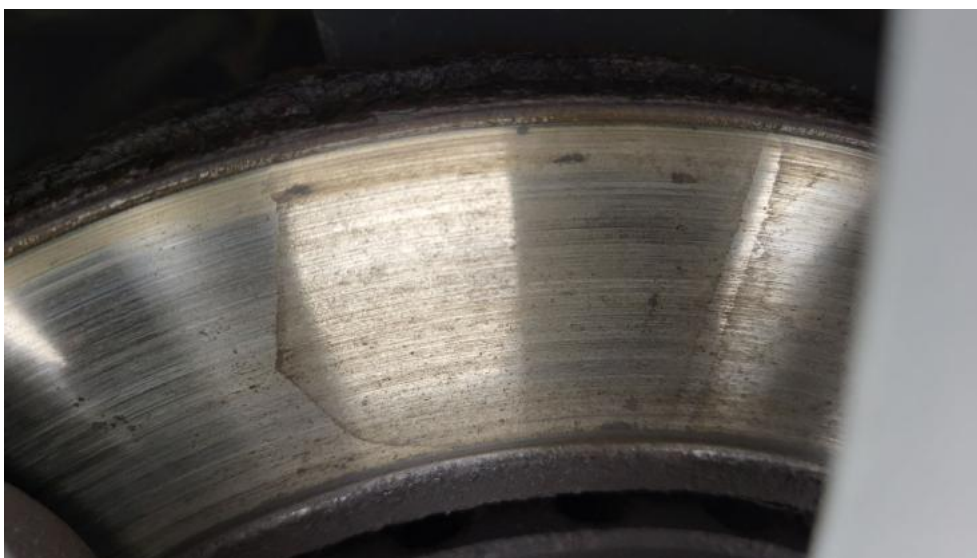
**Photo 18.**

Tarcza hamulcowa przednia lewa

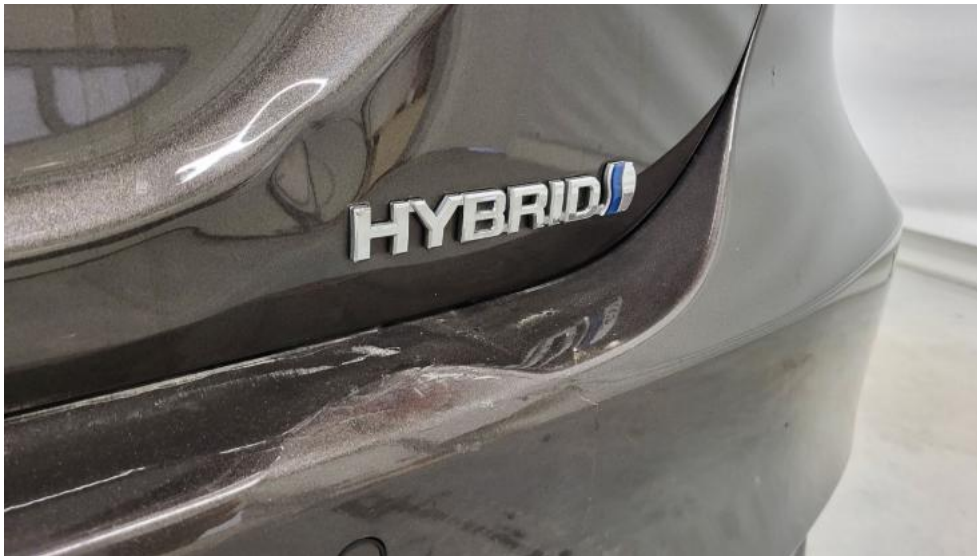
**Photo 37.**

Zdjęcie do protokołu

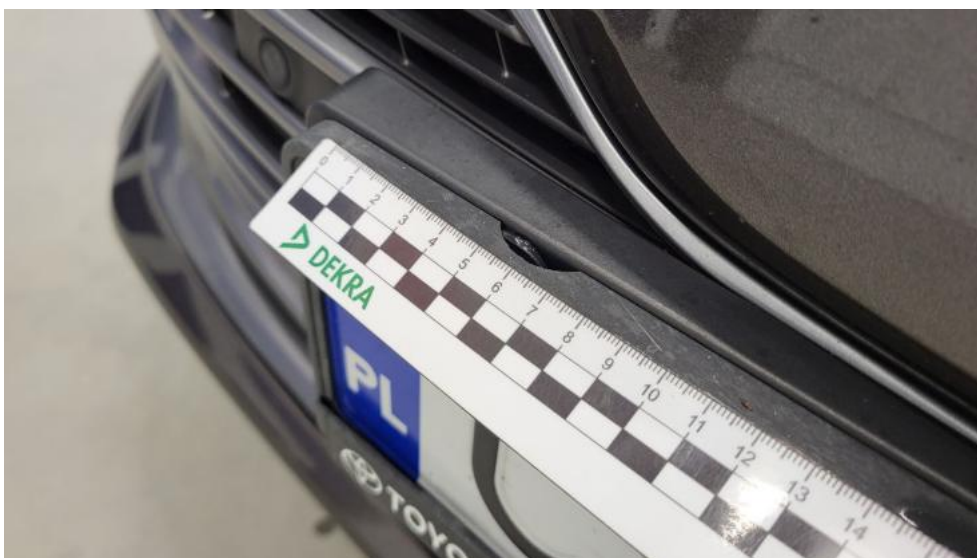
**Photo 38.**

Zdjęcie do protokołu

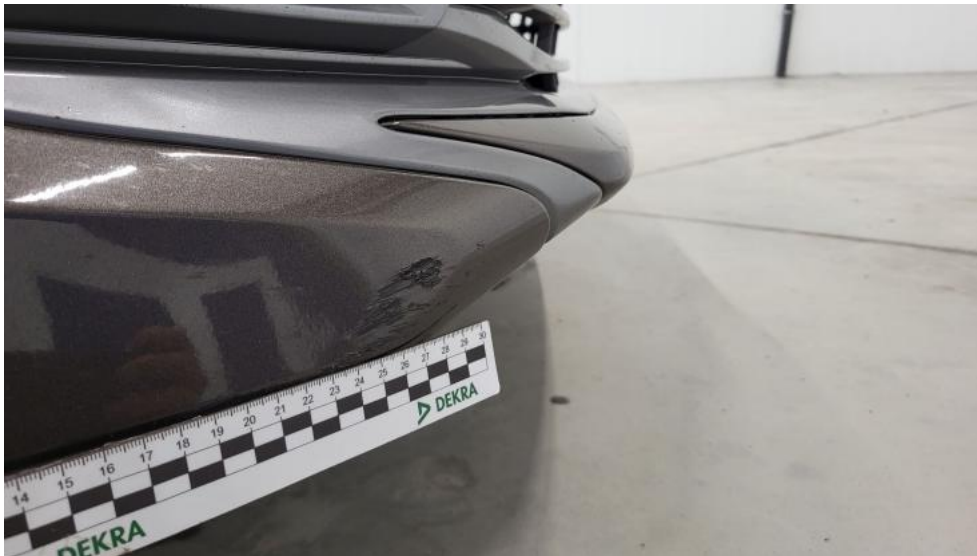
**Photo 45.**

Zderzak - Wgniecenie/odkształcenie 1

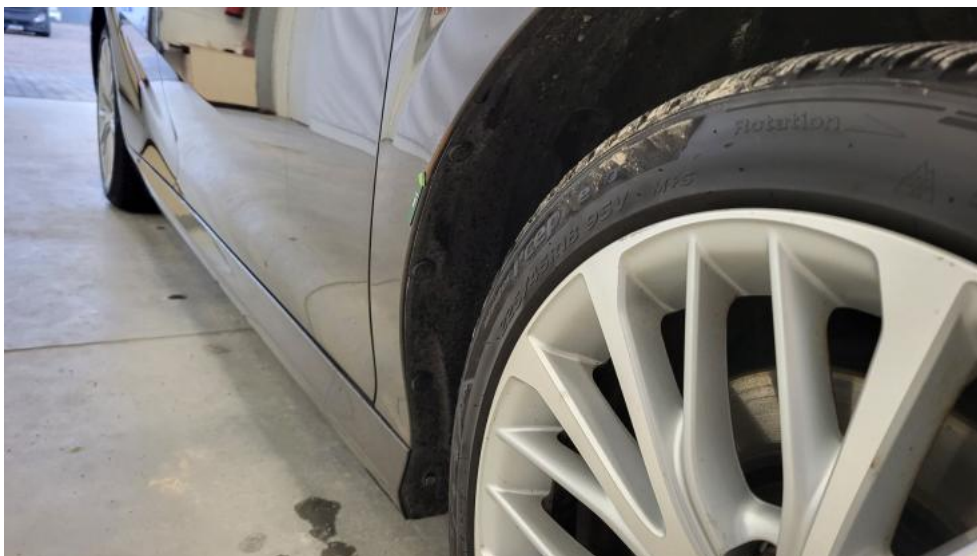
**Photo 46.**

Łotnik przedni P - Wgniecenie/odkształcenie 1

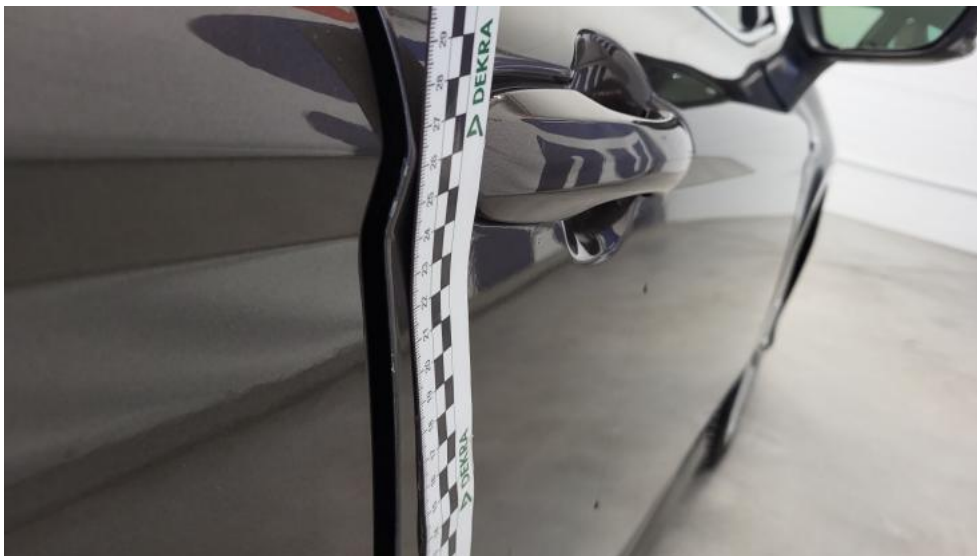
**Photo 49.**

Drzwi przednie P - Rysa/odprysk 1

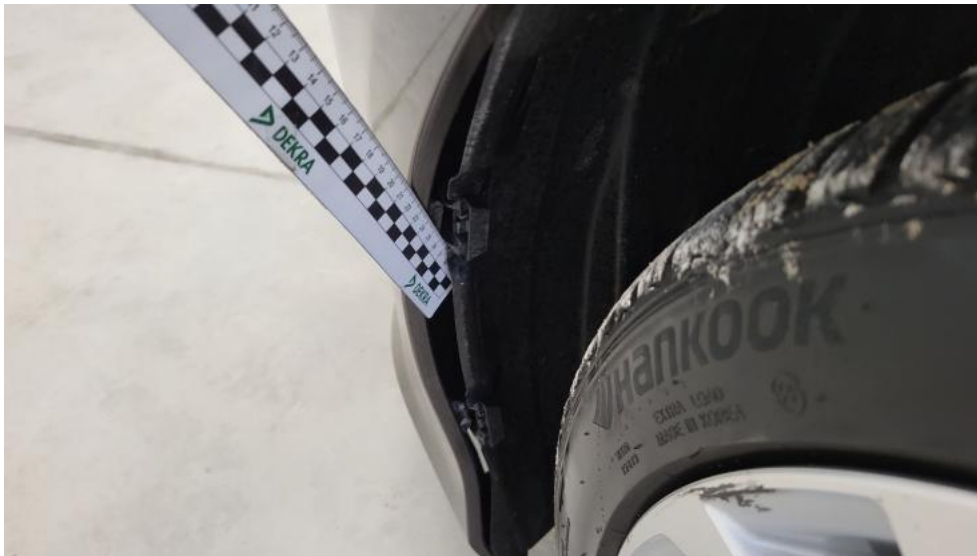
**Photo 71.**

Nadkole przednie L - Inne 1

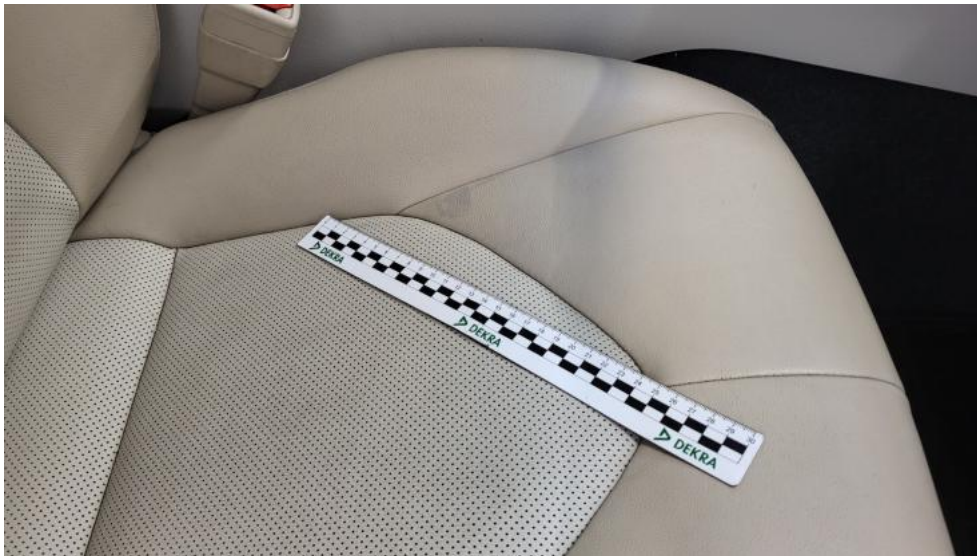
**Photo 75.**

Fotel prz. praw. - Inne 1
